PROPERTY & TIMBER PEST REPORT

Property Address **123 Example Boulevard Greater Brisbane Area
QLD 4000**

Report Number: **I026150**

Inspection Date & Time: **Tuesday 01 January 2013 08:00 AM**

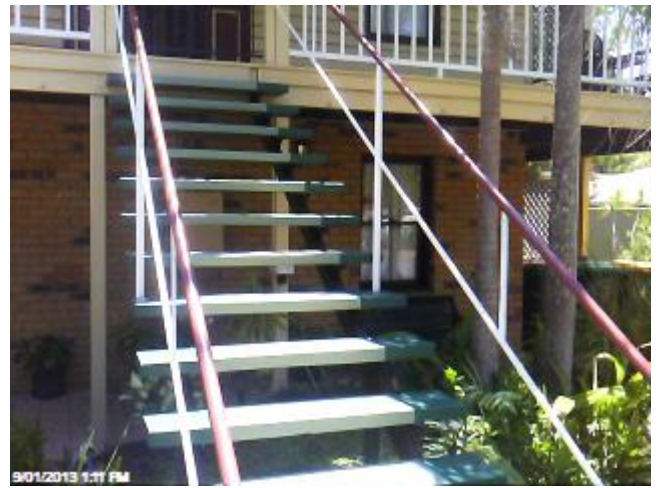
Description	The platform or stair is more than 1 meter from the ground and has gaps greater than 125mm..
Location	The external stairs at the front of the building
Recommendation	<p>This condition is considered potentially dangerous. A further investigation by a licensed building contractor is strongly recommended to determine the extent of remedial work required. The above recommendation should be implemented without delay</p> <p>Immediate action must be taken to ensure that anyone entering the area is warned of this hazard.</p>

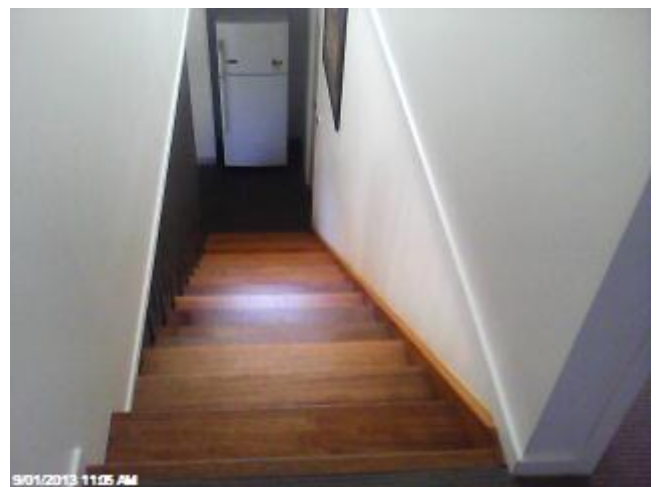
Description	No handrail
Location	The internal stairs
Recommendation	<p>This condition is considered potentially dangerous. A further investigation by a licensed building contractor is strongly recommended to determine the extent of remedial work required. The above recommendation should be implemented without delay</p> <p>Immediate action must be taken to ensure that anyone entering the area is warned of this hazard.</p>

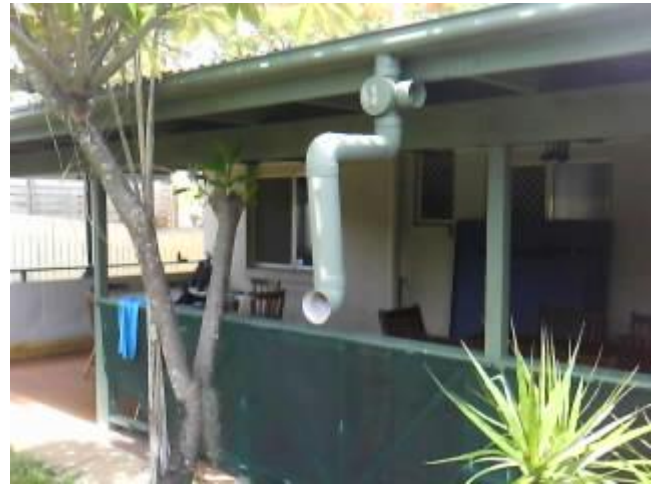
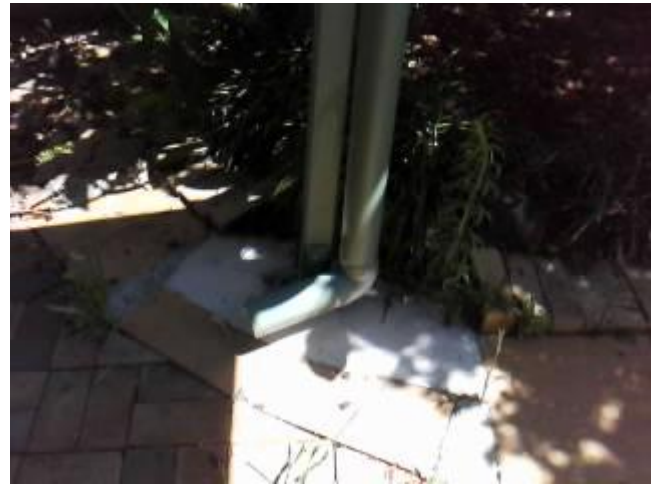
Area	Pergola
Location	Eastern Side Of The Structure
Element	Downpipe
Defect/Observation	Discharging near footings. All drainage should be connected to a storm water drain or directed well away from footings.
Extent	Widespread
Recommendation	This defect falls within the category of Conditions Conducive to Structural Damage & Timber Pest Activity. It is strongly recommended that this condition be removed. A further investigation by a Licensed Plumber is also recommended to determine the extent of work required and associated costs. The above recommendation should be implemented as soon as possible.

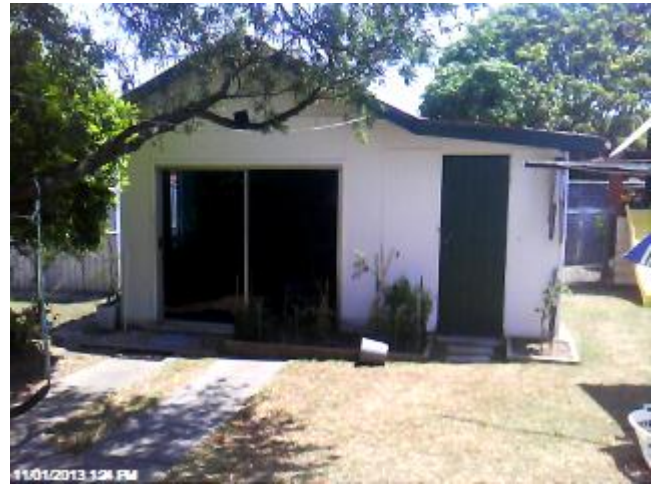
Area	Sleep out
Location	In General
Element	Termite Inspection Zone Termite Barrier
Defect/Observation	Missing
Extent	Widespread
Recommendation	This defect falls within the category of Conditions Conducive to Structural Damage & Timber Pest Activity. It is strongly recommended that this condition be removed. A further investigation by a Licensed Pest Controller (Timber Pest Specialist) is also recommended to determine the extent of work required and associated costs. The above recommendation should be implemented as soon as possible.

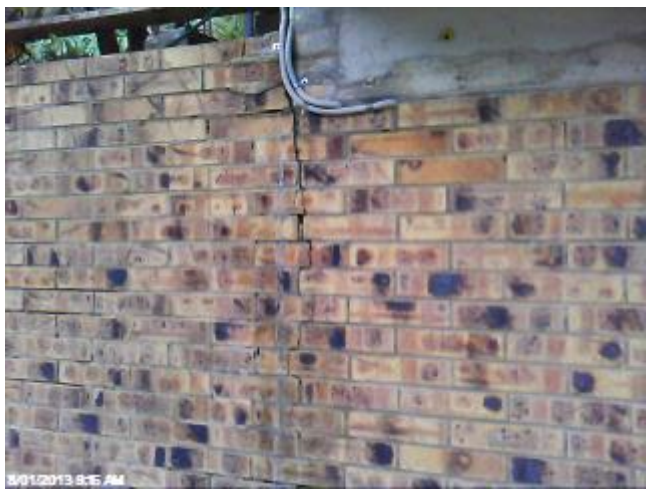
Structure	Retaining wall
Location	To the right hand side of the front door and left hand side of the driveway
Element	Brickwork
Defect/Observation	Cracked
Extent	Localised
Recommendation	This defect falls within the category of “Structural Damage”. It is strongly recommended that this defect be corrected. A further investigation by a Licensed Builder is also recommended to determine the extent of work required and associated costs. The above recommendation should be implemented as soon as possible.

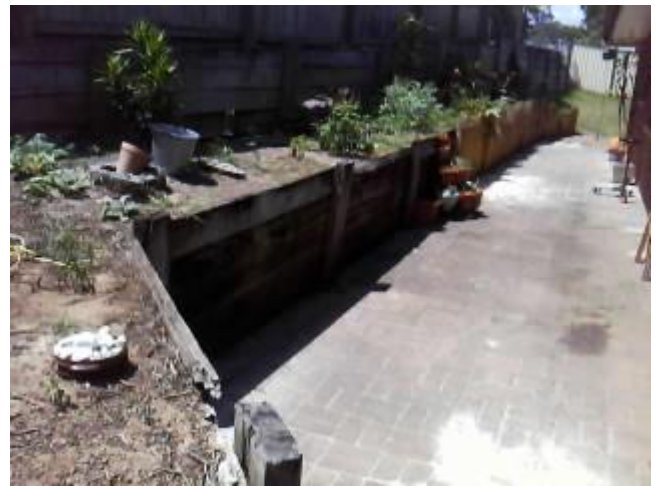
Structure	Retaining wall
Location	Eastern Side Of The Property
Element	All retaining wall elements
Defect/Observation	<p><u>Overturning</u></p> <p>Note: retaining walls above 1M are a safety critical item requiring engineering approval.</p> <p>Typically a failing retaining wall will start to overturn or rotate to a point and then fail catastrophically.</p>
Extent	Widespread
Recommendation	<p>This defect falls within the category of “Structural Damage”. It is strongly recommended that this defect be corrected.</p> <p>A further investigation by a Structural Engineer is also recommended to determine the extent of work required and associated costs. The above recommendation should be implemented as a matter of urgency.</p>

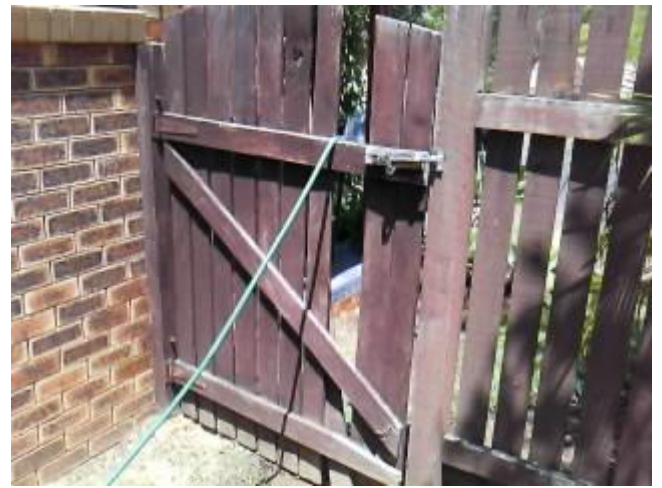
Structure	Gate
Location	Western Side Of The Property
Element	Palings
Defect/Observation	Damaged
Extent	Localised
Recommendation	This defect requires repair or replacement as soon as possible.

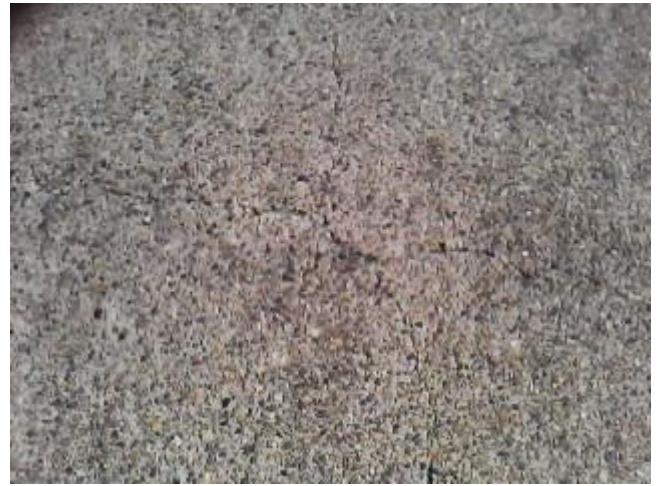
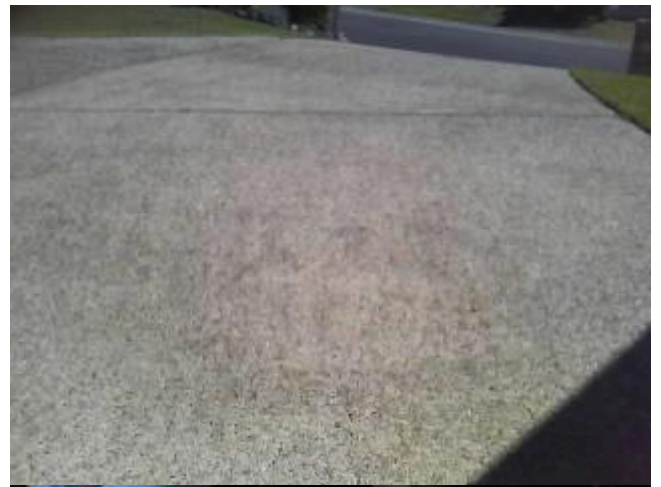
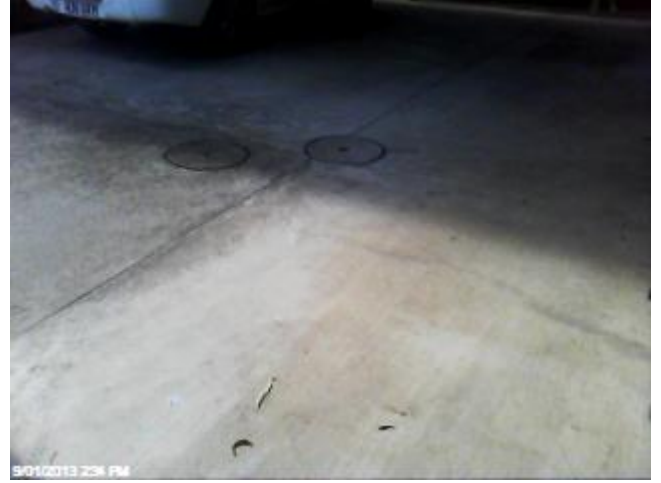
Area	Driveway
Location	Northern side of the property
Element	<p>Concrete Paving</p> <p>Cracking and movement to driveways and other paving in yards is common.</p> <p>The causes of this cracking include poor preparation of the sub-soil, insufficient reinforcing, insufficient thickness of concrete, consolidation of soil, poor drainage, ravages of time etc.</p> <p>Apart from replacement filling cracks with sealant will slow the process of deterioration caused by water entering the cracks.</p>
Defect/Observation	Cracked
Extent	Widespread
Recommendation	<p>The consultant recommends that the client undertakes regular maintenance by filling cracks with sealant and maintaining good drainage.</p> <p>The cracks should continue to be monitored. Repairs may be necessary in the event the defect becomes more significant.</p>

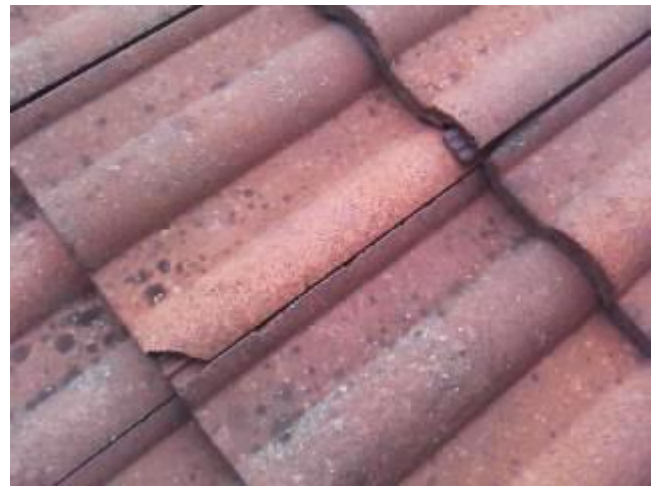
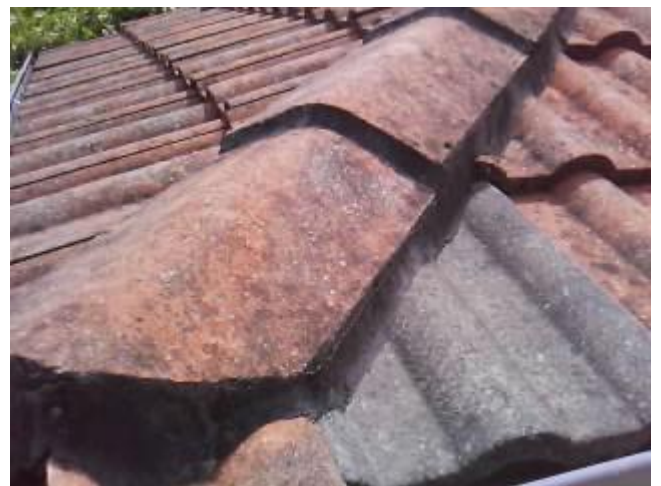
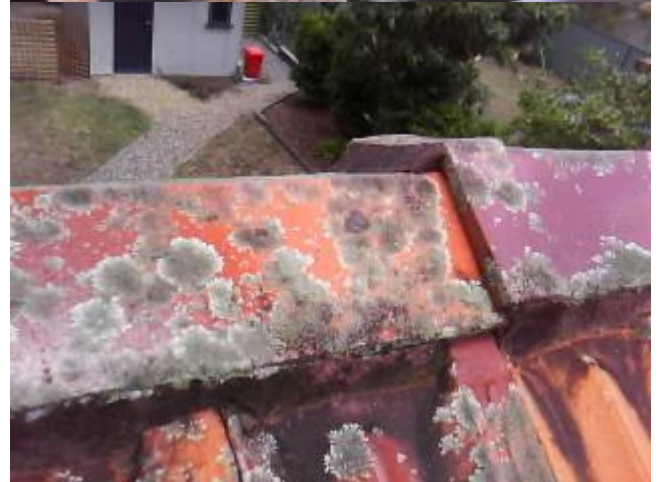
Structure	The lower roof to the main building.
Area Affected	On the south-eastern side of the building
Element	Mortar bedding Mortar pointing Roof tiles
Defect/Observation	Cracked
Extent	Localised
Recommendation	This defect should be addressed by a Licensed Roof Tiler as soon as possible.

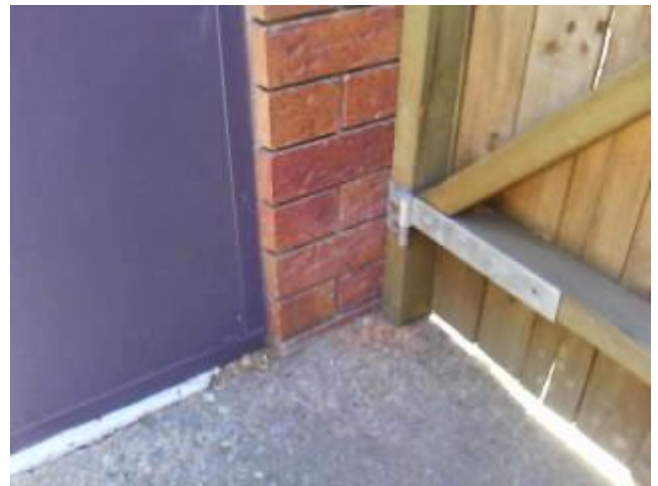
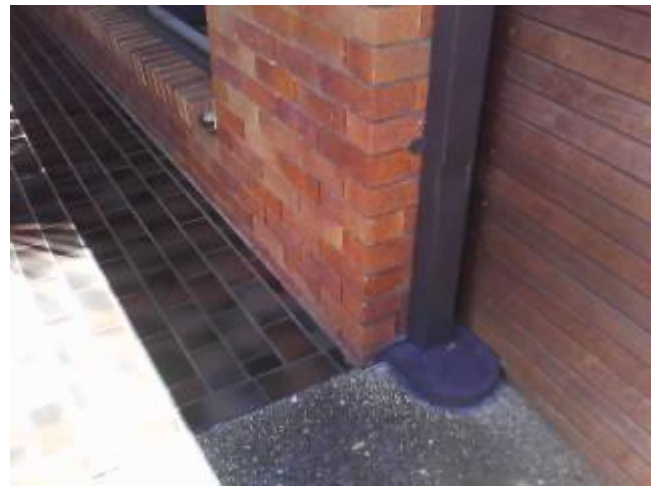
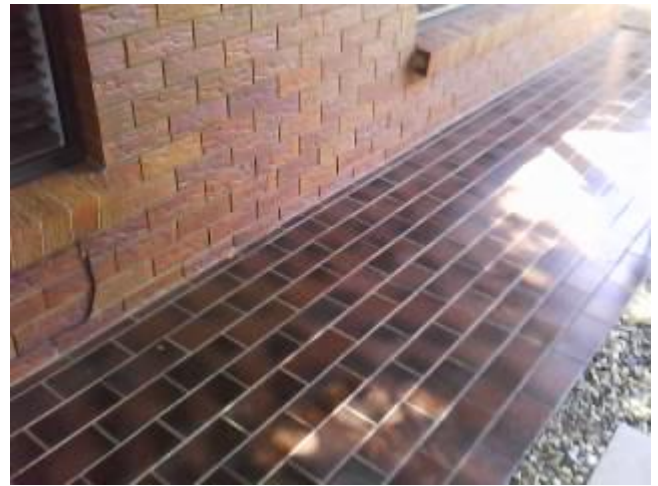
External Wall	External walls to the main building
Location	In general
Element	Termite barrier Termite Inspection Zone
Element Type	Non-loadbearing
Defect/Observation	<p>Bridging</p> <p>Note: 'Bridging' is the spanning of a termite barrier or inspection zone so that subterranean termites are provided with passage over or around that barrier. Australian Standard AS 3660 recognises that barriers shall not be bridged by structures attached to the main building e.g. steps, verandahs, access ramps, claddings, carports, or trellises unless alternative barriers are used to prevent access by termites to the structure.</p>
Extent	Widespread
Recommendation	<p>This defect falls within the category of Conditions Conducive to Structural Damage & Timber Pest Activity. It is strongly recommended that this condition be removed. A further investigation by a Licensed Pest Controller (Timber Pest Specialist) and a Licensed Builder is also recommended to determine the extent of work required and associated costs. The above recommendation should be implemented without delay.</p>

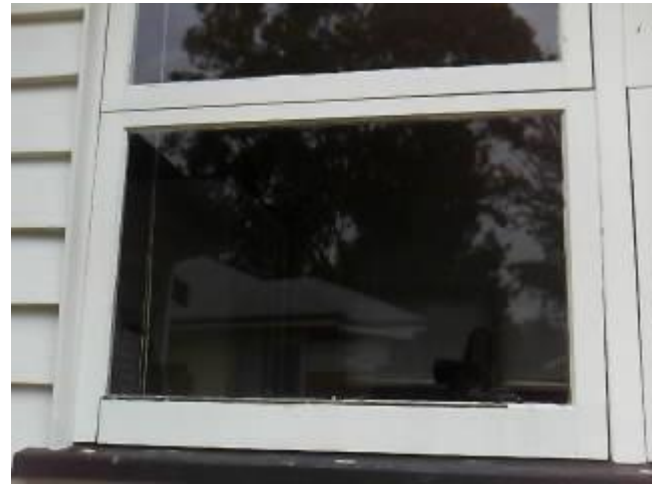
Location	Bedroom window Eastern side of the building
Element	Glass
Defect/Observation	Cracked
Extent	Localised
Recommendation	This defect should be addressed by a Licensed Tradesperson without delay.

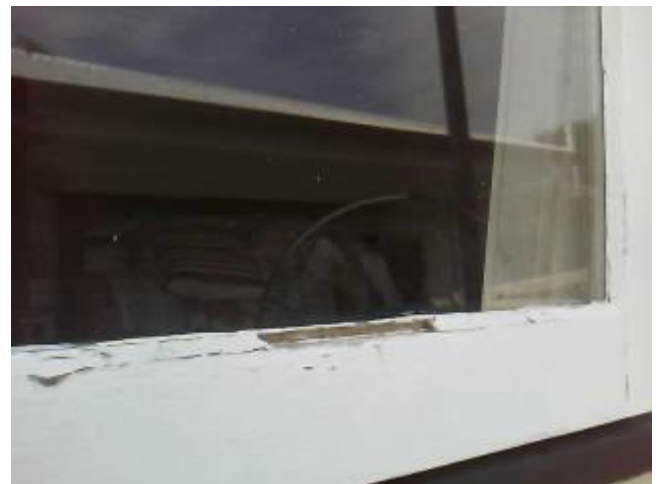
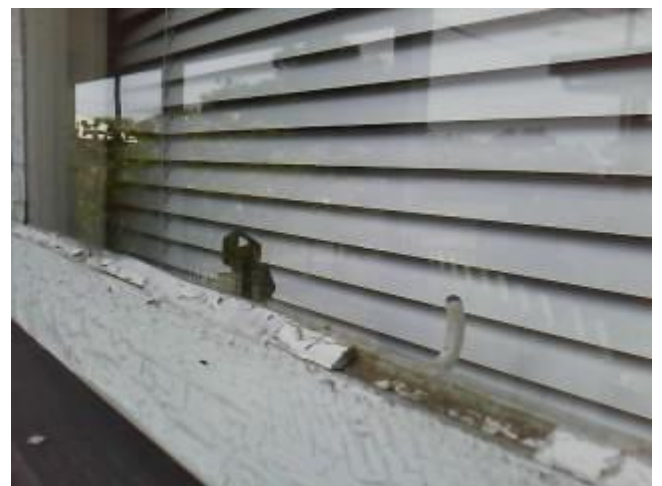
Location	Windows In general
Element	Glazing compound
Defect/Observation	Dislodging
Extent	Localised
Recommendation	This defect should be addressed by a Licensed Tradesperson as soon as possible.

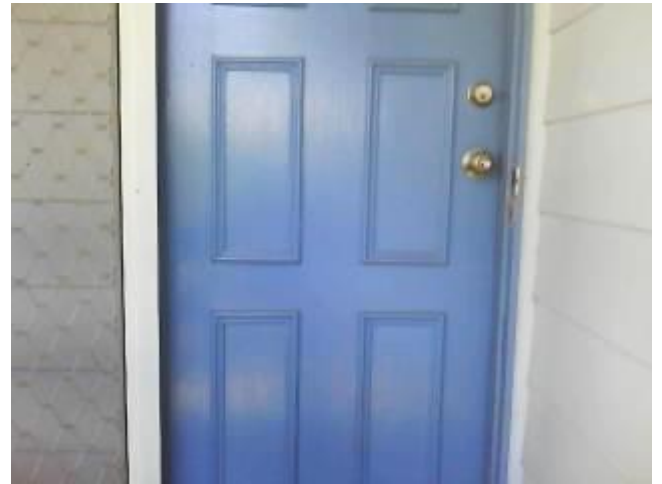
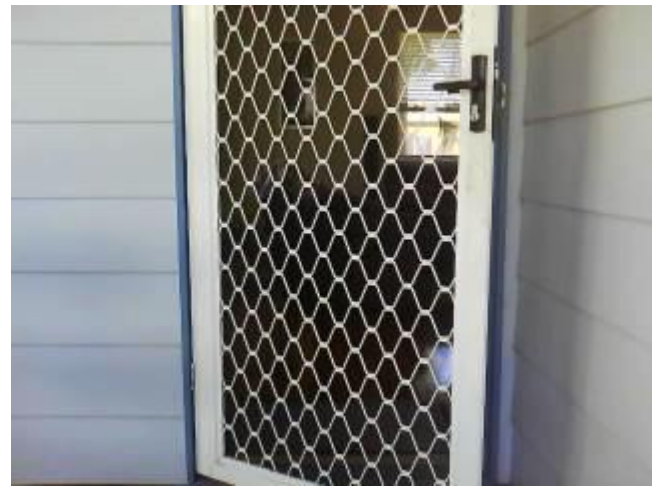
Doors	Front doors
Location	Northern side of the building
Element	Doors
Defect/Observation	Binding, poorly fitted
Extent	Localised
Recommendation	This defect should be addressed by a Licensed Tradesperson as soon as possible.

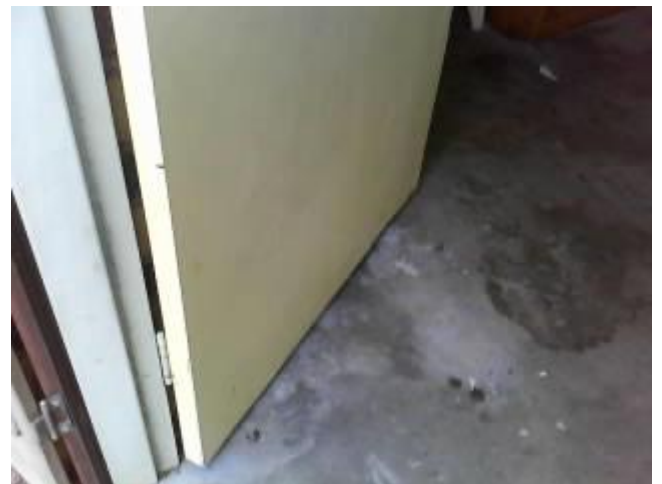
Doors	Laundry door
Location	Southern side of the building
Element	Door
Defect/Observation	Delamination Insufficient protective weather coating has caused layers of plywood or the like to detach or separate from the under layers or frame.
Extent	Localised
Recommendation	This defect requires repair or replacement promptly.

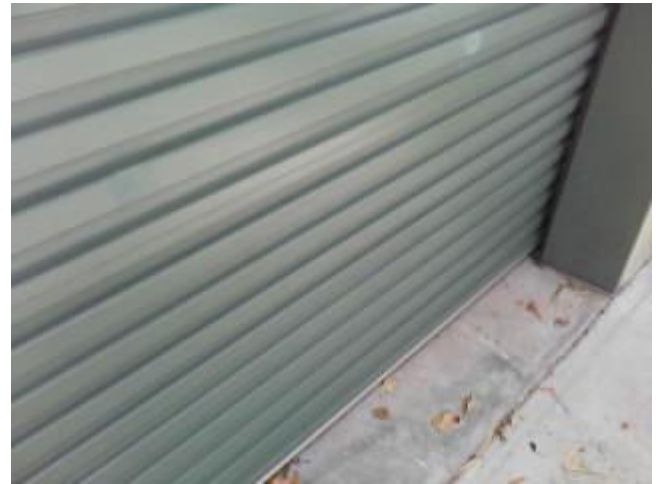
Doors	Garage door
Location	Western side of the building
Element	Door
Defect/Observation	Damaged
Extent	Localised
Recommendation	This defect requires repair or replacement as soon as possible.

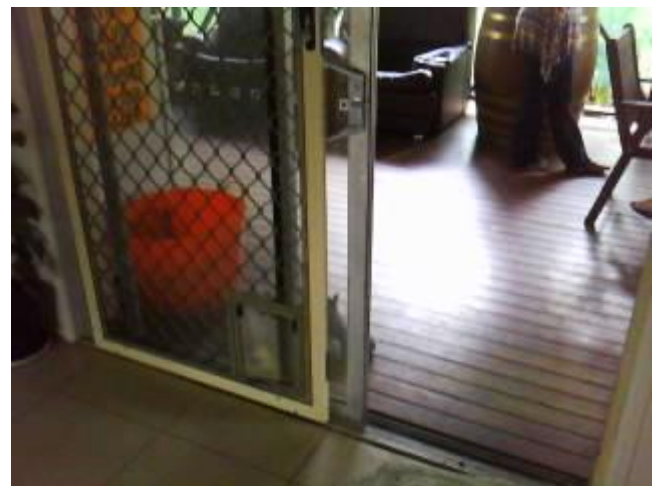
Doors	Sliding glass door
Location	Eastern side of the building
Element	Sliding door rollers
Defect/Observation	Defective Sliding door rollers tend to wear over time and cause sliding doors to become difficult to open and close.
Extent	Localised
Recommendation	This defect requires the rollers to be replaced as soon as possible.

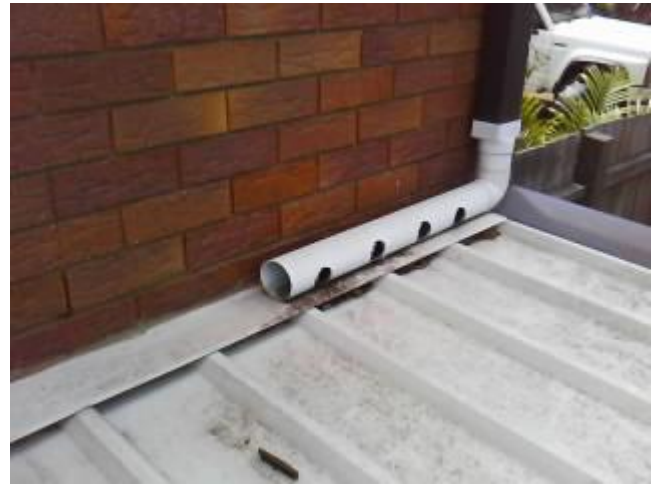
Location	Enclosed patio North-eastern side of the building
Element	Downpipe Spreader
Defect/Observation	Incorrectly installed
Extent	Localised
Recommendation	This defect should be addressed by a Licensed Roof Plumber as soon as possible.

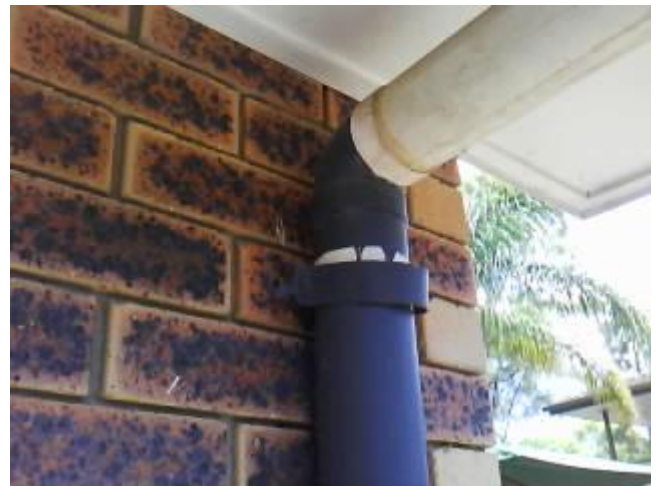
Location	Main building North-eastern side of the building
Element	Downpipe Brackets
Defect/Observation	Dislodged
Extent	Localised
Recommendation	This defect requires repair or replacement as soon as possible.

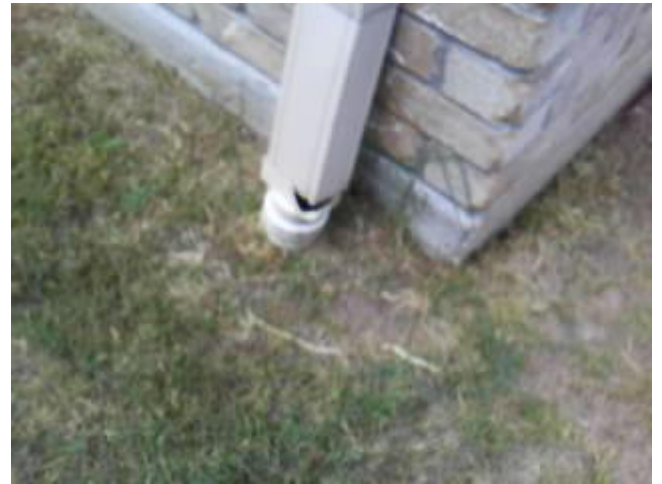
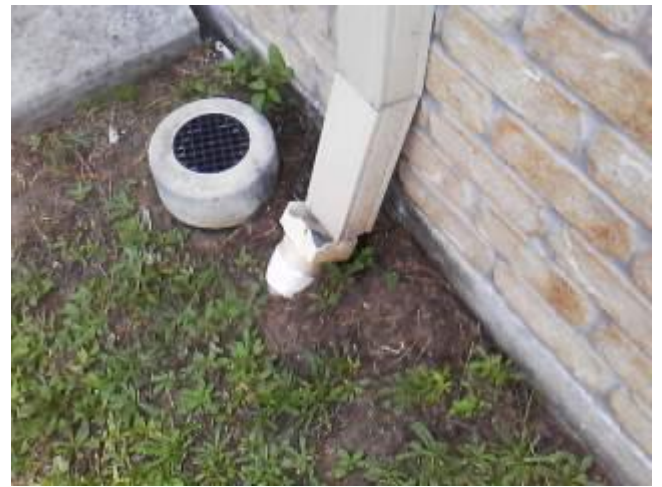
Location	Main building In general
Element	Stormwater Connection
Defect/Observation	Damaged
Extent	Widespread
Recommendation	This defect falls within the category of Conditions Conducive to Structural Damage & Timber Pest Activity. It is strongly recommended that this condition be removed. A further investigation by a Licensed Plumber is also recommended to determine the extent of work required and associated costs. The above recommendation should be implemented as soon as possible.

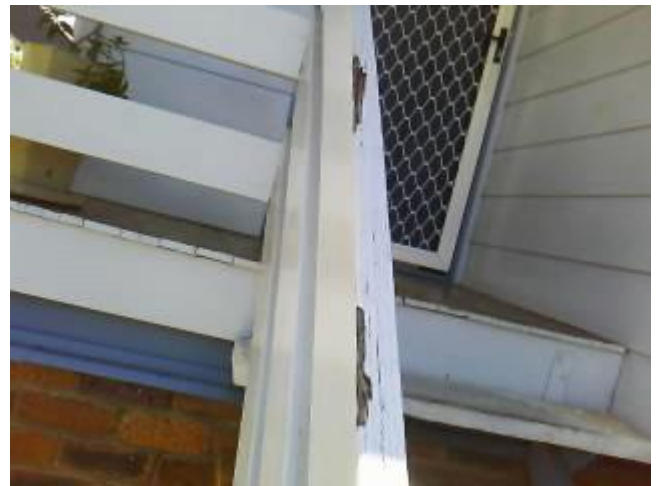
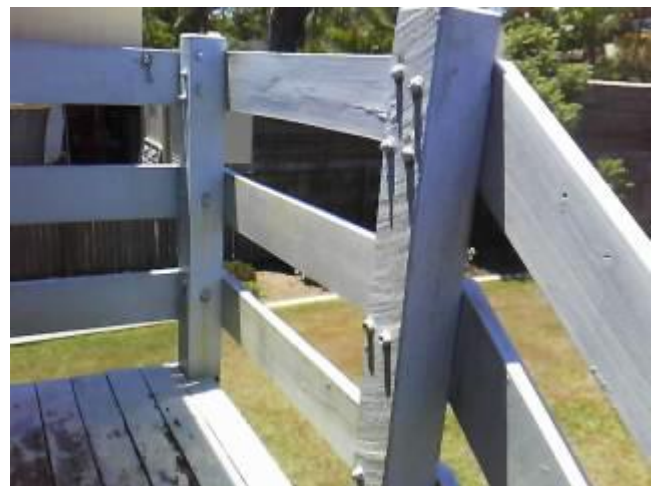
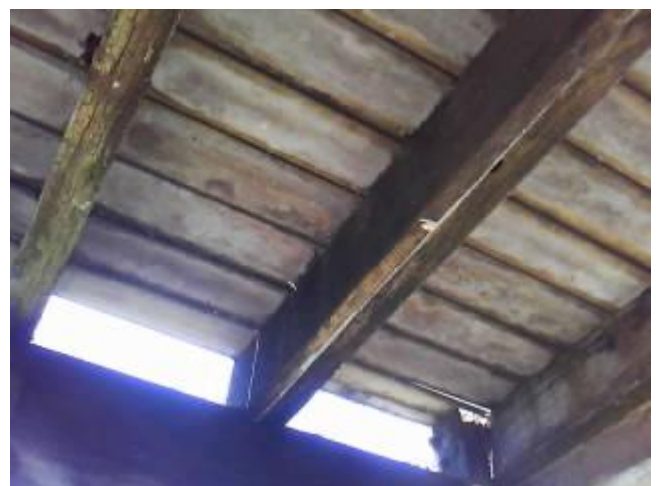
Location	Front and rear stairs
Element	<u>Handrails, Newel</u> Posts, landing joists and floorboards
Defect/Observation	<p><u>Fungal Decay</u> Damage</p> <p><u>Sign of Fungal Decay</u></p> <p>Visible damage to timber</p> <p><u>Damage Status</u></p> <p>Decaying wood</p> <p>Note. Decaying wood contains sufficient moisture to retain its original shape. However, decay will most likely spread (unless sources of moisture are quickly removed).</p>
Extent	Localised
Recommendation	<p>This defect falls within the category of "Timber Pest Activity and/or Damage". It is strongly recommended that action be taken to manage timber pests and repair any damage. A further investigation by a Licensed Tradesperson is also recommended to determine the extent of work required and associated costs. The above recommendation should be implemented as soon as possible</p>

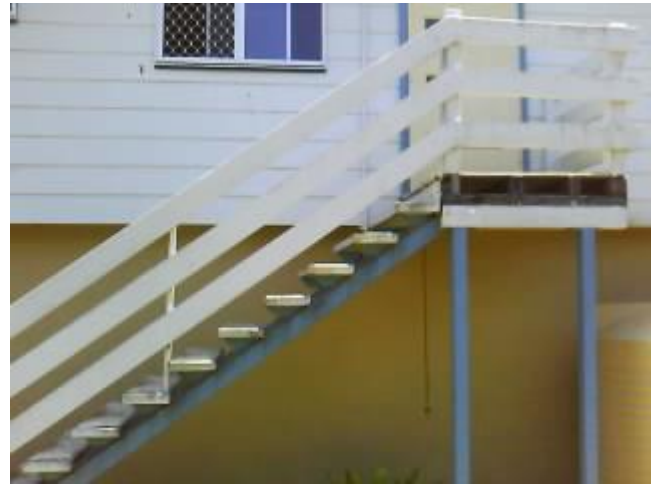
Location	Front and rear stairs
Element	Handrails
Defect/Observation	Do not meet current building regulations
Extent	Localised
Recommendation	Although not required it is still recommended that they are upgraded to meet current regulations as soon as possible.

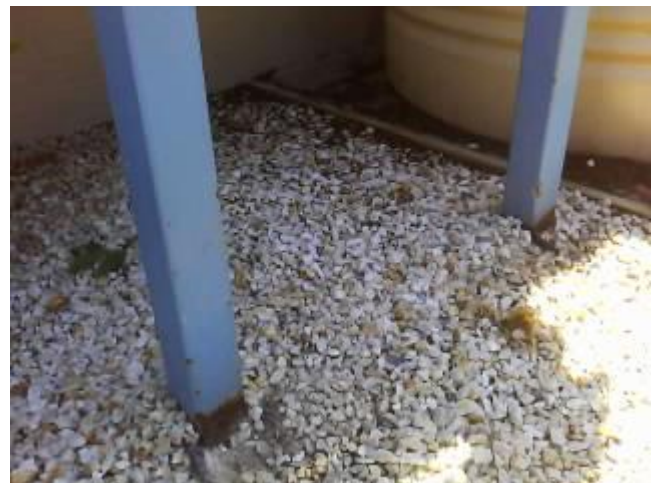
Location	Rear stairs Southern side of the building
Element	Steel columns
Defect/Observation	Corrosion
Extent	Localised
Recommendation	This defect falls within the category of Conditions Conducive to Structural Damage. It is strongly recommended that this condition be removed. A further investigation by a Licensed Tradesperson is also recommended to determine the extent of work required and associated costs. The above recommendation should be implemented without delay.

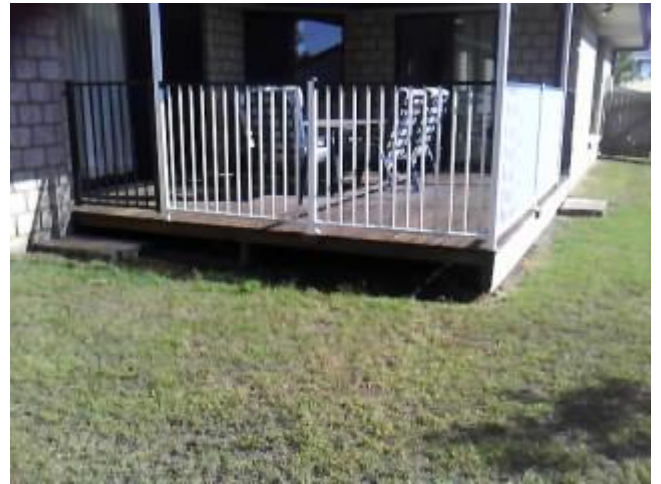
Location	Deck Eastern side of the building
Element	Frame
Defect/Observation	Earth-wood contact Note: Untreated or non-durable timbers in direct contact with the ground/soil produce a ready food source for termites. Also, susceptible timbers used in a hazardous environment are prone to fungal decay.
Extent	Localised
Recommendation	This defect falls within the category of Conditions Conducive to Timber Pest Activity. It is strongly recommended that this condition be removed. A further investigation by a Licensed Builder is also recommended to determine the extent of work required and associated costs. The above recommendation should be implemented promptly.

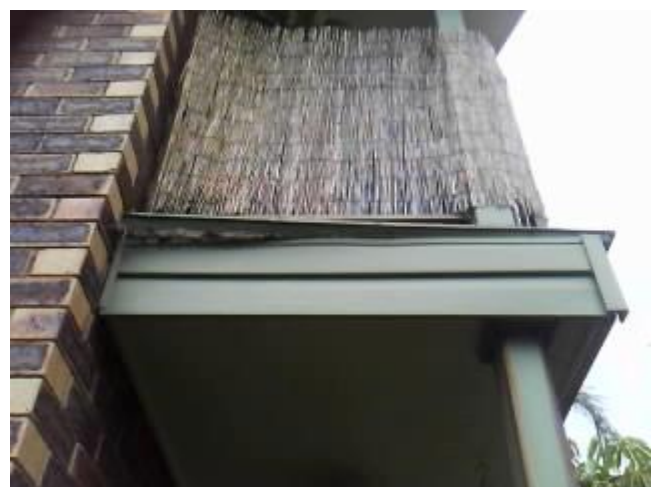
Location	Balcony Northern side of the building
Element	Timber trim
Defect/Observation	Fixing failure
Extent	Localised
Recommendation	Repairs and/or adjustments by a suitably qualified tradesperson are required to correct this defect.

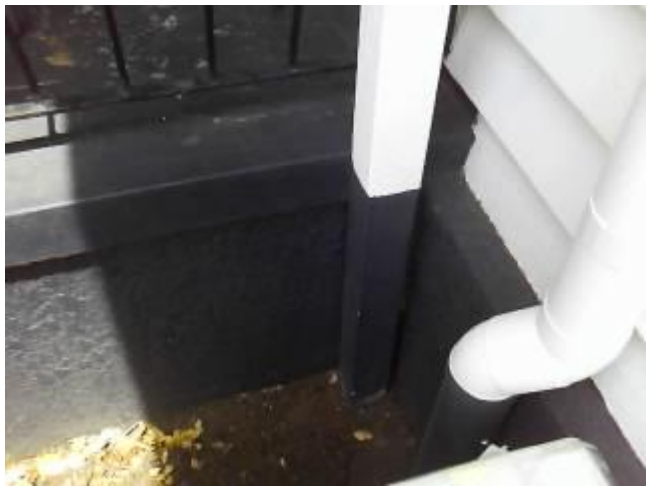
Location	Eastern side of the building

Element	Patio roof posts	
Defect/Observation	Earth-wood contact Note: Timbers in direct contact with the ground/soil produce a ready food source for termites. Also, susceptible timbers used in a hazardous environment are prone to fungal decay.	
Extent	Localised	
Recommendation	This defect falls within the category of Conditions Conducive to Structural Damage & Timber Pest Activity. It is strongly recommended that this condition be removed. The above recommendation should be implemented as soon as possible.

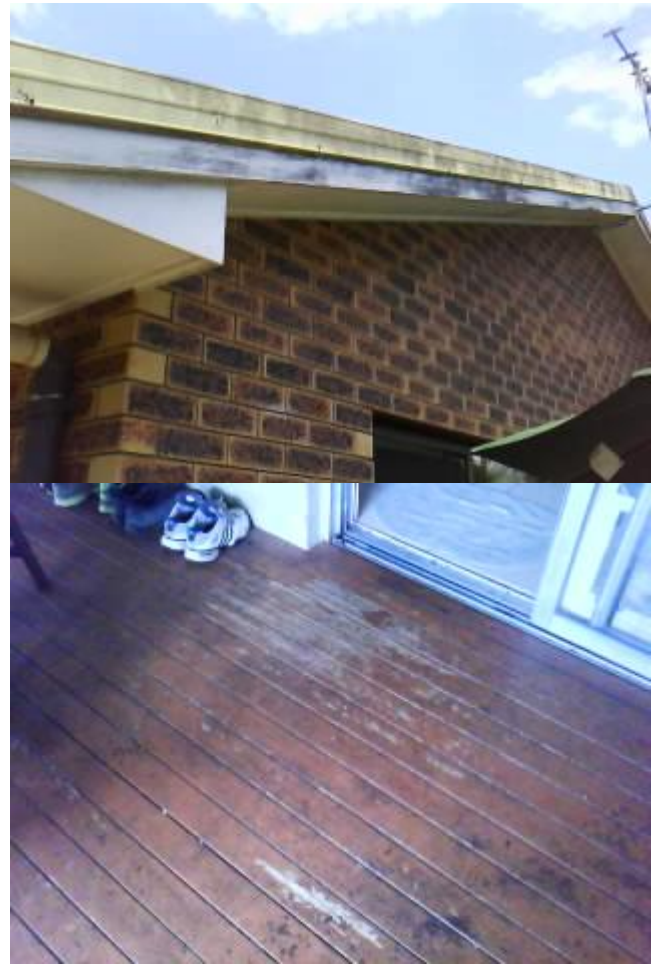
Location	In general
Element	Paintwork
Defect/Observation	Deterioration
Extent	Widespread
Recommendation	Repainting is required.

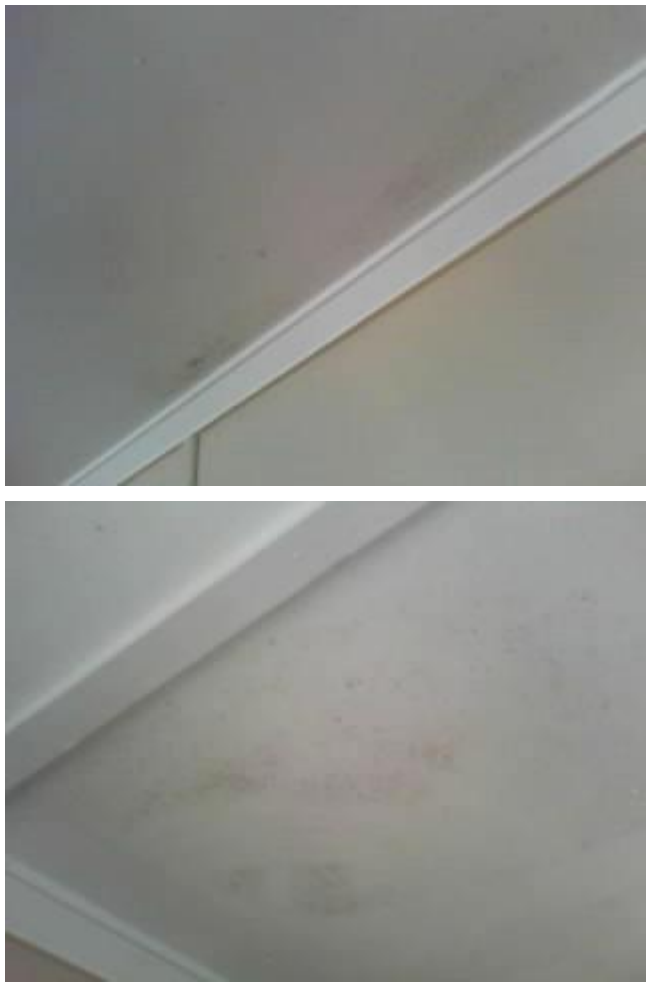
Element	Ceiling

Location	Kitchen	
Defect/Observation	<p>Mould growth</p> <p>Note: Where evidence of mould growth was noted, there may be environmental, biological or health issues associated with this report. Any questions concerning such issues due to the presence of mould, the release of mould spores or concerning indoor air quality should be immediately directed to an appropriately qualified inspector.</p>	
Extent	Localised	
Recommendation	<p>This defect should be addressed by a Licensed Tradesperson as soon as possible.</p>

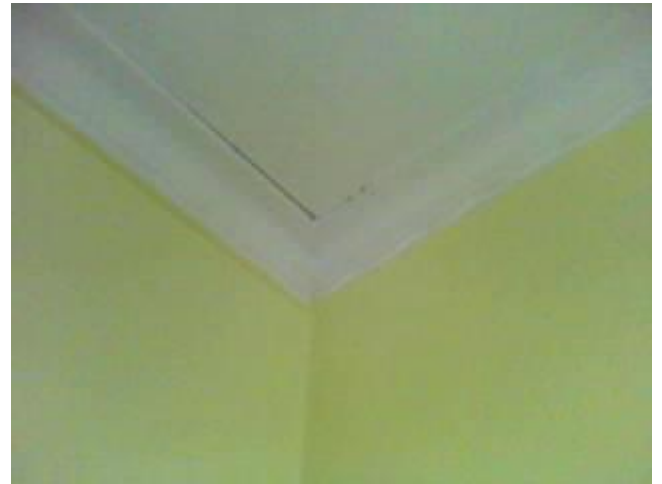
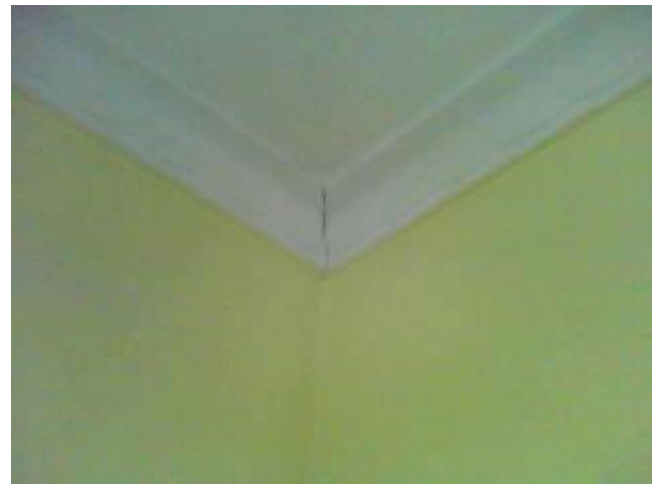
Element	Cornice
Location	Bathroom, First floor South-western side of the building
Defect/Observation	Cracked The consultant is of the opinion that these cracks are consistent with common minor settlement and frame shrinkage.
Extent	Localised
Recommendation	When the interior of the building is next decorated these cracks should be filled and sanded prior to repainting. In the event that the cracks become significantly larger a further investigation may be required by a licenced builder to establish the extent of remedial work required and associated costs.

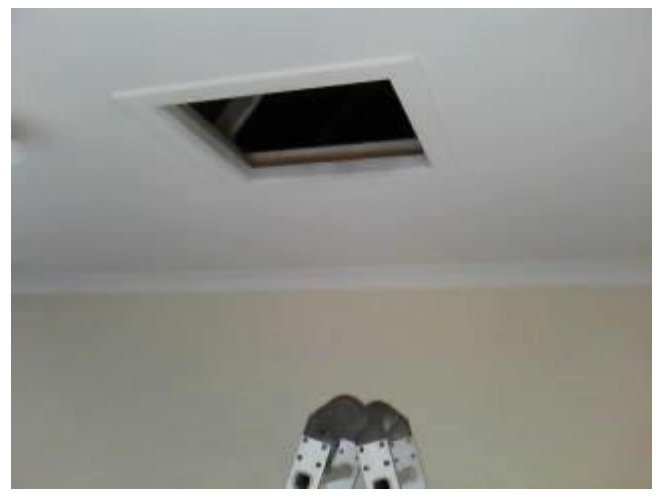
Element	Man hole cover
Location	Garage, Entry level North-eastern side of the building
Defect/Observation	Missing
Extent	Localised
Recommendation	Replace the missing element as soon as possible.

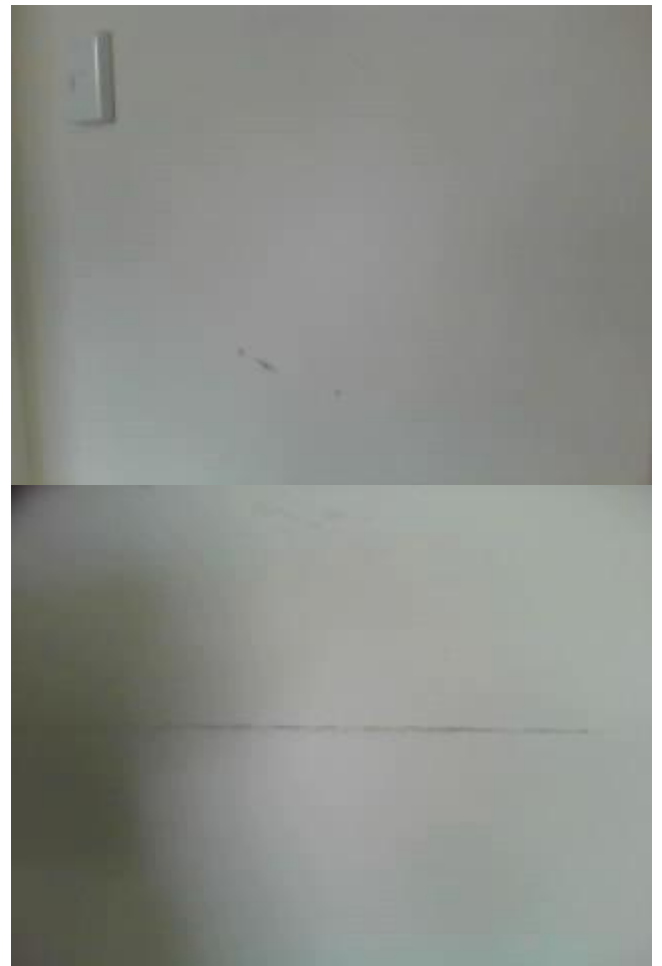
Location	In general, Ground floor Throughout
Element	Walls
Defect/Observation	Dents, marks & scratches
Extent	Widespread
Recommendation	The consultant recommends that the client undertakes regular maintenance. Repairs may be necessary in the event the defect becomes more significant.

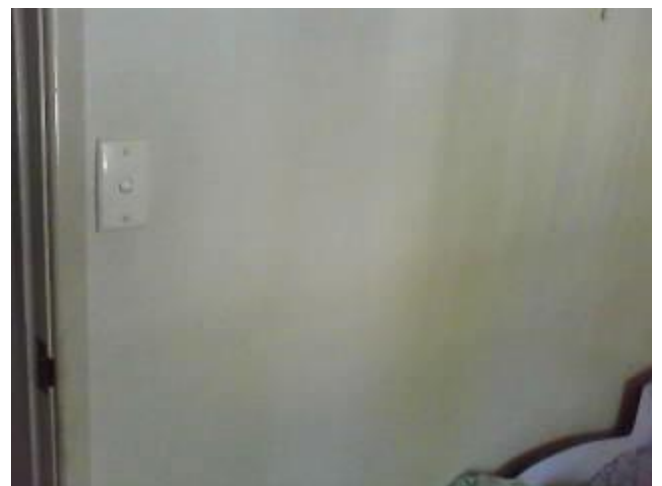
Location	In general
Element	Wall finishes and paintwork
Defect/Observation	The general decorative condition and painting throughout the interior is poor.
Extent	Widespread
Recommendation	Preparation and Repainting is required.

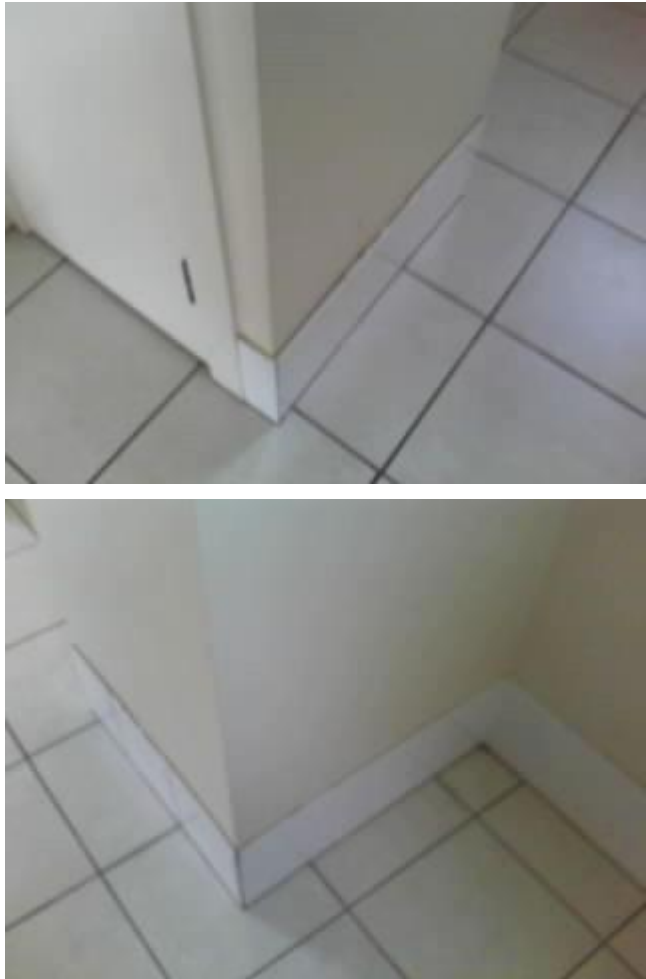
Element	Skirting tiles

Location	Laundry, WC, Bathroom, Entry level Western side of the building	
Defect/Observation	Dislodged	
Extent	Localised	
Recommendation	This defect requires repair or replacement as soon as possible.

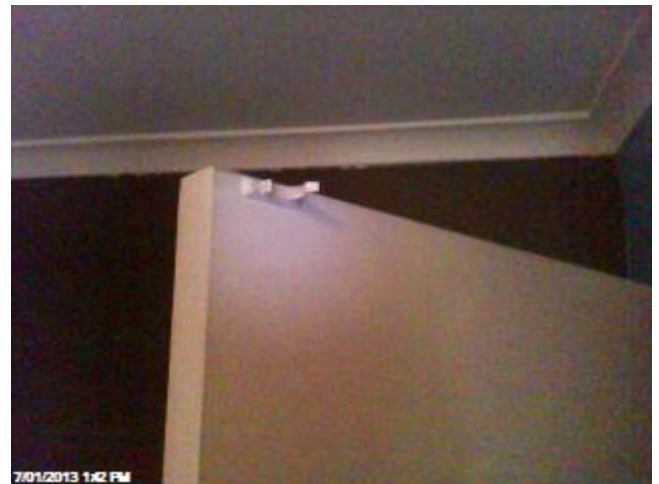
Built-In-Fittings	Cupboards
Location	Laundry Ground floor
Element	Plastic catches
Defect/Observation	Broken
Extent	Localised
Recommendation	This defect requires replacement as soon as possible.

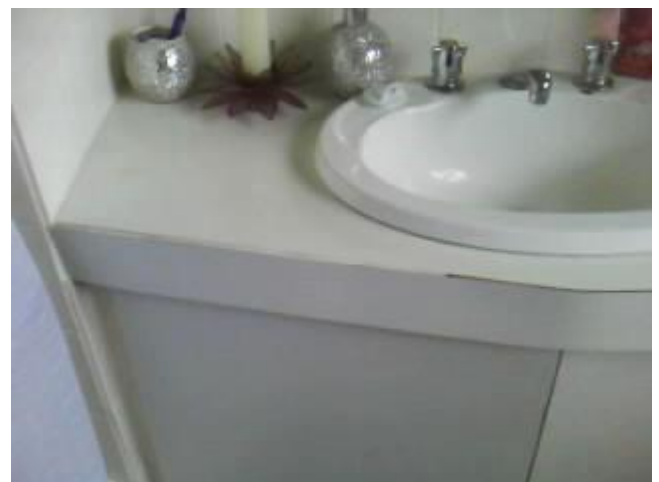
Built-In-Fittings	Built-in-fittings
Location	Bathroom, First floor South-western side of the building
Element	Worktop edge strip
Defect/Observation	<u>Damp</u> damage
Extent	Localised
Recommendation	This defect requires repair or replacement as soon as possible.

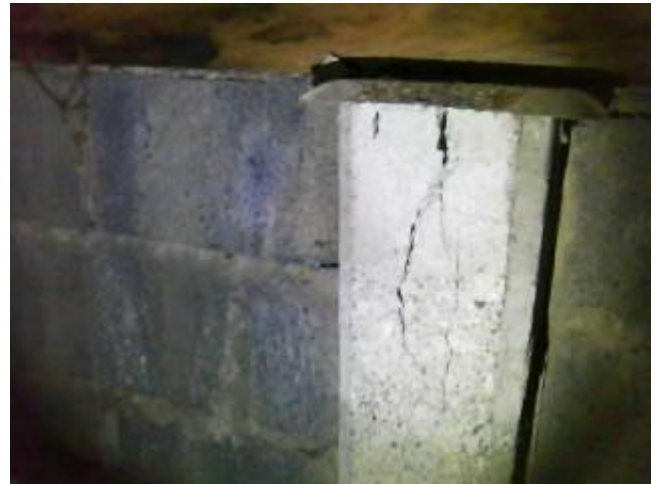
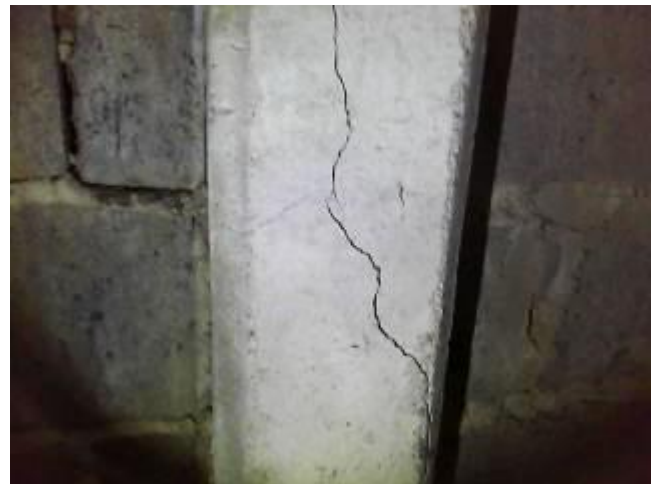
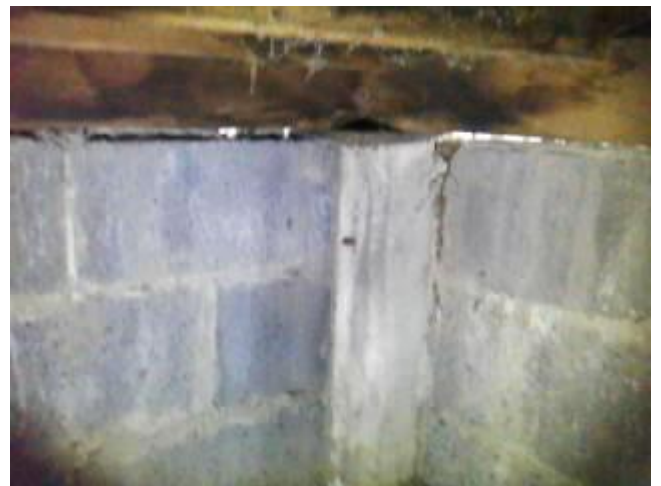
Area	Subfloor space to the main building
Location	In general
Element	Stumps
Defect/Observation	Cracked
Extent	Localised
