HANDOVER REPORT

Property Address **265 Example Lane, The Greater Brisbane Region
QLD 4000**

Report Number: **#####**

Inspection Date & Time: **Monday 01 January 2013 08:00 AM**

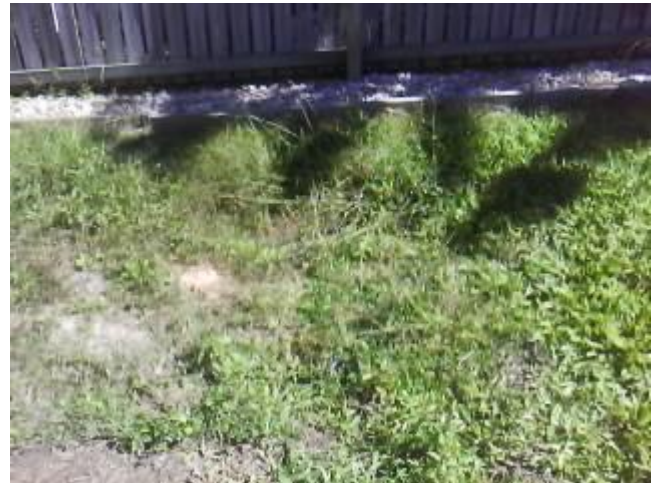
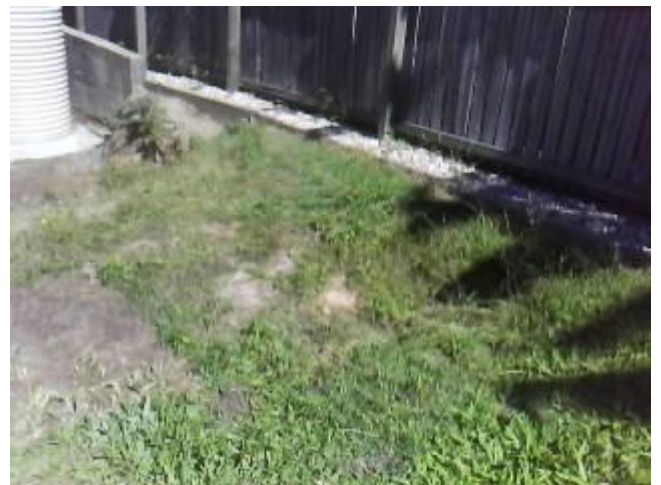
<u>Serious Safety Hazard</u>	
Description	Fall hazard.
Location	The grounds at the rear of the building
Recommendation	<p>This condition is considered potentially dangerous. A further investigation by a competent person is strongly recommended to determine the extent of remedial work required. The above recommendation should be implemented without delay</p> <p>Immediate action must be taken to ensure that anyone entering the area is warned of this hazard.</p>

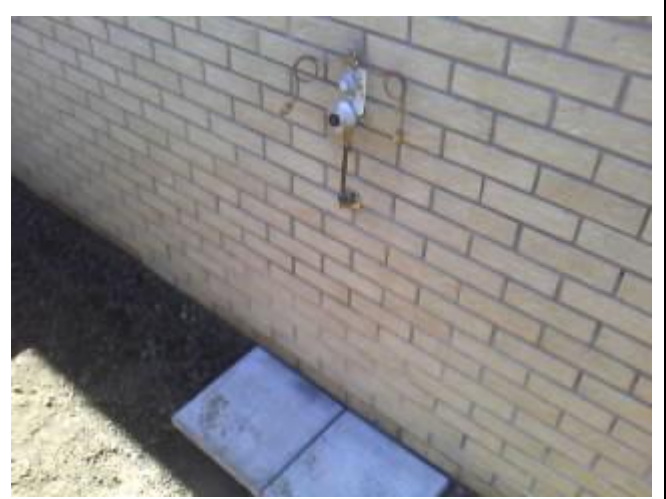
Description	LPG gas cylinders have not be adequately restrained in accordance with AS5601.1. If cylinders are knocked or blown over gas line may rupture releasing gas..

Recommendation	<p>This condition is considered potentially dangerous. A further investigation by a licensed gasfitter is strongly recommended to secure the cylinders. The above recommendation should be implemented as a matter of urgency</p> <p>Immediate action must be taken to ensure that anyone entering the area is warned of this hazard.</p>

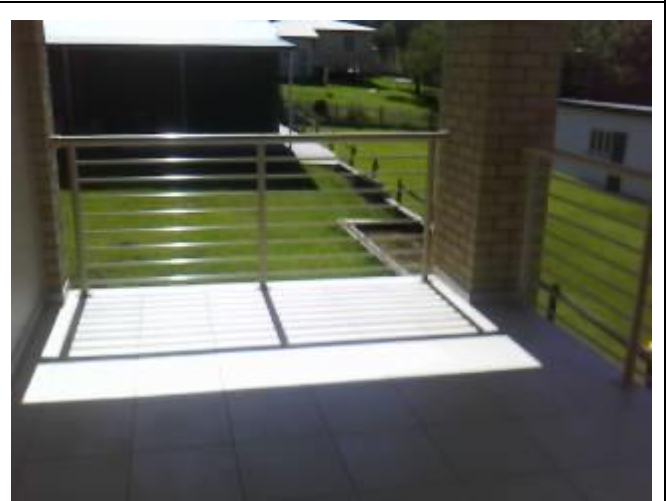
Description	Part of the platform or stair is more than 4 meters from the ground and the balustrade climbable. .

Location	The balcony at the rear of the building	
Recommendation	<p>This condition is considered very dangerous. A further investigation by a licensed building contractor is strongly recommended to modify the balustrade to render it non climbable. The above recommendation should be implemented as a matter of urgency</p> <p>Immediate action must be taken to ensure that anyone entering the area is warned of this hazard.</p>

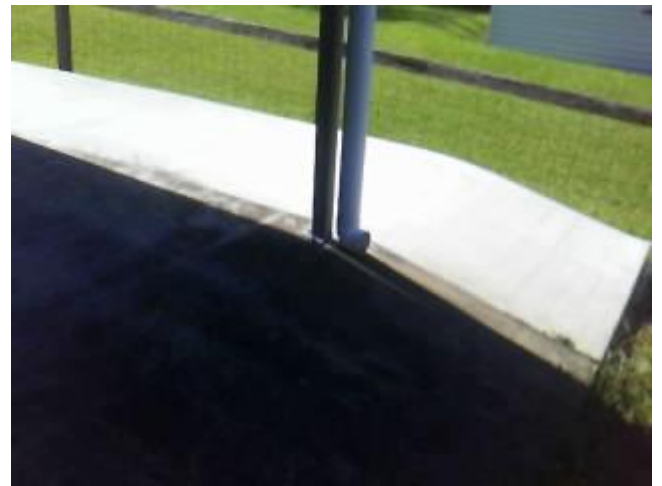
Area	Exterior Of The Detached Garage
Location	Western Side Of The Structure
Element	Downpipe
Defect/Observation	Discharging near footings. All drainage should be connected to a storm water drain or directed well away from footings.
Extent	Localised
Recommendation	This defect falls within the category of Conditions Conducive to Structural Damage & Timber Pest Activity. It is strongly recommended that this condition be removed. A further investigation by a Licensed Plumber is also recommended to determine the extent of work required and associated costs. The above recommendation should be implemented as soon as possible.

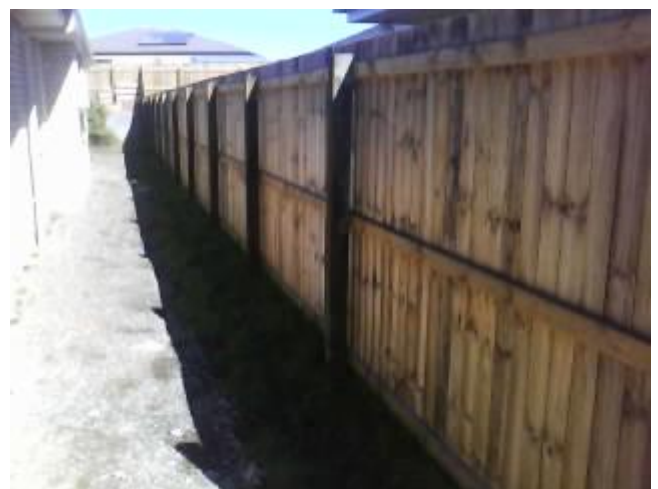
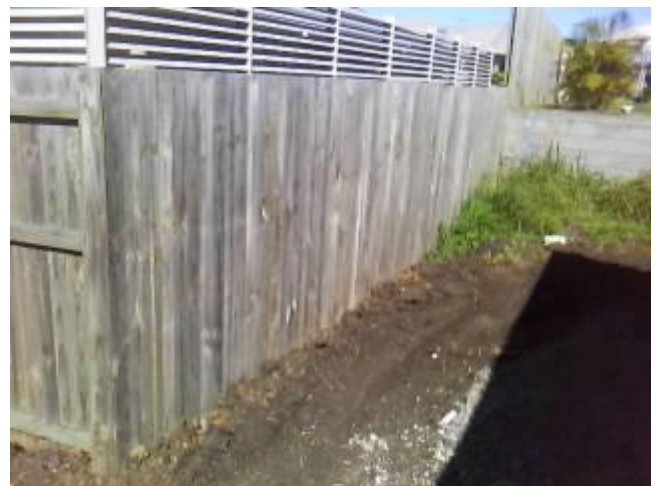
Structure	Boundary fence
Location	In General
Element	Palings
Defect/Observation	<p>Earth-wood contact</p> <p>Note: Untreated or non-durable timbers in direct contact with the ground/soil produce a ready food source for termites. Also, susceptible timbers used in a hazardous environment are prone to fungal decay.</p>
Extent	Widespread
Recommendation	<p>This defect falls within the category of Conditions Conducive to Timber Pest Activity. It is strongly recommended that this condition be removed by either lowering the ground level or removing 30mm from the bottom of the palings. A further investigation by a Fencing specialist is also recommended to determine the extent of work required and associated costs. The above recommendation should be implemented without delay.</p>

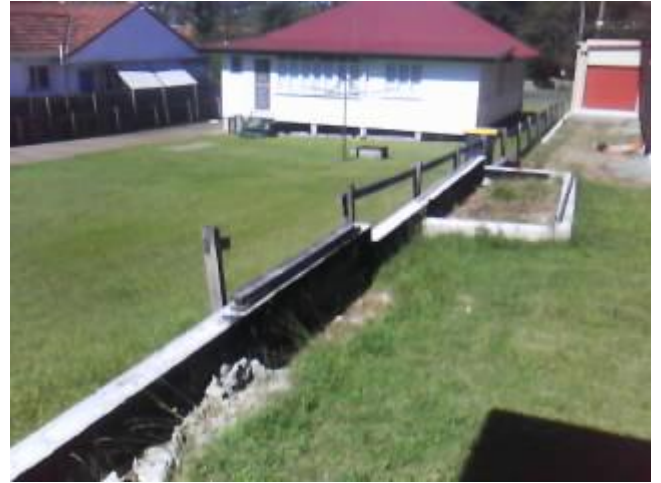
Structure	Boundary fence
Location	Eastern Side Of The Property
Element	All fence elements
Defect/Observation	Dilapidated The boundary fence is in a general state of dilapidation and is at the end of its useful life
Extent	Widespread
Recommendation	This fence requires replacement as soon as possible.

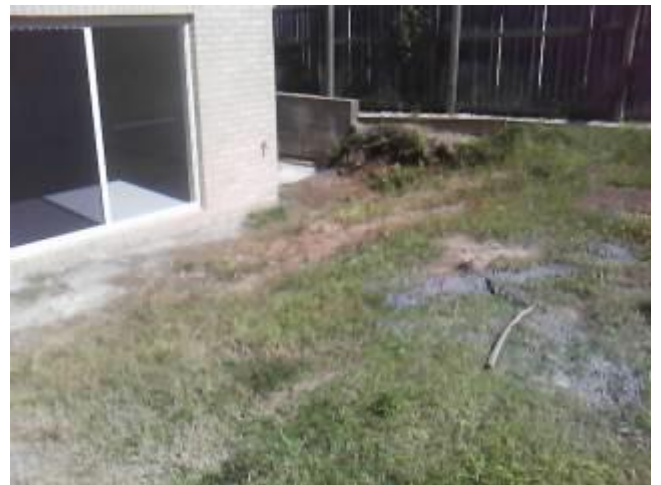
Structure	Retaining wall
Location	Southern Side Of The Property
Element	All retaining wall elements
Defect/Observation	Missing
Extent	Widespread
Recommendation	Replace the missing element as soon as possible.

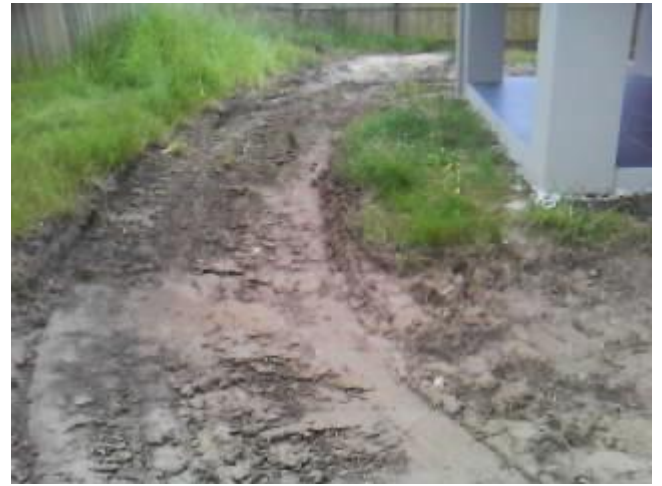
Area	Surface Drainage
Location	In general
Element	Finished Ground Level
Defect/Observation	Incomplete
Extent	Widespread
Recommendation	This defect should be addressed by a Licensed Tradesperson as soon as possible.

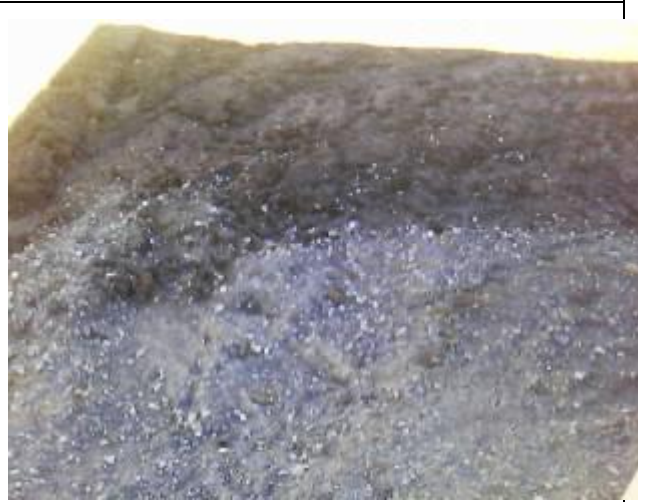
Area	Yard
Location	South-eastern side of the property
Element	Ground Around The Building
Defect/ Observation	<p>Poorly <u>Drained</u></p> <p>Poor drainage leads to excessive moisture being retained in the soil which over time can destabilise the foundations and promote timber pest activity such as fungal decay and termites.</p> <p>Drainage problems are often only discernible during wet periods.</p> <p>Note: The effect of poor drainage on foundations is often dependent on the soil type. Establishing soil type is beyond the scope of a standard pre-purchase inspection.</p> <p>Also, timbers pest activity including termites and fungal decay are commonly associated with poor drainage.</p> <p>Generally, to ensure that water drains away from the footings, the profile of the ground adjacent to the building should slope away from the base of the exterior walls and all stormwater drainage should be maintained in good condition and free from blockage.</p>

Extent	Widespread
Recommendation	<p>This defect falls within the category of Conditions Conducive to Structural Damage & Timber Pest Activity. It is strongly recommended that this condition be removed. A further investigation by a Licensed Pest Controller (Timber Pest Specialist) and a Licensed Plumber & Drainer is also recommended to determine the extent of work required and associated costs. The above recommendation should be implemented promptly.</p>

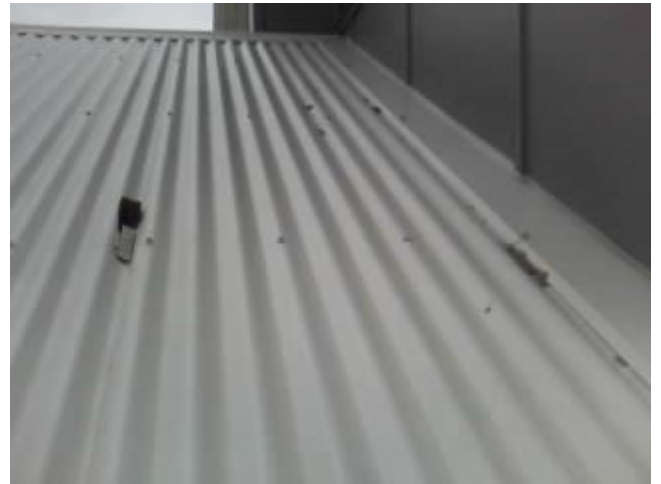
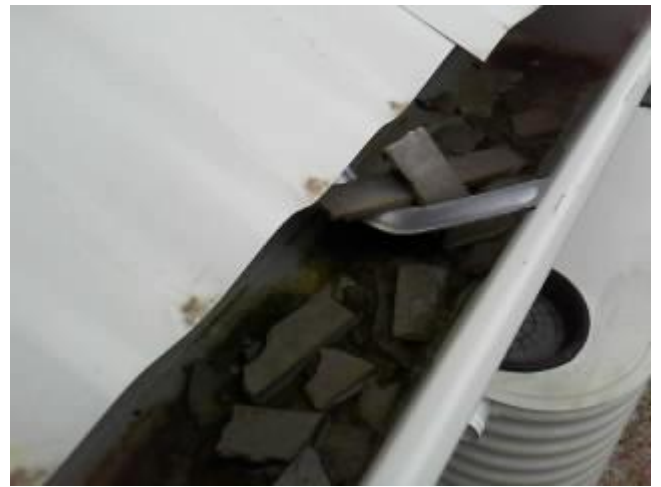
Structure	Patio Roof.
Area Affected	In general
Element	Roof sheeting and Eaves gutters
Defect/Observation	Excess building debris
Extent	Localised
Recommendation	This defect should be addressed by a Licensed Tradesperson as soon as possible.

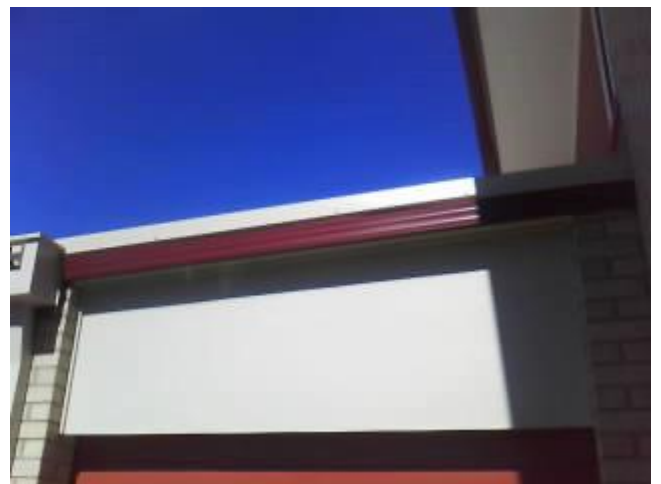
Structure	The roof to the garage.
Area Affected	At the rear of the building
Element	Flashing
Defect/Observation	Poor workmanship out of level
Extent	Localised
Recommendation	This defect requires repair or replacement as soon as possible.

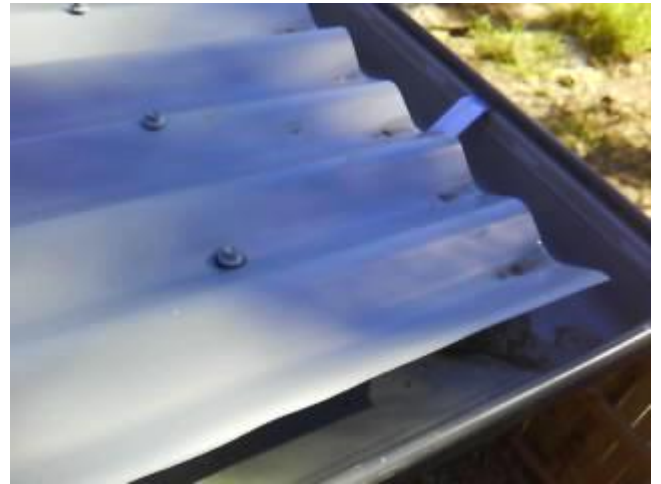
Structure	The lower roof to the main building.
Area Affected	On the north-eastern side of the patio
Element	Roof sheeting/ Fastening
Defect/Observation	Screw fixing through the bottom corrugation of the roof sheet.
Extent	Localised
Recommendation	The consultant recommends that the client undertakes regular maintenance and continues to monitor the defect. Repairs may be necessary in the event the defect becomes more significant.

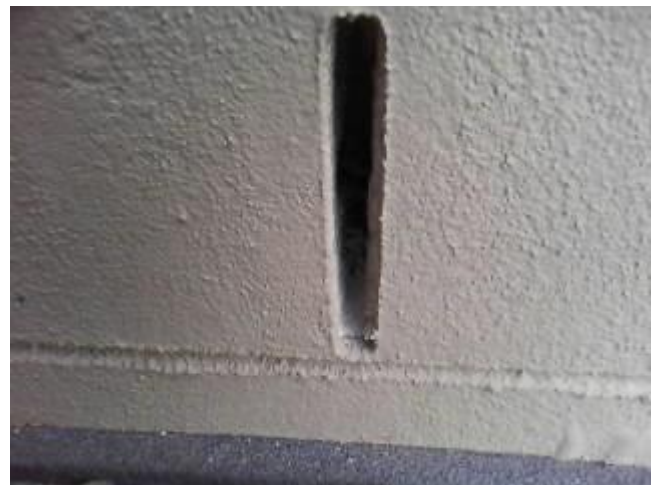
External Wall	External wall to the main building
Location	In general
Element	Weephole
Element Type	Non-loadbearing
Defect/Observation	Filled with Mortar and/or render
Extent	Widespread
Recommendation	This defect should be addressed by a Licensed Tradesperson promptly.

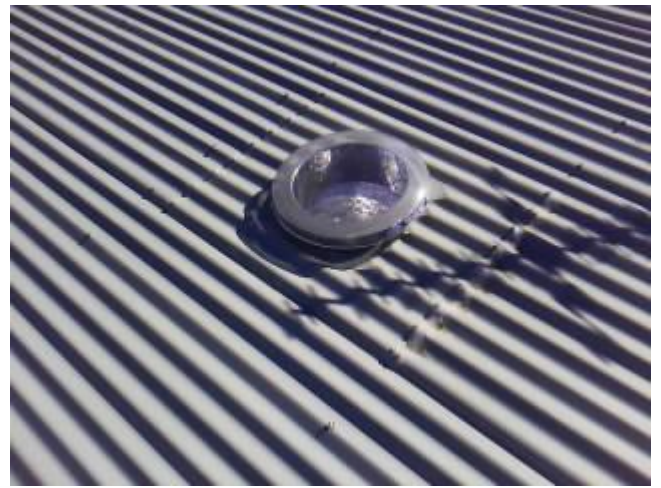
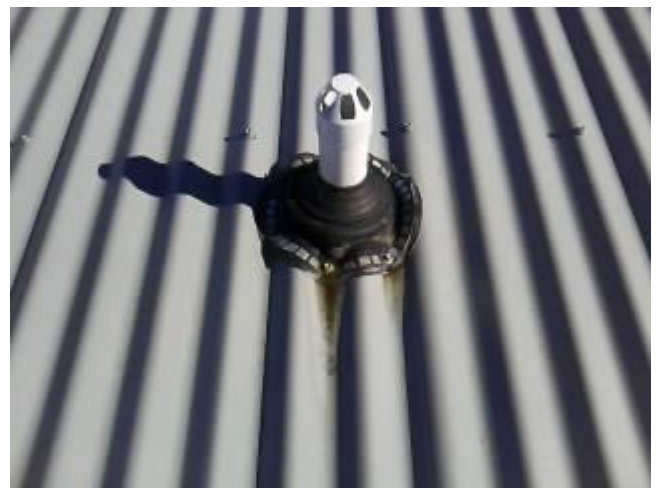
Structure	The upper roof to the main building.
Area Affected	In general
Element	Flashings
Defect/Observation	Skylight poorly fitted Vent pipe flashing holding water
Extent	Localised
Recommendation	The consultant recommends that the client undertakes regular maintenance and continues to monitor the defect. Repairs may be necessary in the event the defect becomes more significant.

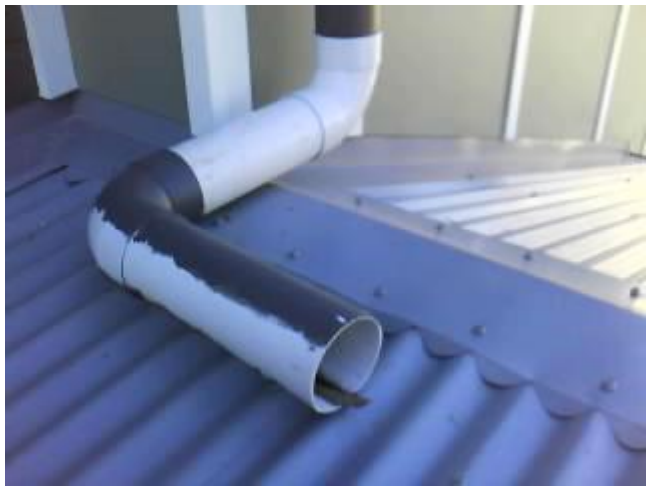
Structure	The lower roof to the main building.

Area Affected	On the western side of the building	
Element	Downpipe spreaders	
Defect/Observation	Pipes not half capped on the ends to control flow. One not painted.	
Extent	Localised	
Recommendation	This defect should be addressed by a Licensed Tradesperson as soon as possible.

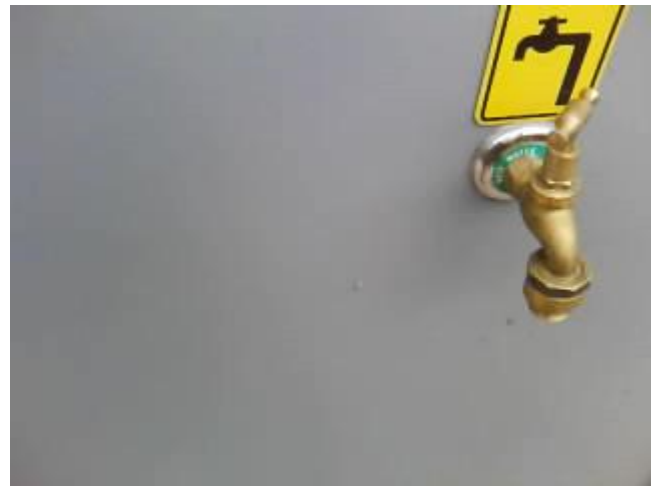
External Wall	External wall to the main building
Location	South-eastern side of the building
Element	Wall sheeting
Element Type	Non-loadbearing
Defect/Observation	Popped fixing
Extent	Localised
Recommendation	This defect should be addressed by a Licensed Tradesperson as soon as possible.

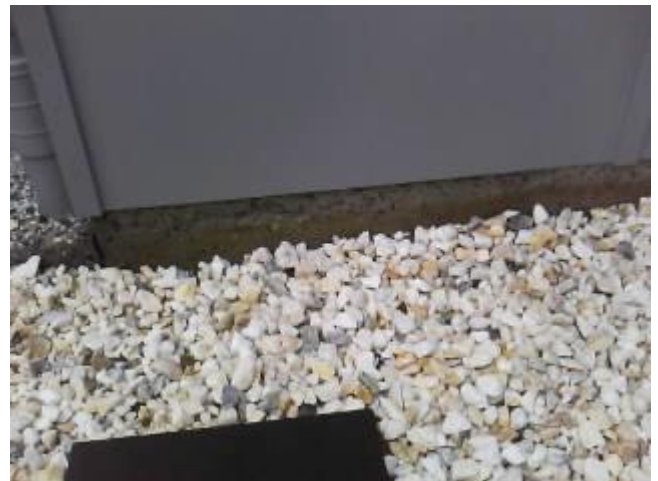
External Wall	Slab edge exposure
Location	South-western side of the building
Element	Concrete
Element Type	Loadbearing
Defect/Observation	Rough finish
Extent	Localised
Recommendation	This defect should be addressed by a Licensed Tradesperson as soon as possible.

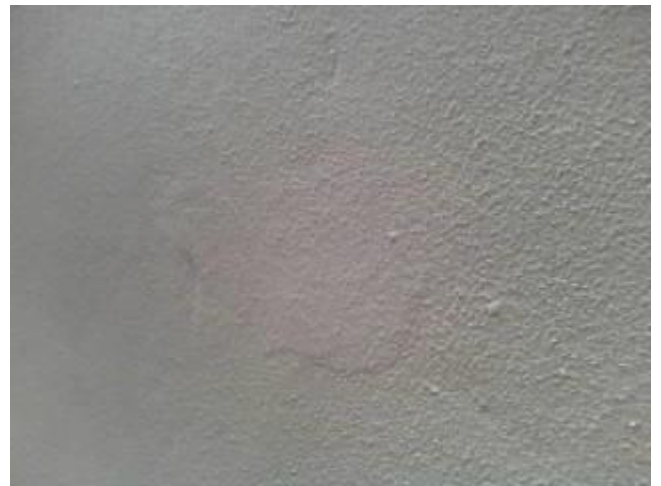
External Wall	External wall to the main building
Location	In general
Element	Render
Element Type	Non-loadbearing
Defect/Observation	Poor workmanship (trowel marks, lumps and dents)
Extent	Widespread
Recommendation	This defect should be addressed by a Licensed Tradesperson as soon as possible.

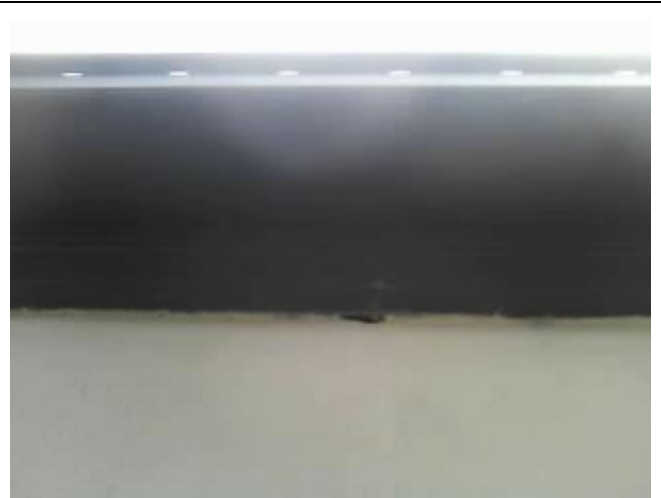
External Wall	External wall to the main building
Location	South-western side of the building
Element	Render (gap where render meets fascia)
Element Type	Non-loadbearing
Defect/Observation	Poor workmanship
Extent	Localised
Recommendation	This defect should be addressed by a Licensed Tradesperson as soon as possible.

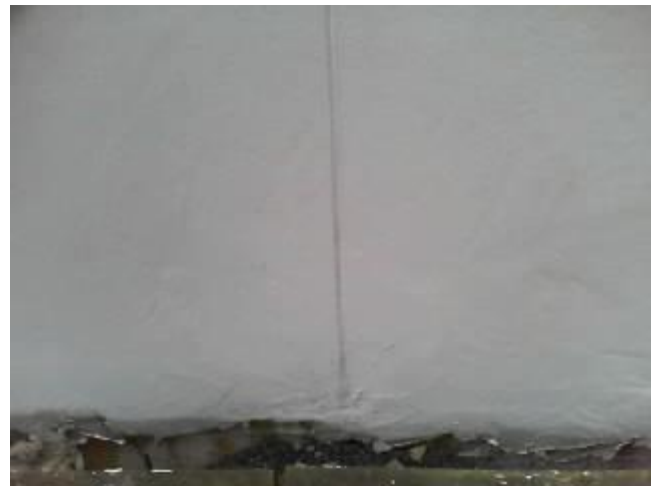
External Wall	External wall to the main building
Location	In general
Element	Control joint
Element Type	Non-loadbearing
Defect/Observation	Not filled with flexible sealant
Extent	Undetermined
Recommendation	This defect should be addressed by a Licensed Tradesperson as soon as possible.

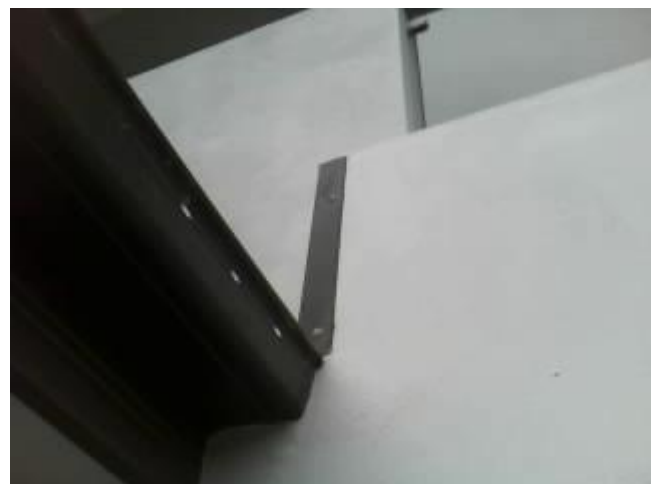
External Wall	External wall to the main building
Location	North-western side of the building
Element	Flashing (vertical)
Element Type	Non-loadbearing
Defect/Observation	Damaged
Extent	Localised
Recommendation	This defect should be addressed by a Licensed Tradesperson as soon as possible.

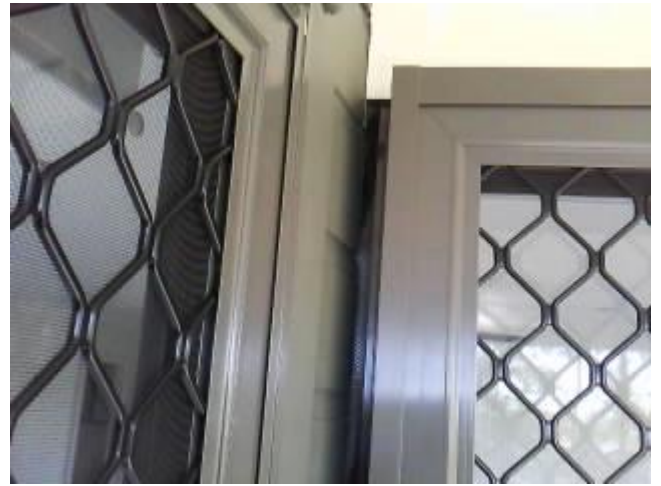
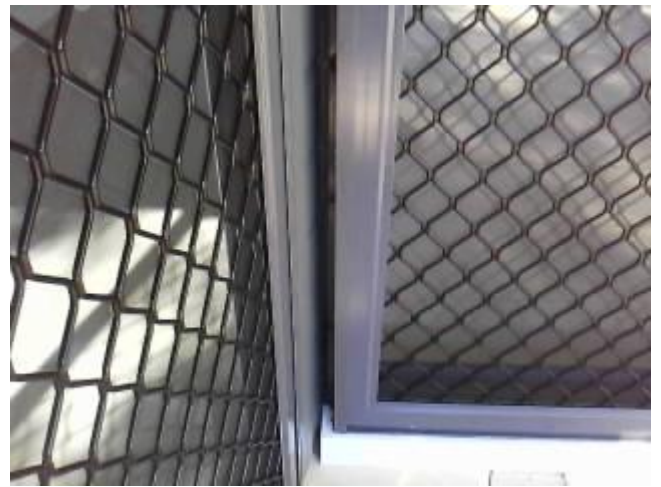
External Wall	External wall
Location	North-western side of the building
Element	Construction joint between wall and door frame.
Element Type	Non-loadbearing
Defect/Observation	Incomplete
Extent	Localised
Recommendation	This defect should be addressed by a Licensed Tradesperson as soon as possible.

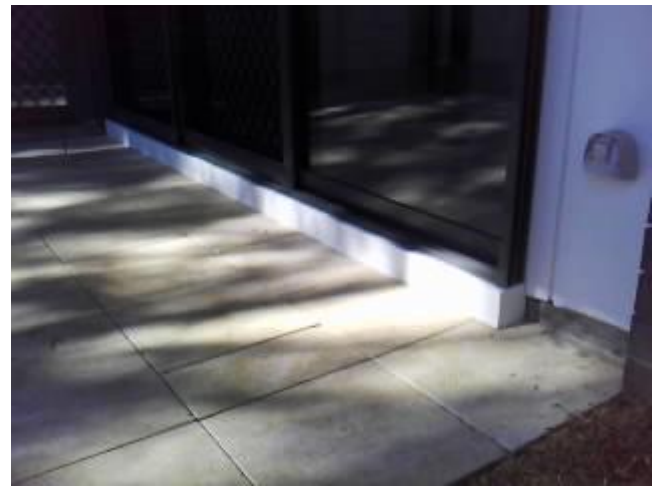
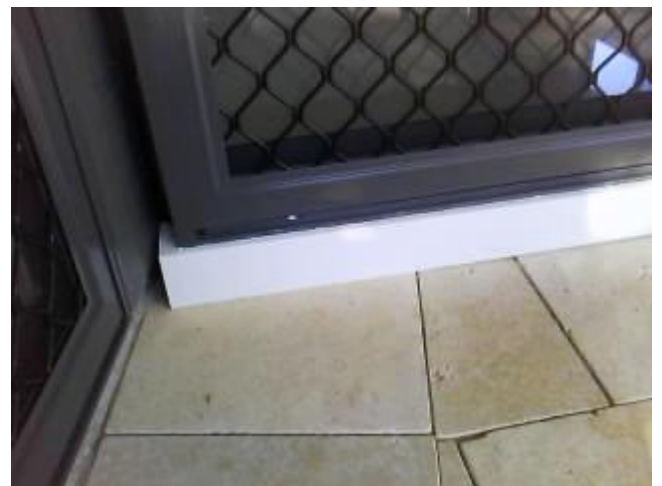
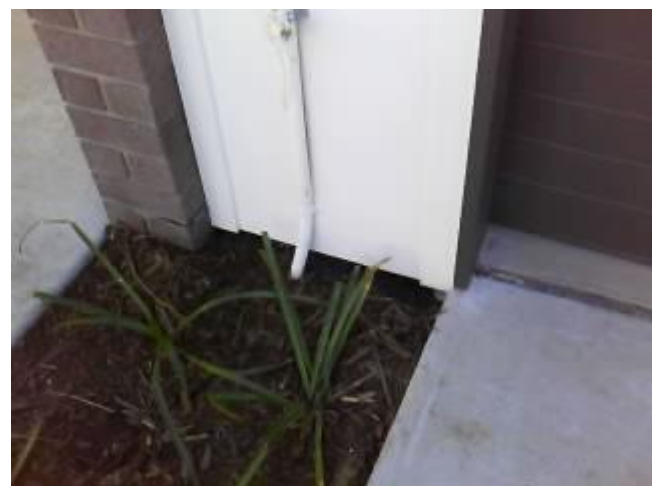
External Wall	External walls
Location	Patio, North-western side and adjacent garage door opening of the building
Element	Termite Inspection Zone
Element Type	Non-loadbearing
Defect/Observation	Obstructed
Extent	Localised

This defect falls within the category of Conditions Conducive to Timber Pest Activity. A further investigation by a Licensed Pest Controller (Timber Pest Specialist) is also recommended to determine the extent of work required and associated costs. The above recommendation should be implemented without delay.

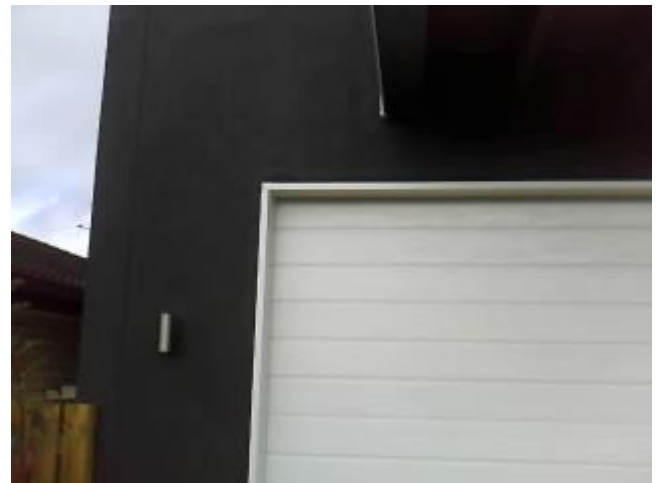
Doors	Garage door
Location	North-eastern side of the building
Element	Head flashing
Defect/Observation	Not installed
Extent	Localised
Recommendation	The consultant recommends that the client undertakes regular maintenance and continues to monitor the defect. Repairs may be necessary in the event the defect becomes more significant.

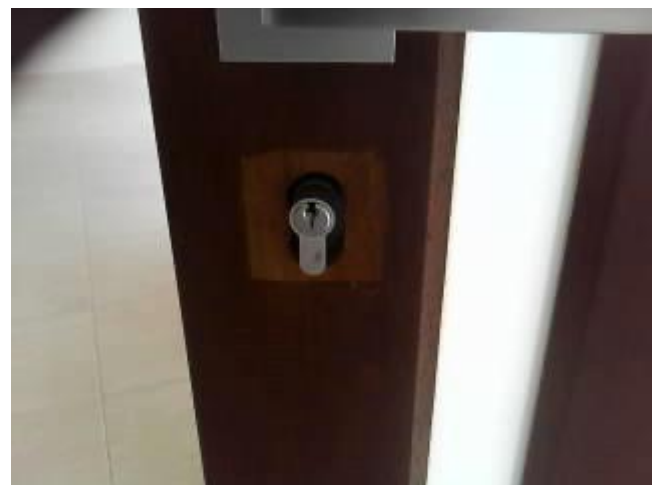
Doors	Front door
Location	Northern side of the building
Element	Door furniture
Defect/Observation	Incomplete
Extent	Localised
Recommendation	This defect should be addressed by a Licensed Tradesperson as soon as possible.

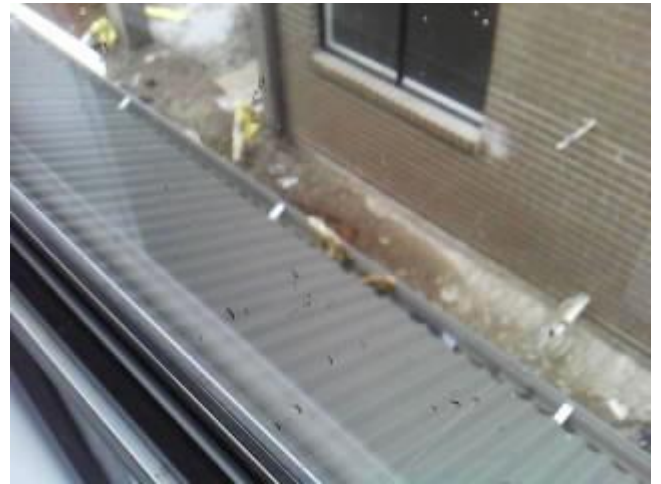
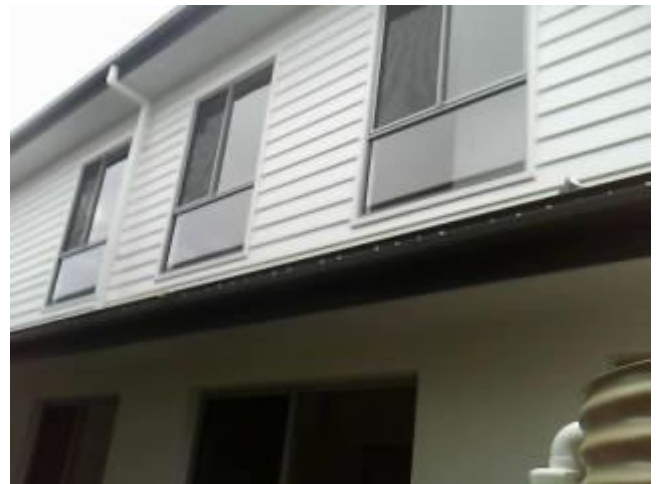
Location	Main building Southern side of the building
Element	Eaves Gutter
Defect/Observation	Not cleaned out, debris in gutter
Extent	Widespread
Recommendation	This defect should be addressed by a Licensed Tradesperson as soon as possible.

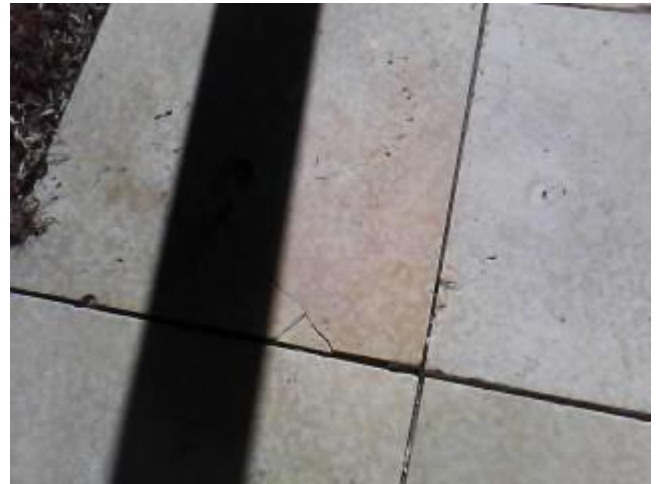
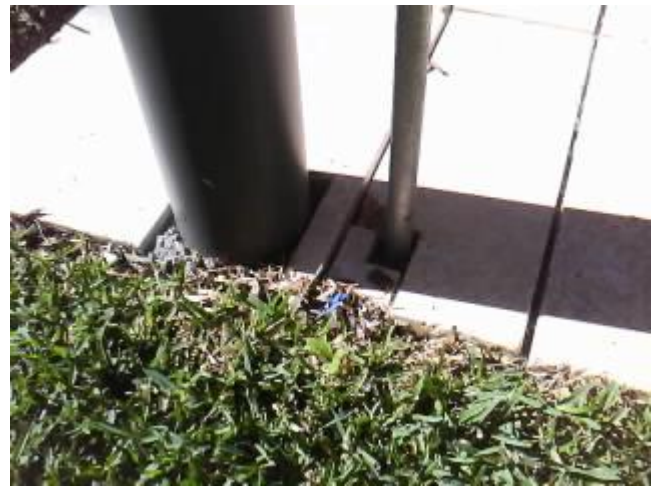
Location	Patio North-western side of the building
Element	Tiles
Defect/Observation	Cracked
Extent	Localised
Recommendation	This defect should be addressed by a Licensed Tradesperson as soon as possible.

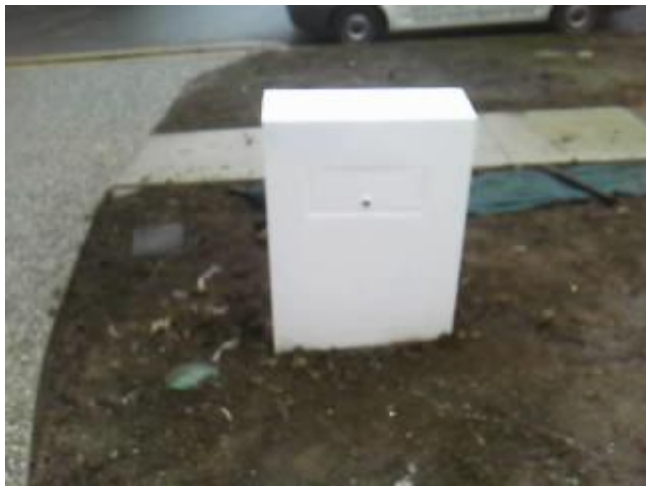
Location	Western side of the building

Element	Letterbox	
Defect/Observation	Difficult and/or unable to unlock	
Extent	Localised	
Recommendation	This defect should be addressed by a Licensed Tradesperson as soon as possible.

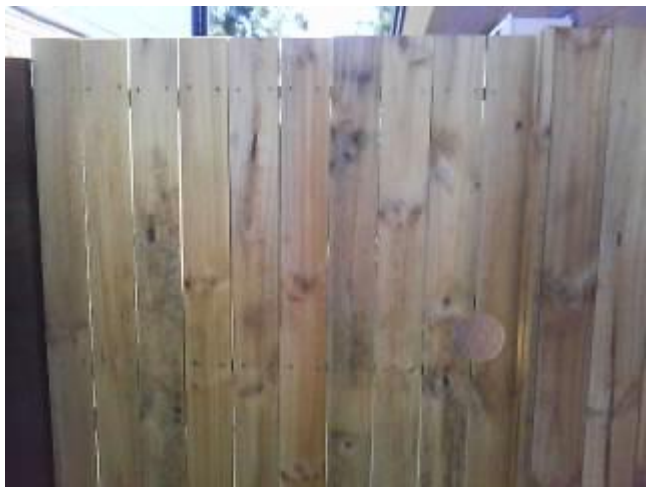
Location	South-western side of the building

Element	Side gate	
Defect/Observation	Binding	
Extent	Localised	
Recommendation	This defect should be addressed by a Licensed Tradesperson as soon as possible.

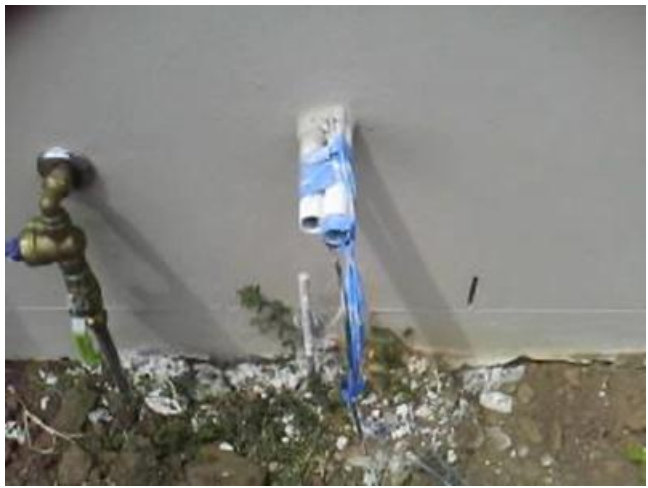
Location	North-western side of the building

Element	Electrical and/or data cable	
Defect/Observation	Incomplete	
Extent	Localised	
Recommendation	This defect should be addressed by a Licensed Tradesperson as soon as possible.

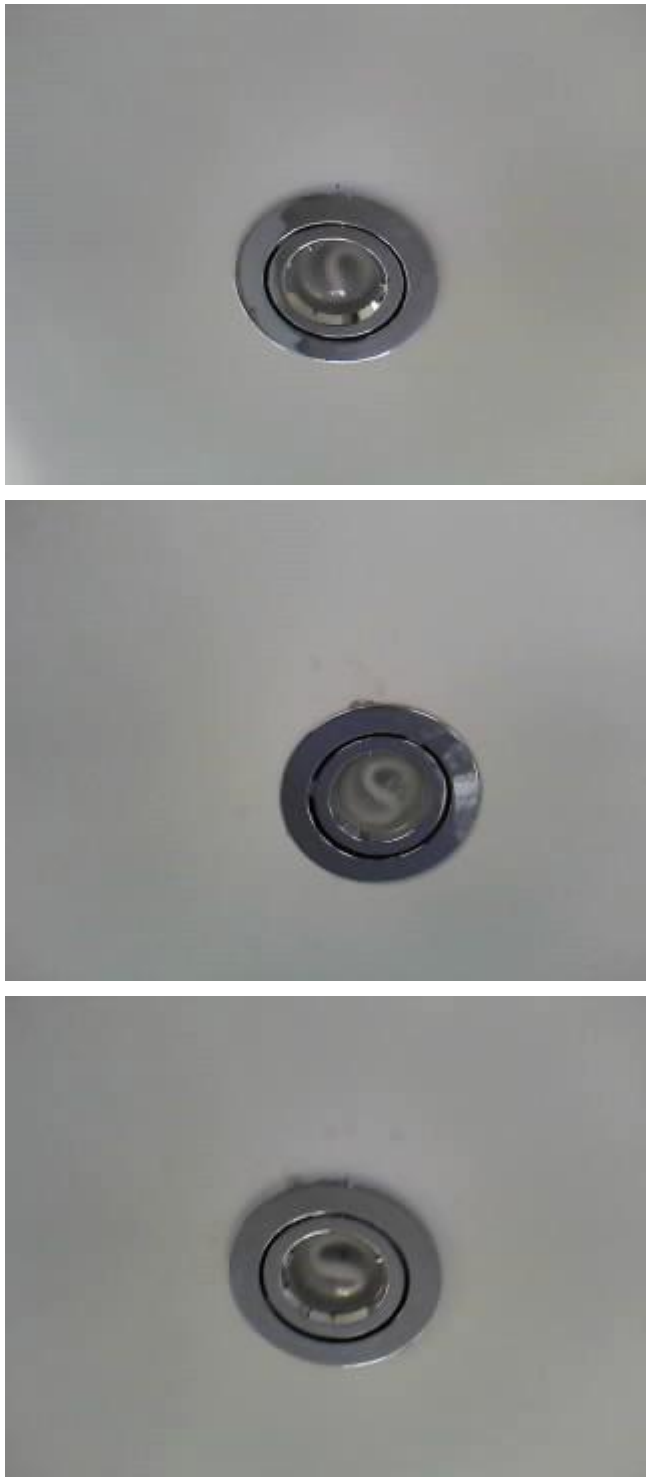
Element	Ceilings

Location	In general throughout	
Defect/Observation	Impact/scratch marks around downlights	
Extent	Localised	
Recommendation	This defect should be addressed by a Licensed Tradesperson as soon as possible.

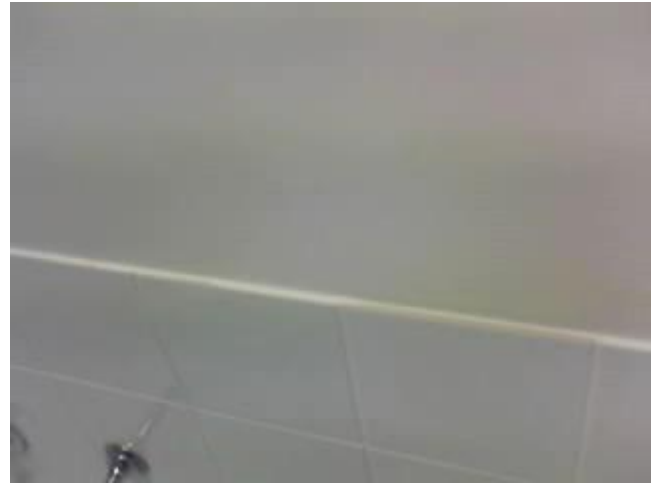
Location	Bathroom First floor Eastern side of the building
Element	Wall tiling
Defect/Observation	Patchy paintwork
Extent	Localised
Recommendation	This defect should be addressed by a Licensed Tradesperson as soon as possible.

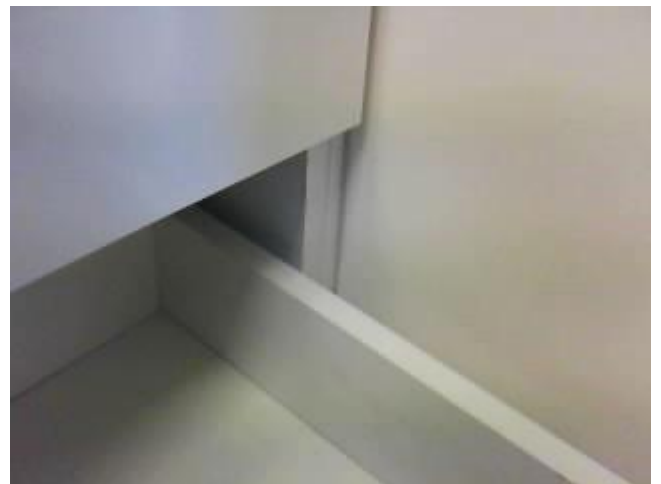
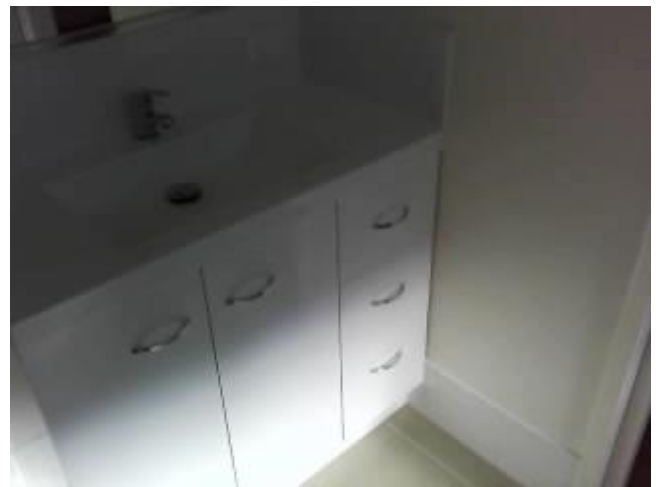
Location	Bathroom and ensuite First floor Eastern side of the building
Element	Wall linings adjacent vanity unit draws
Defect/Observation	Not painted
Extent	Localised
Recommendation	This defect should be addressed by a Licensed Tradesperson as soon as possible.

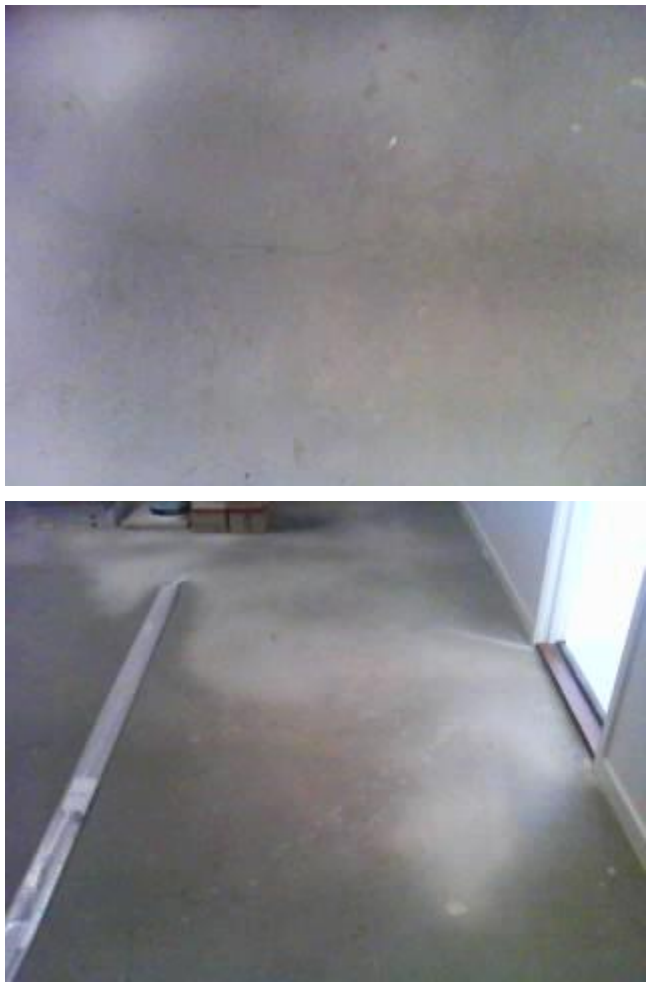
Element	Floor slab

Location	Garage, Ground floor North-eastern side of the building	
Defect/Observation	<u>Cracked</u> The consultant is of the opinion that the cracking is consistent with shrinkage during the drying process and/or minor settlement.	
Extent	Localised	
Recommendation	The consultant recommends that the client undertakes regular maintenance (applying sealant to keep moisture from entering the crack and corroding the reinforcing steel) and continues to monitor the defect. Repairs may be necessary in the event the defect becomes more significant.
