Building Inspection Report

25 Intrepid Lane, The Placetobe, 7171

Inspection prepared for: Gary Brown Inspection Date: 1/6/2011 Time: 3.55pm Age: 2004

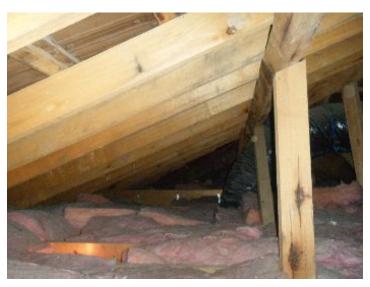
MAINT	PREV	MONIT	DEFR	DEFIC	01
					Observations The roof structure generally appears sound, although some minor
					deflections due to settling in over time were noted.

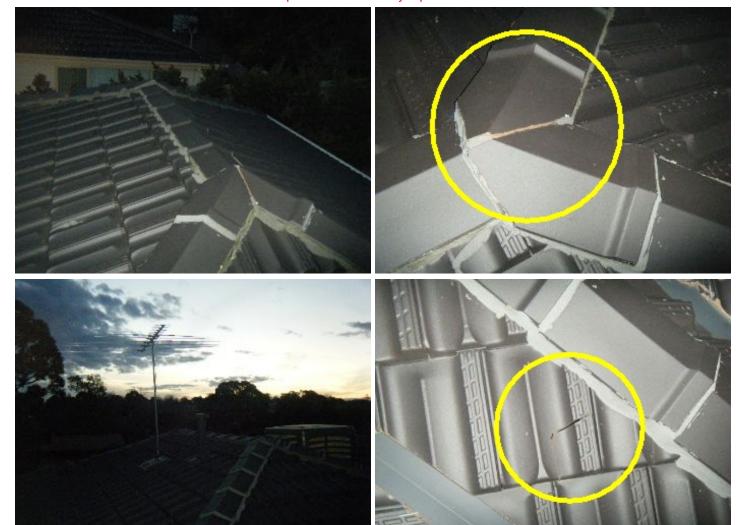
There is 1 cracked tile that you should have repaired or replaced to forestall the possibility of leakage. This is located near the front of the home above the garage.

Cracked tile

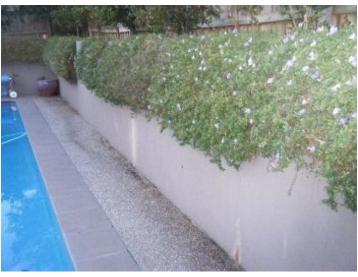
Dampness evident
