# **Building Inspection Report**

25 Intrepid Lane, The Placetobe, 7171

Inspection prepared for: Gary Brown Inspection Date: 1/6/2011 Time: 3.55pm Age: 2004

Weather: Overcast
\*\*\*\* Sample Inspection Report \*\*\*\*

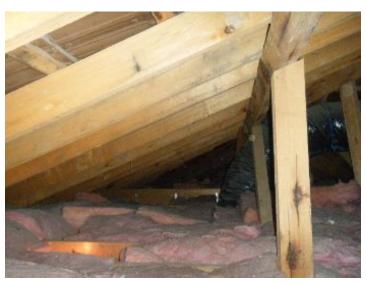
MAINT	PREV	MONIT	DEFR	DEFIC	
					Observations The roof structure generally appears sound, although some mino
					deflections due to settling in over time were noted.

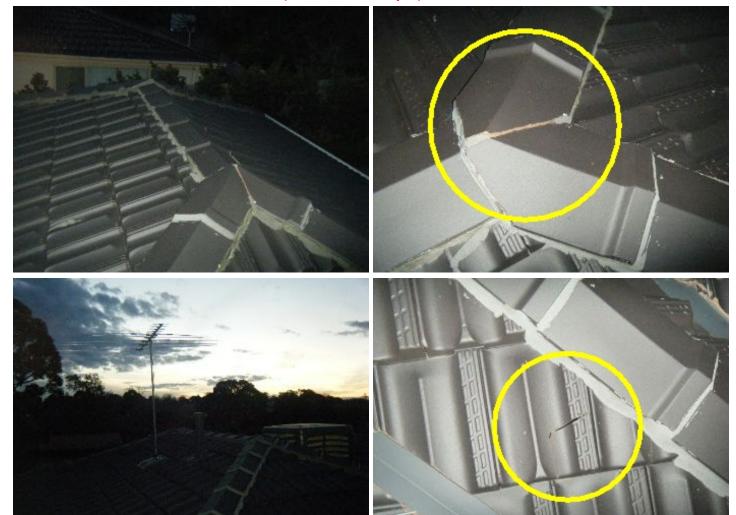
There is 1 cracked tile that you should have repaired or replaced to forestall the possibility of leakage. This is located near the front of the home above the garage.

There is a gap on a connection point between the hip and ridge cap tiles above the alfresco area that needs repair as it is currently a potential leak source.

Cracked tile

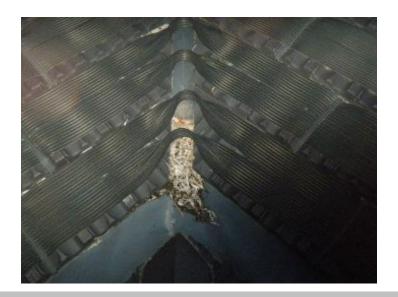
• Some of the valley flashings have some leaf debris which should be cleared out.

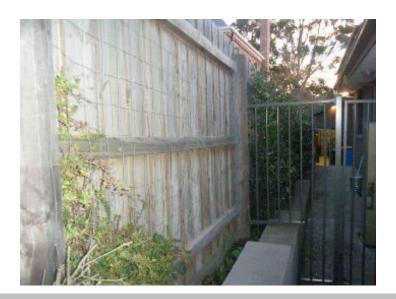
- Appeared serviceable at time of inspection.
- Fence leaning in areas.

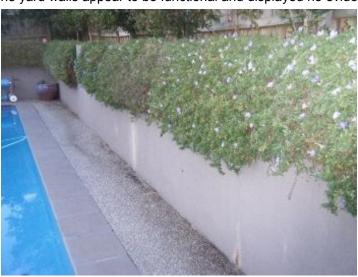
Dampness evident
