Building Inspection Report

25 Intrepid Lane, Placetobe Lane, 7171

Inspection prepared for: Gary Brown Inspection Date: 1/6/2011 Time: 3.55pm

Resicert Structural Plus Inspection

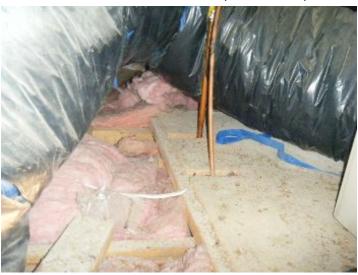
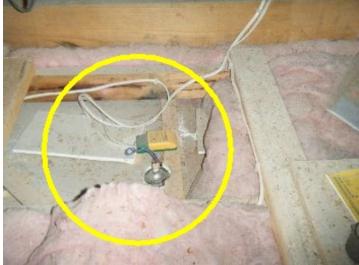
- Insulation appears adequate.
 The insulation installed in the rafters has been disturbed. It is necessary to have this insulation put back into place to be effective.

Disturbed insulation - use light covers

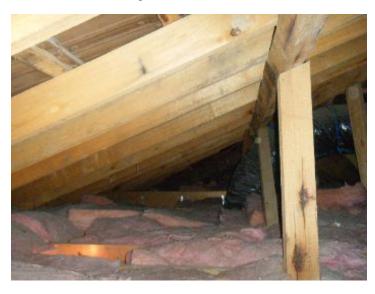
Observations The roof structure generally appears sound, although some minor deflections due to settling in over time were noted.

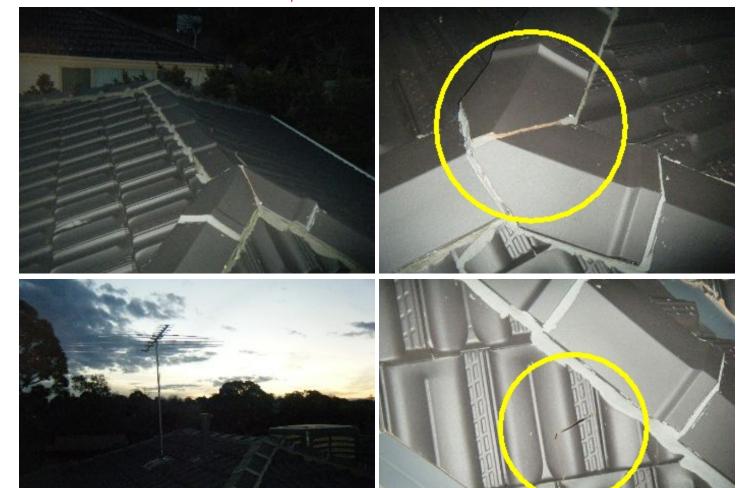
There is 1 cracked tile that you should have repaired or replaced to forestall the possibility of leakage. This is located near the front of the home above the garage.

There is a gap on a connection point between the hip and ridge cap tiles above the alfresco area that needs repair.

Cracked tile

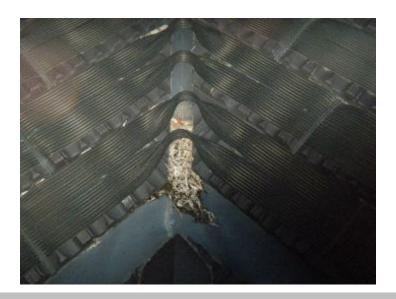
• Some of the valley flashings have some leaf debris which should be cleared out.

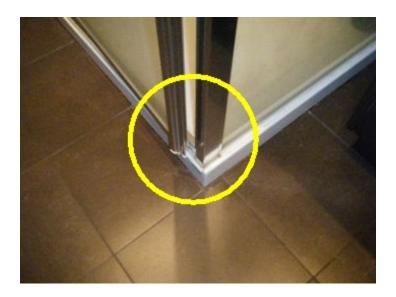
The shower enclosure was functional at the time of the inspection.
The shower door in main bathroom was catching at bottom lip. This requires attention.

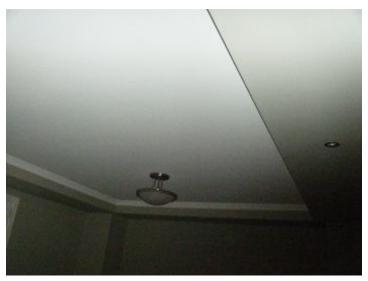
• A light fixture in the living area - low voltage down light - was not working and requires attention.

Light not working

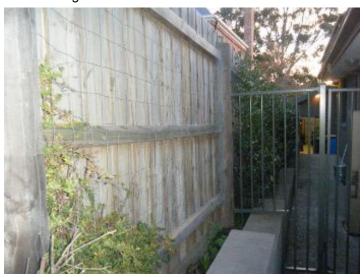
- Appeared serviceable at time of inspection.
- Fence leaning in areas.

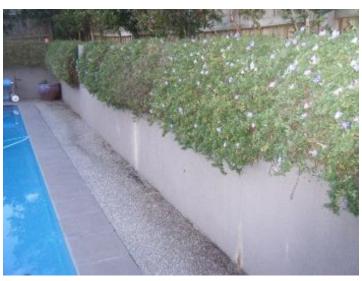
Dampness evident
