STANDARD PROPERTY INSPECTION REPORT

**Complies with Australian Standard AS4349.1 Property Inspections - Part 1
Residential Buildings**

ADDRESS: 1 SMITH STREET PRAHRAN VIC 3181.

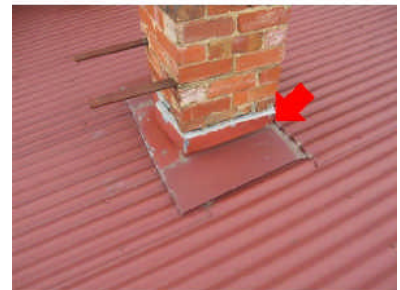
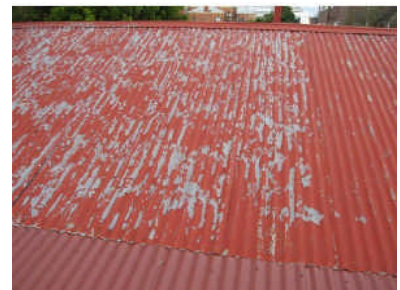
The overall condition of the roof coverings is fair. The flashing around this chimney requires replacement. Competent advice (e.g. from a Licensed Roofing Plumber) is strongly recommended to determine the method and extent of any remedial work required and associated costs.

Flashing is cracked, missing, damaged or in poor condition at the chimney. The potential for water entry is present. A licensed roofing contractor should be called to make further evaluation and repairs as needed.

The flashing around the chimney is in poor condition and will require repair or replacement.

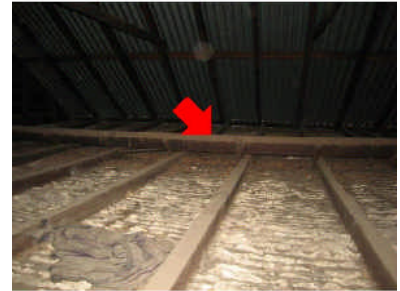
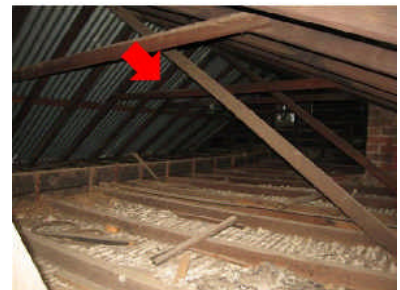
Additional support is required generally through the roof cavity in the form of collar ties. Additional support is also required in the form of ceiling joist hangers over bedroom two.

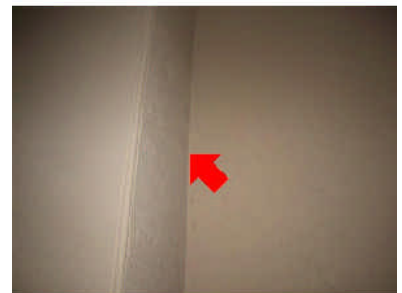
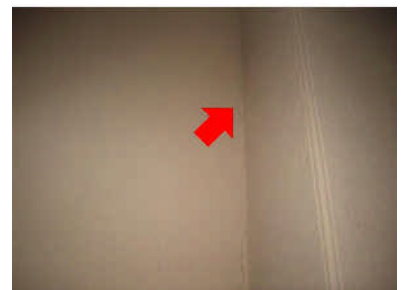
The condition of the walls is generally poor. Minor settlement cracks in walls beside chimney. Periodic maintenance may be required.

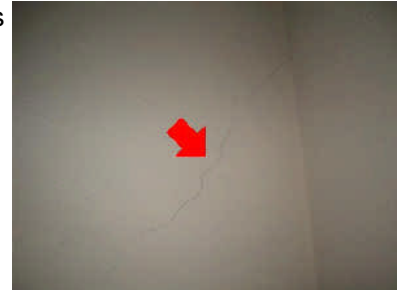
The condition of the walls is generally poor. Minor settlement cracks in walls. Periodic maintenance may be required.

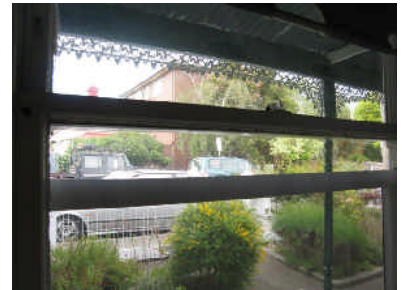
Exposed gap in window frame where pane does not fit window was evident.

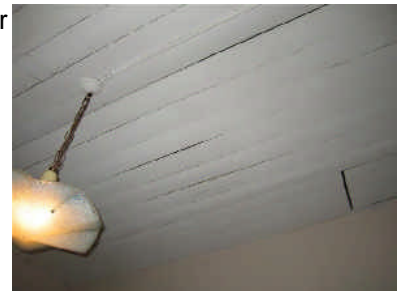
The condition of the ceilings is generally fair. Evidence of past water penetration through the ceiling. No evidence of any current leaks.

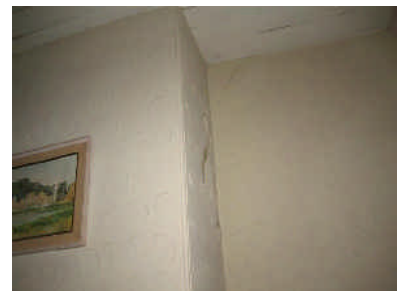
The condition of the walls is generally poor. Moderate settlement cracks in walls. Periodic maintenance will be required.

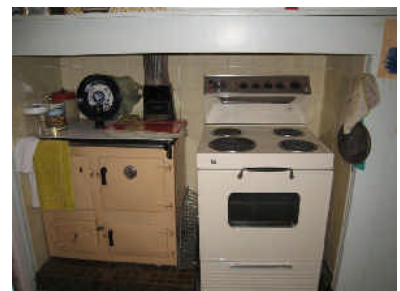
The condition of the fixtures is generally fair. The cook top is not working properly.

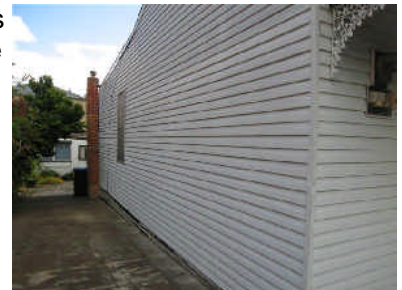
The condition of the walls is generally fair. The external wall timbers show signs of age and weathering. Competant advice from a house painter is recommended as to the extent and cost of any remedial works required.

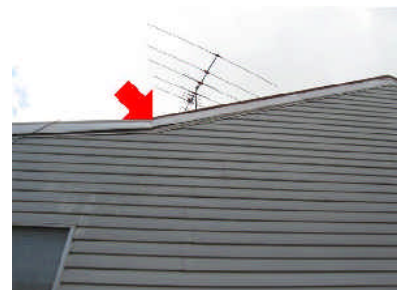
The overall condition of the fascias/bargeboards is fair. Moderate wet rot decay is present to timber fascias and barge boards. Maintenance is required. The paint work is deteriorating and maintenance is required.

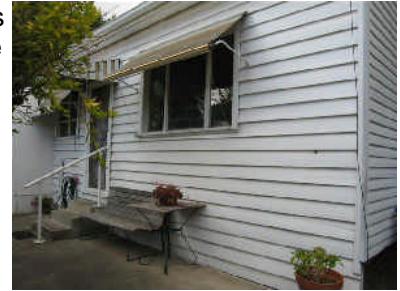
The condition of the walls is generally fair. The external wall timbers show signs of age and weathering. Competant advice from a house painter is recommended as to the extent and cost of any remedial works required.

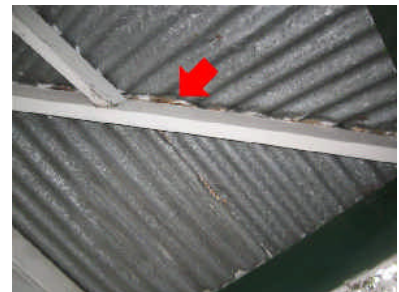
Framing members are inadequate and/or excessively spaced. The metal roof sheeting is rusting and treatment is required.

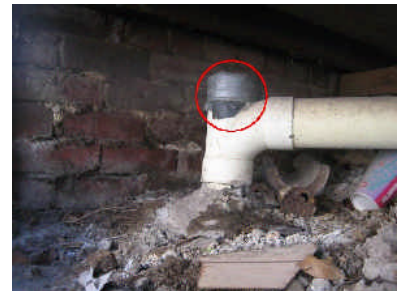
Subfloor: Cracked pipes were noted as leaking under the house. Competent advice (e.g. from a Registered Plumbing Contractor) is strongly recommended to determine the method and extent of any remedial work required and associated costs.

Cracked or broken PVC drainage pipes are present. These should be replaced by a licensed plumber or drainer.

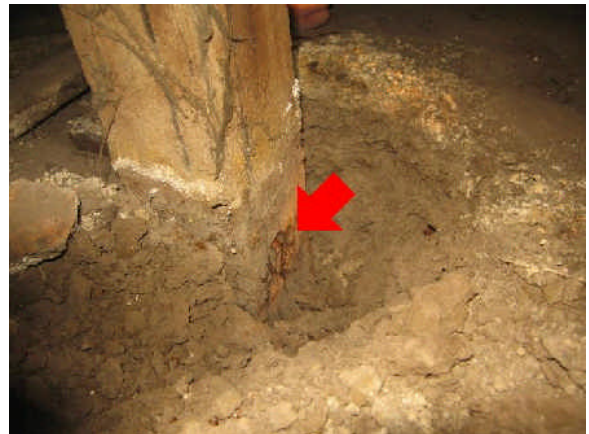
Some or all of the timber stumps have deteriorated and are not adequately supporting the bearers and joists. A further detailed investigation by a suitably qualified house reblocker is advised to determine the extent and cost of any remedial works required.

Some or all of the timber stumps have deteriorated and are not adequately supporting the bearers and joists. This is consistent with the floors throughout the house being uneven/out of level.

As a guide restumping (reblocking) using concrete stumps can cost between \$70 and \$90.00 per stump. An average size timber house of approx 150 square meters would be expected to require between 80-90 stumps at a cost of approx \$6,000 and \$8000. This cost is an indicative cost only and allowance would need to be made for extra labour costs such as plastering, repairs to doors and replacement of any bearers and joists etc.

A further detailed investigation by a suitably qualified house reblocker is recommended to determine the extent and cost of any remedial works required.

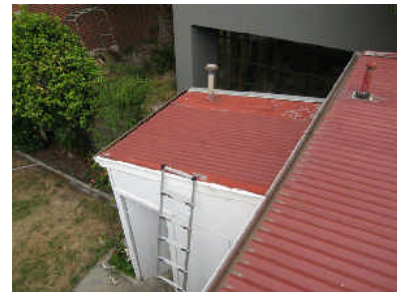
The overall condition of the roof coverings is fair. The metal roofing is rusting and requires treatment to limit further deterioration.

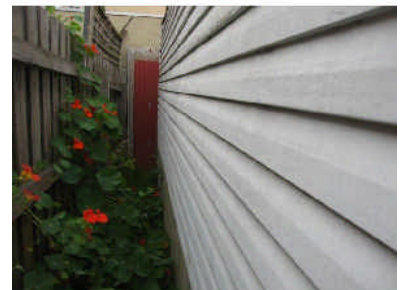
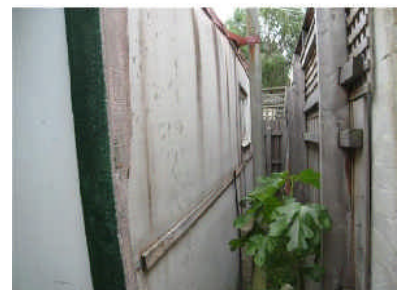
The condition of the walls is generally poor.

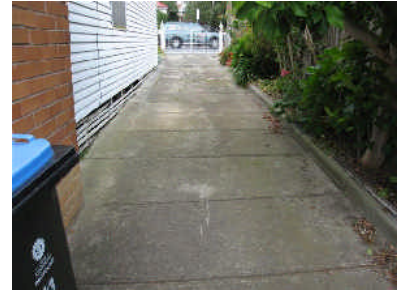
The concrete driveway stands in fair condition. The concrete driveway has some visible cracking that should be monitored for further movement.

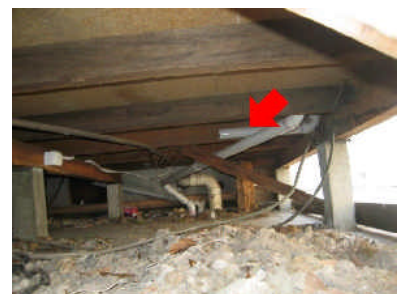
Suspect Plumbing was noted at the time of the inspection. Advice from a licensed plumbing contractor should be sought to provide additional information as to the extent of remedial works and associated costs that may be required to rectify the problem.

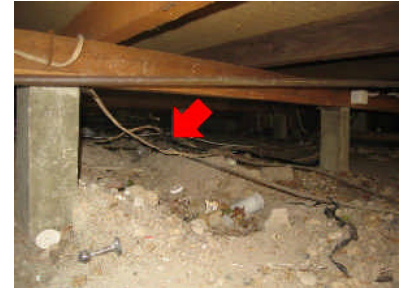
Electrical wiring is suspect with cables on the ground under the subfloor and should be checked by an appropriately qualified contractor.
