Visual Property Inspection Report

18 Cotton Grove, Bella Vista.

VISUAL BUILDING INSPECTION REPORT

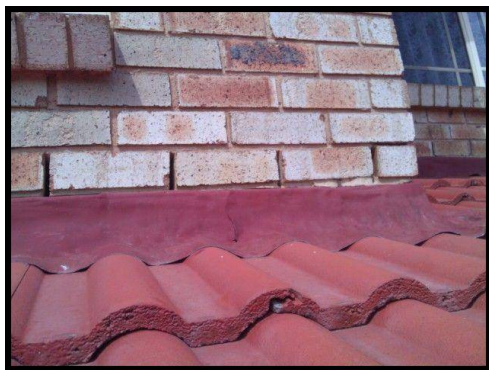
A small number of cracked roof tiles were noted and should be replaced. Mortar beds to the hip and ridge capping are cracked and require maintenance or re bedding and pointing in areas.

Flashing material is of lead. Flashing is split, in poor condition and will require rectification to the following areas; Junction of the pitched roof/s and wall. Recommend the installation of a soaker or apron flashing to roof junction/s. Failure to install these flashings may cause water entry and damage to property. These flashings should be installed to comply with Standards.

Estimated cost from: \$750.

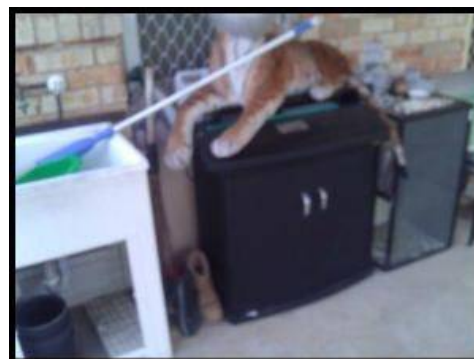
Restrictions:	Inspection to sections of the exterior was restricted due to the stored goods. These goods must be removed to enable a more complete report to be submitted. Southern side of the structure.
----------------------	--

Defects and or damage requiring rectification may not be apparent to the inspector due to restriction. If restrictions are noted we STRONGLY recommend access be gained to enable a full inspection of the area.

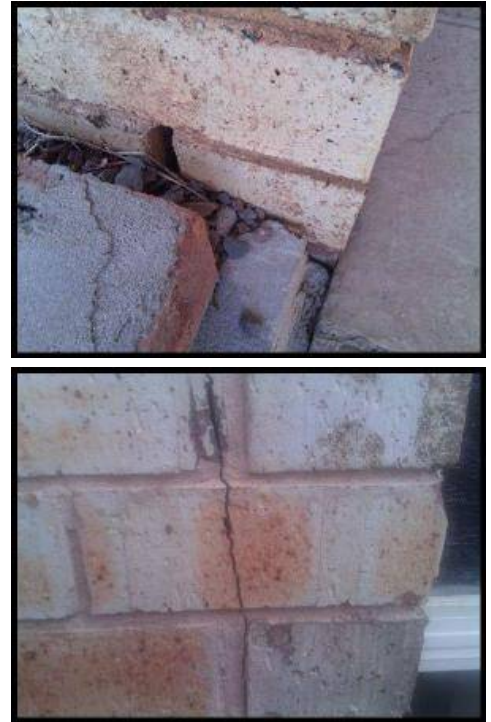
Position/Location: Northern elevation. Eastern elevation.

Wall Condition:	Cracks are evident to masonry. Visible cracking appears major and a Structural Engineers opinion should be sought. Please refer to section of this report - CRACKING OF BUILDING ELEMENTS for additional details. The ground levels are close or covering the damp proof course material and should be lowered to prevent dampness problems. The height of a DPC, or flashing serving as a DPC is recommended be not less than 150 mm above the adjacent ground level, 75 mm above the finished surface level of adjacent paved, concrete or landscaped areas that slope away from the wall or 50 mm above finished paved, concrete or hard landscaped areas.
------------------------	---

Structural Defect Cracking: Crack Type: Stepped cracking Vertical cracking Located: East elevation Width: 5mm Length: 2.0M.

Due to the unpredictable nature of cracking in building elements it is not possible for the inspector to determine past or future occurrences that have or will impact cracking in this building. Because of these unknowns and the possibility of concealed defects related to cracking in building elements we recommend an engineer be consulted prior to acceptance or purchase this building.

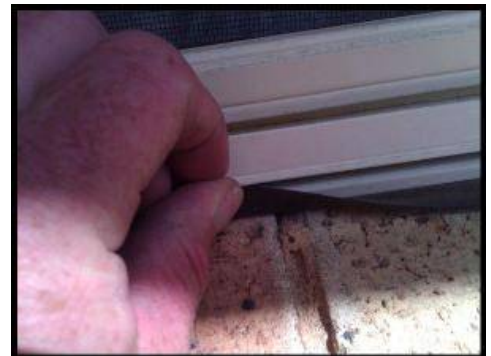
The clearance under the window sills is not sufficient to allow for settlement. Clearances should be modified to prevent damage to windows, cladding and internal finishes when the timber frame settles. Clearances should be a minimum of 5mm for single or lower levels and 10mm for second storey windows.

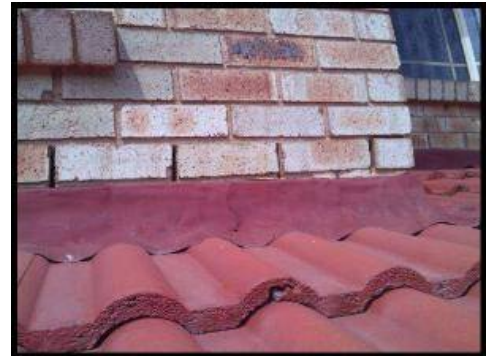
Flashing material is of lead. Flashing is split, in poor condition and will require rectification to the following areas; Junction of the pitched roof/s and wall. Recommend the installation of a soaker or apron flashing to roof junction/s. Failure to install these flashings may cause water entry and damage to property. These flashings should be installed to comply with Standards.

Estimated cost from: \$750.

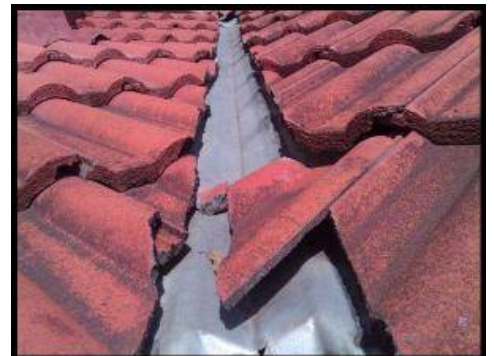
Some tiles have slipped into the valley area and will require repositioning and securing to prevent water entry.

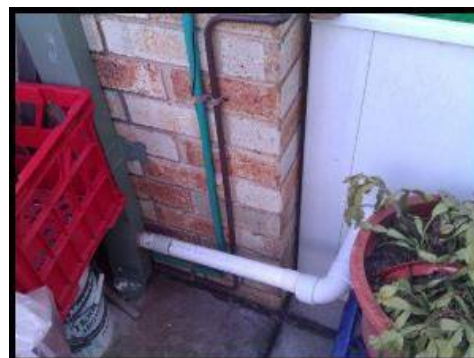
Room Location:	Externally.
Tub & Taps:	The tub is loose and should be secured to the wall. A licensed Master plumber should be called to make further evaluation and repairs as needed. The sewer and stormwater lines may be illegally connected and we recommend a licensed plumber further investigate.

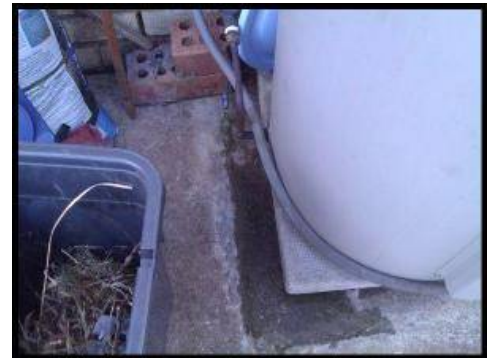
Mains electric hot water system: Mains pressure: Located externally: The hot water system appears to be in working condition. No specific tests other than running the hot water tap were carried out. No determination has been made as to the suitability or adequacy of the hot water system in relation to capacity or otherwise. Hot water overflow pipe should be diverted away from the external walls. Damp soil around the building may cause swelling and lead to heaving of structure and cracking to walls. Moisture also encourages termites into the area. We strongly recommend the overflow relief valve be connected to a drainage point.
