Visual Termite Inspection & Report in Accordance with AS 3660.2-2000

1243 Smith Pl, Never Never Land NSW, Australia

Client:	Mr Smith
Client Address:	C/O Real Estate XYZ WYEE ROAD, WYEE NSW 2259
Re: Structure at:	243 Smith Pl, Jilliby NSW 2259, Australia
Phone:	
Fax:	
Mobile:	
Date of the Inspection:	14-Jun-2016
Invoice No:	XYZ 1212

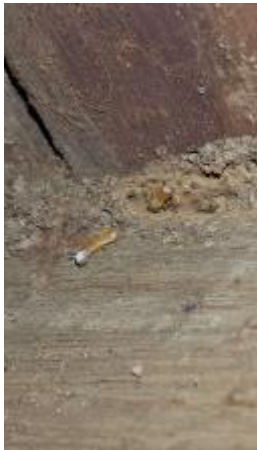
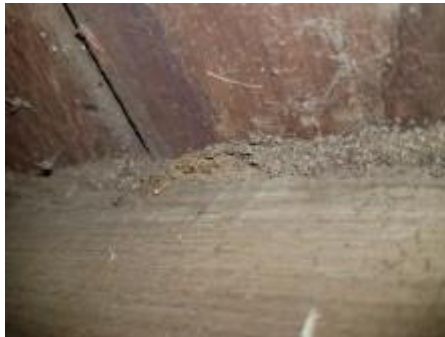
At the time of the inspection were active termites (live insects) found?	Yes
Active termites were located in but not necessarily limited to the following areas:	Subfloor

If the answer was "Yes" then the termites are believed to be	Coptotermes Spp.
---	------------------

The termites have the potential to cause **Extensive to Severe** amounts of damage to structural and decorative timbers.

Live Termite to Bearer and Mudding to Joist

Subterranean termite treatment recommendation: A suitable management program that accords with AS 3660 against subterranean termites is considered to be	Essential
---	-----------

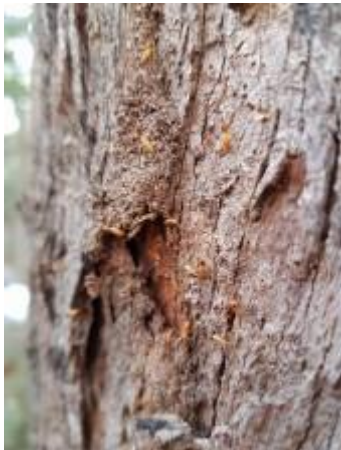
(If yes, describe & state the location): Aborial nest found up in tree facing front door

Live Activity Noted To Tree

Environmental, other Conditions and/or general information: Recommend test drilling of all trees within 30-50mtr be essential as workings are visible as well as fly cuts. Recommend removing coated metal roofing for inspection as alates have been found around the house.

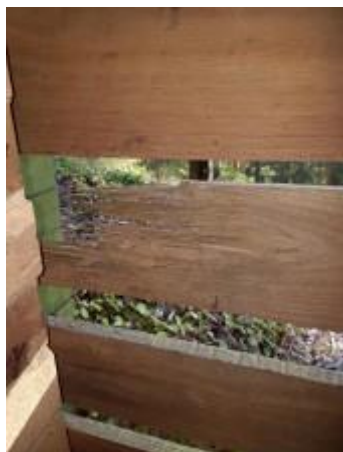
Wood rot: At the time of the inspection was visible evidence of wood decay fungi (rot) found?	Yes
Evidence was found in	Subfloor, Wall Exterior, Decking Front, Bathrooms

Decay and old damage to sub floor fence

Wood decay fungi are conducive to subterranean termites. You should consult a builder or other building expert to find out what must be carried out to prevent further decay (repairing of drainage, leaks and/or sealing the timber) and to repair the damage.
