Pre-Purchase Building Inspection & Report - Residential Building

Visual Timber Pest Inspection & Report

SAMPLE ONLY

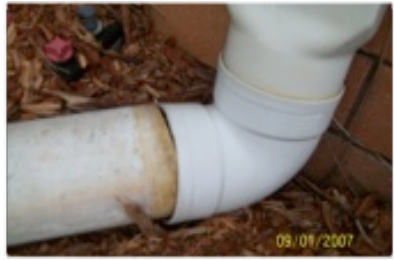
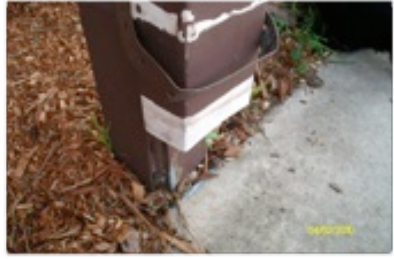
<p>Downpipes Colorbond</p> <p>Guttering colorbond</p>	Damp related	<p>downpipe at front left corner of the house currently extended with PVC pipe to discharge directly into the garden. Elbow not fitted properly and will certainly leak.</p> <p>downpipe at the front of the house discharges direct to the path - should be connected to a stormwater system</p>

- **Downpipes:** should be connected to a subterranean stormwater system, which discharges roof water to the street kerb or rubble drains.
 - 1) downpipe at front left corner of the house currently extended with PVC pipe to discharge directly into the garden. However elbow fitting not connected properly and would certainly leak.

- 2) downpipe at the front of the house discharges direct to the path
- **Carport:** corrosion noted on corrugated roof sheeting and downpipe should be connected to outlet in gutter. Currently discharges direct to ground from outlet.

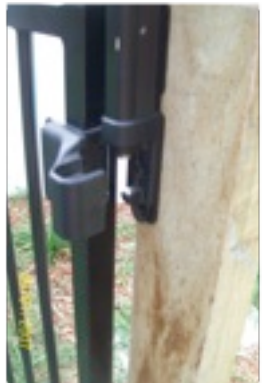
Description of Area Inspected	Type of Defect	Description & Significance of Defects Noted	Image
Not part of the scope of this inspection - see "Other Inspections Recommended."	Operational defect & safety issue	Pool gate is non-compliant as it does not self-close and latch automatically. Rectify immediately. See "Significant Items"

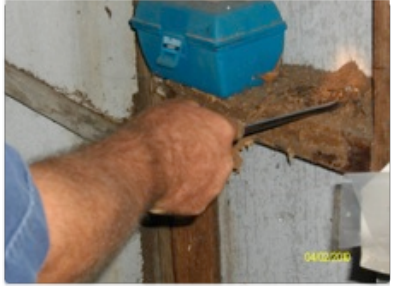
Description of Area Inspected	Type of Defect	Description & Significance of Defects Noted	Image
<p>Timber wall & roof framing</p> <p>Concrete slab</p>	<p>Damage defect</p>	<p>Termite damage and activity noted - see Section 10 and "Significant Items"</p>

- 4) balustrades are not suitably secure.
- **Detached Garage Work Shed:** Active termites and extensive termite workings throughout this structure. Strongly recommend that termite activity be treated immediately and damage to framing repaired. Refrain from placing garden soil or mulch against exterior cladding. Expose concrete slab edge.

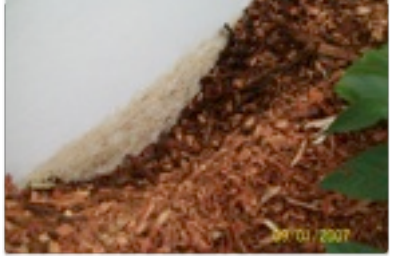
<p>FC exterior cladding</p>	<p>Installation defect</p>	<p>Clear soil / gardens away from base of cladding as this increases risk of decay and concealed termite access</p>

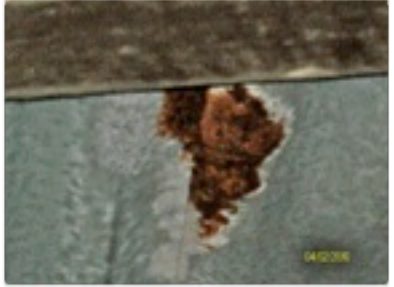
<p>Corrugated roof sheeting</p> <p>Note. Second hand roof sheeting used as evidenced by holes where original fixings applied.</p>	<p>Material deterioration</p>	<p>Corrosion noted in roof sheeting</p>

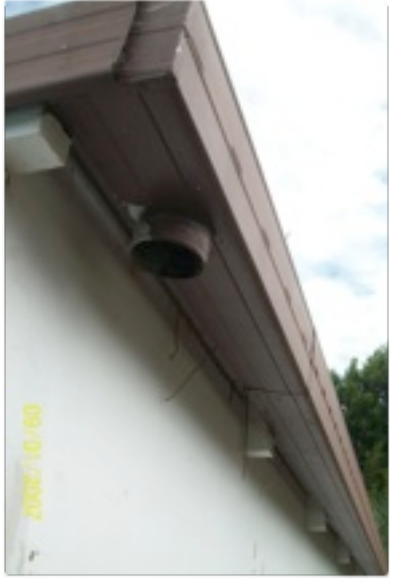
<p>Omission (installation defect)</p>	<p>Downpipe should be connected to outlet</p>

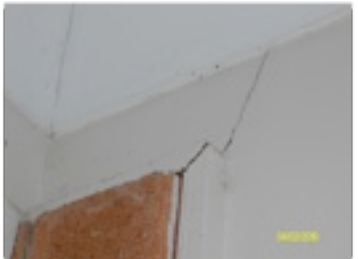
<p>Walls Single skin brickwork perimeter walls Timber frame partition walls with FC cladding & paneling to Entry</p>		<p>Cracks at lintels probably due to hwd timber frame shrinkage.</p>

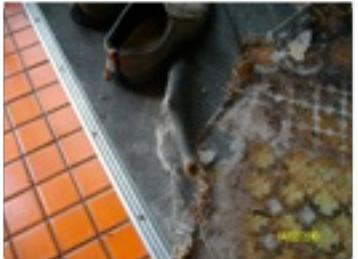
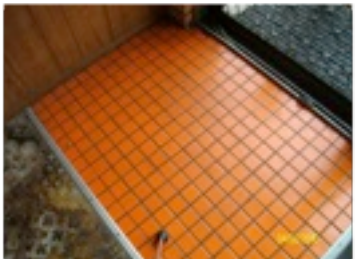
<p>Floors Concrete slab unsighted due to floor coverings - Carpet in Entry and 2 Bed / Storerooms</p> <p>Ceramic tiles in Laundry, Bathroom Entry</p>	<p>Damage</p>	<p>Carpet in poor condition at entry</p>

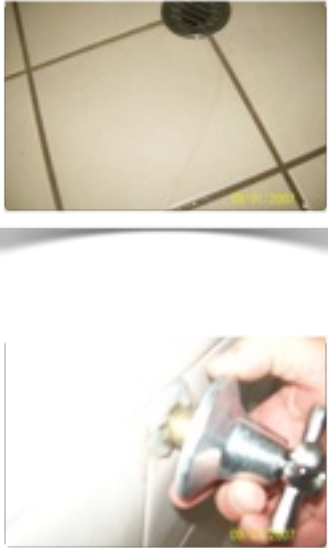
- **Bathroom (Upstairs):** cracks in floor tiles inside the shower recess could lead to water penetration to the lower level. Unable to check inspection hatch in Laundry ceiling as it is screw fixed. Moisture tested hatch with moisture meter - no excess moisture detected. Recommend owner removes the inspection hatch / cover plate for further inspection purposes.

<p>Shower Tiled recess Glass shower screen</p> <p>Tapware turned on & visually checked for leaks Checked behind shower tap flanges</p>	Possible water penetration defect	See "Significant Items" regarding hairline cracks noted in shower floor

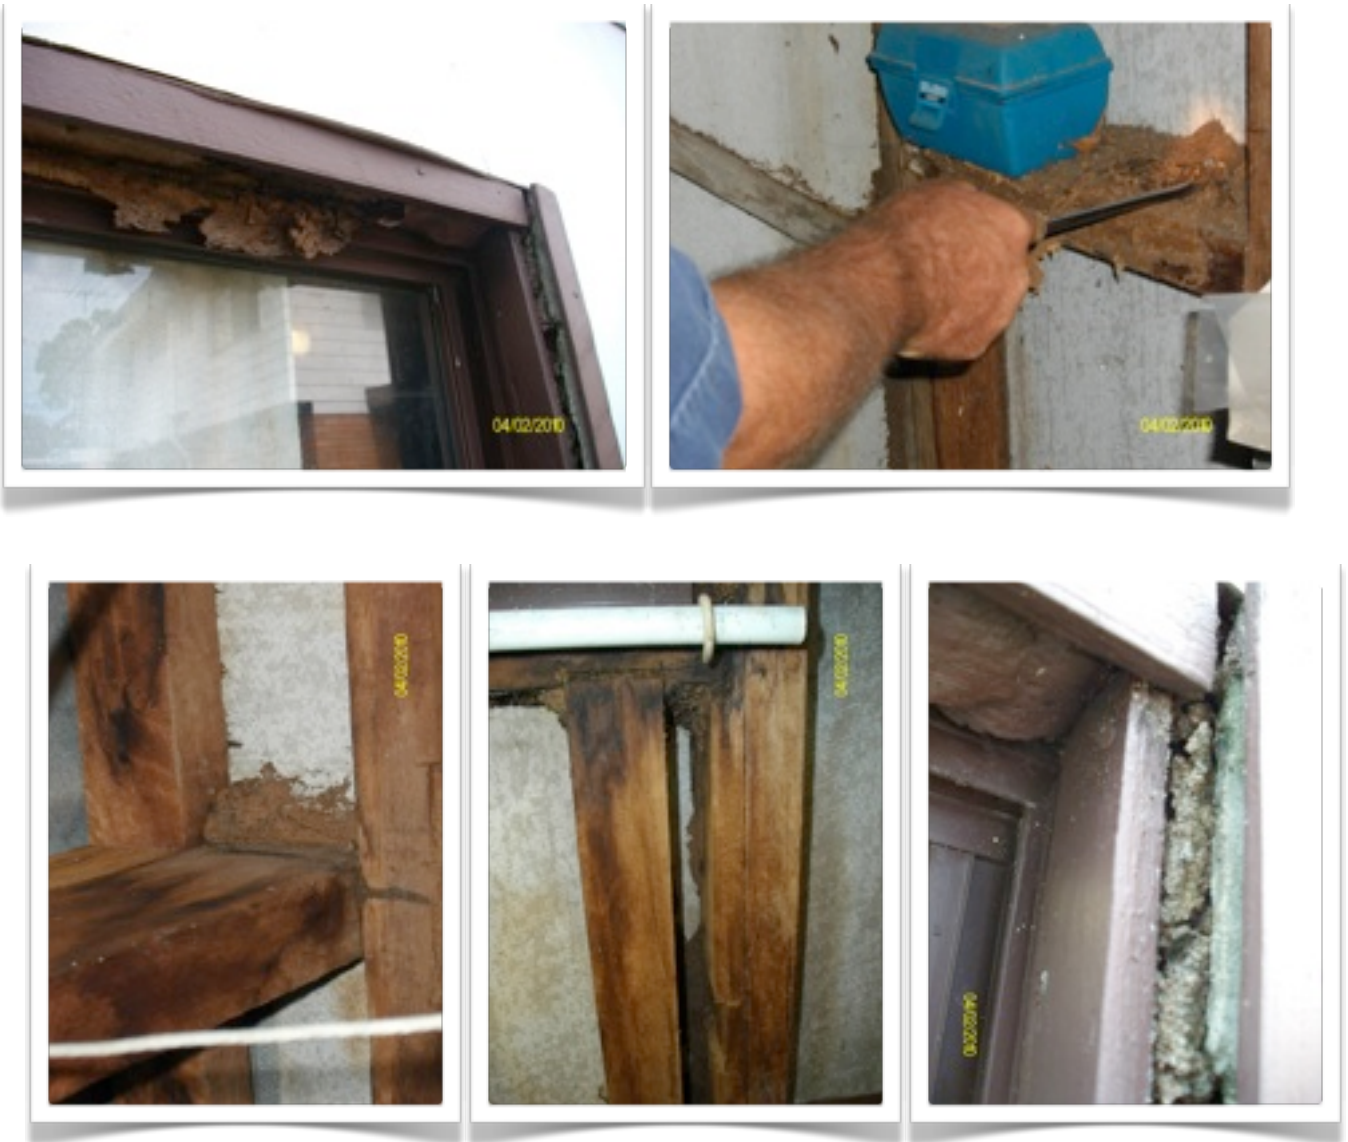
10.01 Active termites (live insects) and visible evidence of subterranean termite workings and extensive damage was present in the garage work shed at the time of the inspection.

- The termites were located mainly in, but not necessarily limited to, the following areas: detached Garage / Shed wall and roof framing
- The termites are believed to be *Shedorhinotermes* and have the potential to cause extensive damage to structural and decorative timbers.

A management program in accord with AS 3660-2000 to eliminate current infestation and to protect against subterranean termites is considered to be **essential** and we strongly recommend that the client seeks quotations for the installation of a suitable barrier.

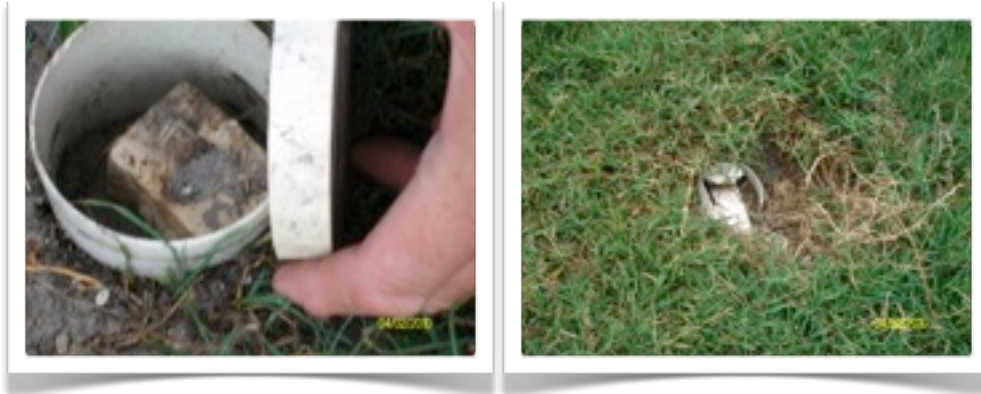
10.03 No durable notice was found on site to indicate that a termite management system is in place. However, 3 bait monitoring stations were found around the front right of the property where a tree has been removed. No other stations found and no indication that they have been monitored. Therefore the Inspector judges this property to be unprotected and at extremely high risk of termite attack.

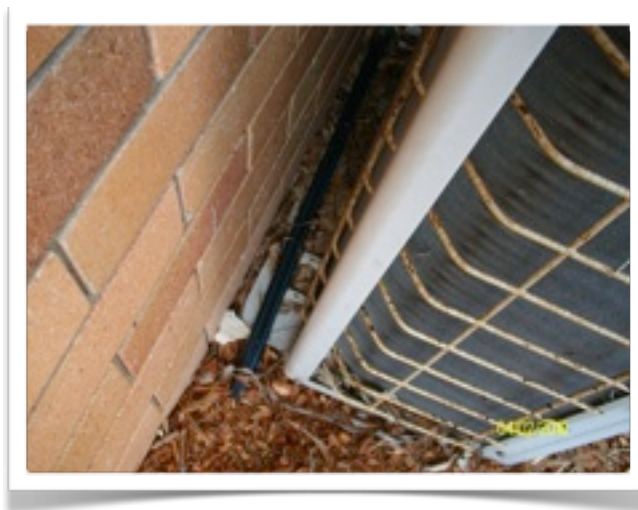
Condensation line discharges direct to ground

- **Air conditioner (exterior):** currently leaning - rectify. Also, condensation line discharges directly into the garden bed against the exterior of the house. Should be run to a drain or downpipe. Resultant moisture against the exterior of the house is conducive to attracting termite activity.

11.4 Hot Water Units / Air Conditioning Units / Downpipes : which release water alongside or near to building walls should be piped to a drain. If not possible then extend to discharge several meters away from the building as the resulting wet area is highly conducive to attracting termites.

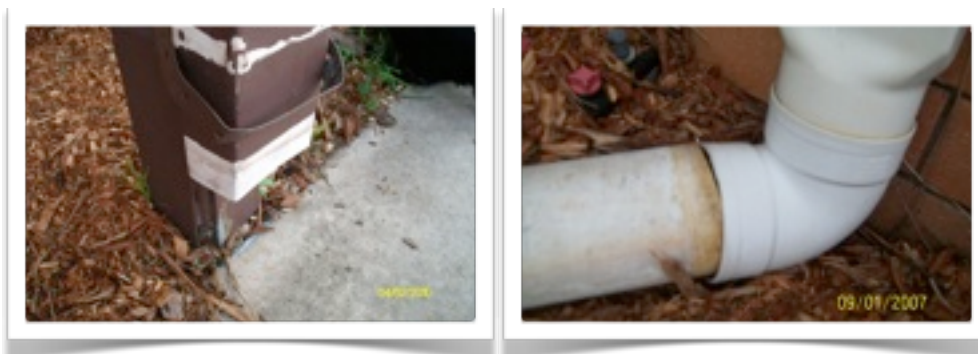
Downpipes discharge direct to ground and should connect to stormwater system
