Product & Services Guide 2011

Escalator Safety Services Pty Ltd

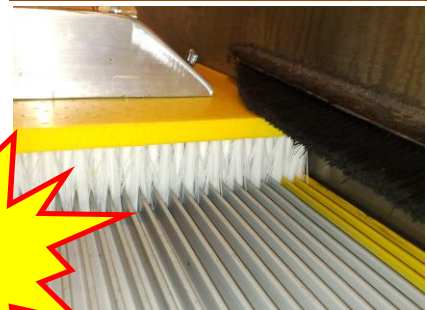
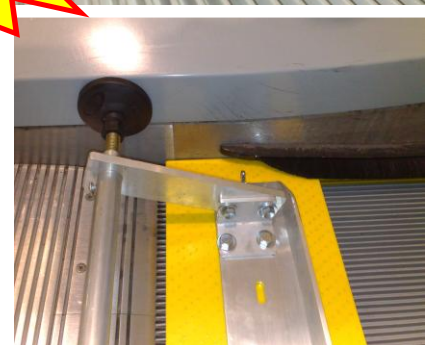
Tread Brush Cleaner™ 267 is an integrated brush cleaning system designed to clean **Tread Safety™ Grip 254** grip surface, channels and demarcation lines of a Travelator or Escalator unit in one operation.

The multi level brush bristle is designed to improve foot traction, reduce coating removal and channel abrasion.

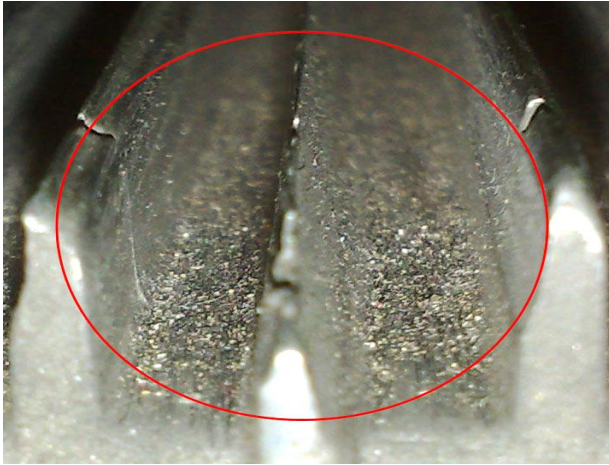
Rib Re-Build™ Razor 260 is an integrated **In-situ** service that restores sharp ‘razor blades’ and damaged rib treads caused through metal objects becoming jammed in the comb plate. A Razor can also catch clothing, footwear, cords and shoe laces which may lead to personal injury.

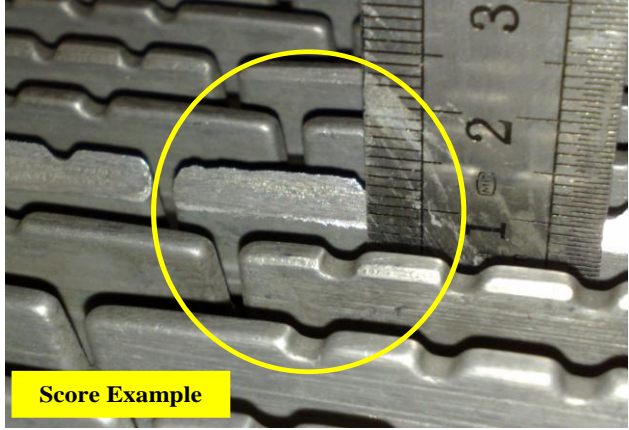
Score Example

Rib Rebuild™ - Score 261 is an integrated **In-situ** service that repairs ‘scored’ and damaged rib treads caused through metal objects becoming jammed in the comb plate. A Score can also be a burred edge that can catch clothing, footwear, cords and shoe laces which may lead to personal injury. Using a special metalized compound Escalator and Travelator ribs can be restored providing a safer public environment and returning the unit back into service within 8 hours. To avoid tread plate channel, rib and coating abrasion, ESS recommend using **Tread Brush Cleaner™ 267**

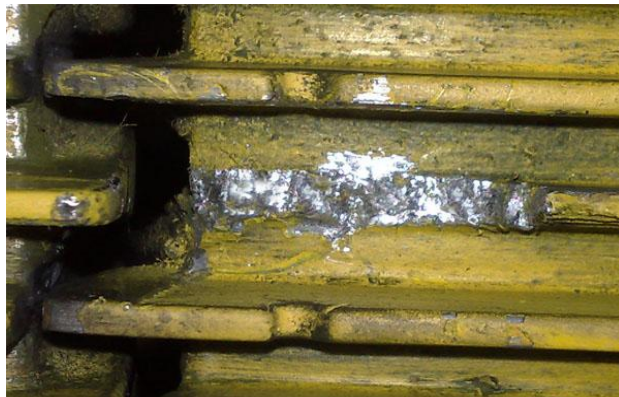
Chip Restoration	1 < > 50mm in length
	50-90mm in length

Rib Rebuild™ Chip 258 is an integrated system designed to rebuild broken or damaged rib treads caused through impact or objects snapping the rib profile making it unsafe or hazardous for public use. Using a molecular metal compound Escalator and Travelator damaged ribs can be restored “In-situ” and the unit returned back into service within eight hours.

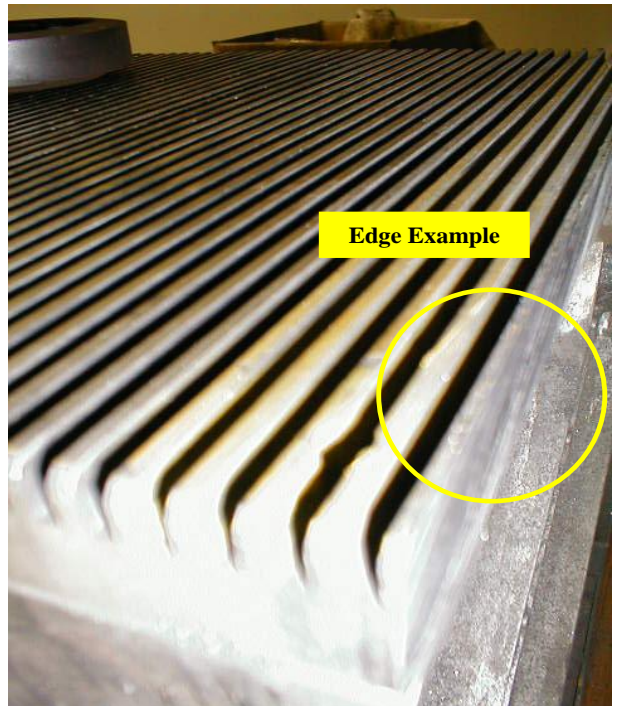
Rib Rebuild™ Edge 255 is designed as an “Offsite” restoration service for the rebuilding of worn abraded tread plate edges due to misalignment on Escalator and Travelator plates. Applying a molecular metal compound avoids heat distortion and is ready for installation within eight hours.

Metalized Compound
Tread Rib Edge Restoration
Max. 15° < 35mm
Taber. CS17, 55mm3
ASTM G8 Class B
12 Months, excluding
impact and abrasion.
