BUILDING INSPECTION REPORT

4 sample street, Blackwood, 5051

Date of Inspection: 21/7/2016 Size: 4bdrm 2bthrm 4cars
Weather: Overcast

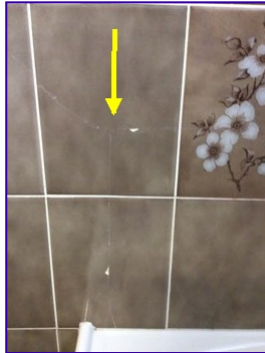
- 9.1. In serviceable condition at the time of inspection
- 9.2. Broken tile observed.
- 9.3. Minor moisture detected behind tiles. Recommend cleaning and application of grout seal to reduce further water intrusion.
- 9.4. Suggest all tile edges and tub/shower walls be caulked and sealed to prevent moisture penetration. All missing/damaged grouting should be replaced. Failure to keep walls sealed can cause deterioration and extensive moisture damage to the interior walls and surrounding sub-flooring. This damage is not always visible or accessible to the inspector at the time of inspection.

damaged tiles, need to be replaced to assure there is no moisture penetration behind tiles.

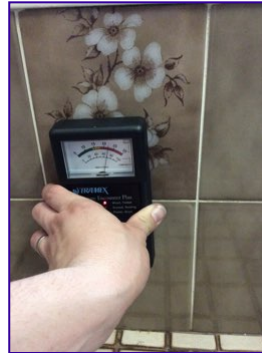
high moisture reading to bath surround, this indicates moisture behind tiles.

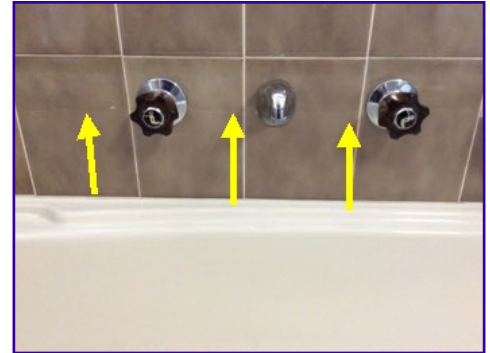
crack which passes through several tiles, this must be repaired to assure no moisture gets behind tiles

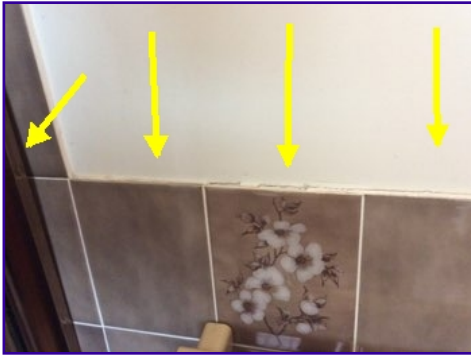
- 11.1. In serviceable condition at the time of inspection
- 11.2. Broken tile observed.
- 11.3. Caulking needed to prevent water from leaking into the substrate
- 11.4. Minor moisture detected behind tiles. Recommend cleaning and application of grout seal to reduce further water intrusion.

tiles are coming away from wall, this will allow moisture behind tiles, this has already occurred as tiles are drummy and peeling away from walls

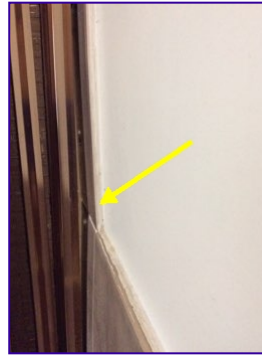
wall is deformed, looks as though it has been pushed and broken, someone has possibly fallen and knocked the wall, therefore damaging it.

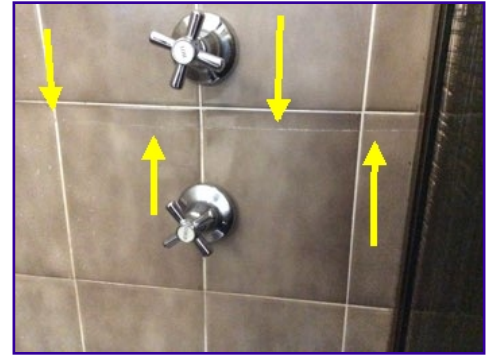
this crack continues around most of the shower, this must be repaired to prevent moisture penetrating behind the tiles and damaging the wall, houses of this age have no waterproofing in wet areas, keeping the tiles and silicone in good order is a must to stop water damage to walls.

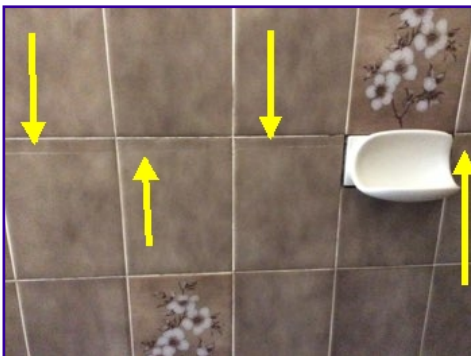
this is the same crack continuing around the shower wall

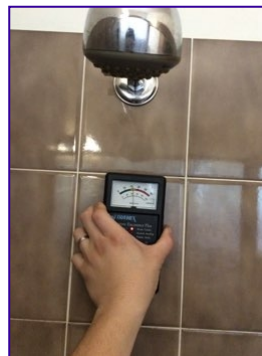
slightly elevated moisture reading, this will be due to damaged tiles, moisture is penetrating behind tiles

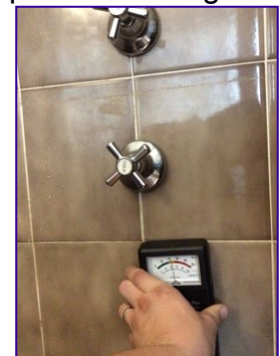
slightly elevated moisture reading

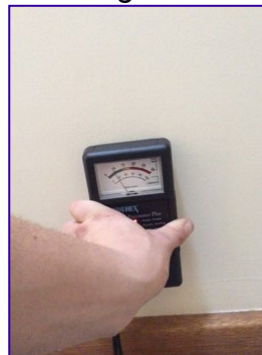
moisture reading is ok on external wall adjoining the back of the shower, to stop moisture which is penetrating behind tiles from slowly damaging wall and causing water damage and timber decay in this wall and other adjoining walls to this bathroom, the tiling must be repaired.

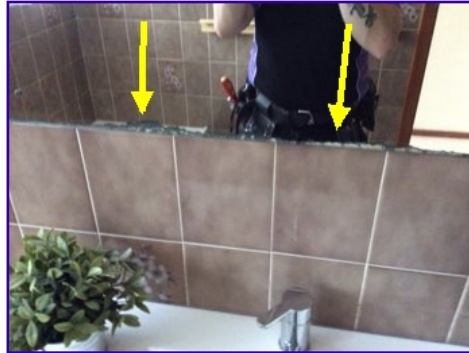
14.2. Partial de-silvering noted.

de-silvering to mirror, this is common in mirrors of this age.

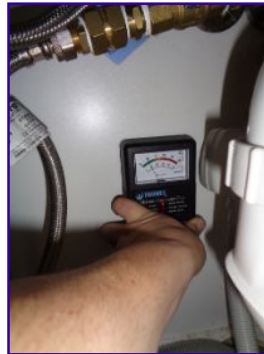
low moisture reading on wall below sink

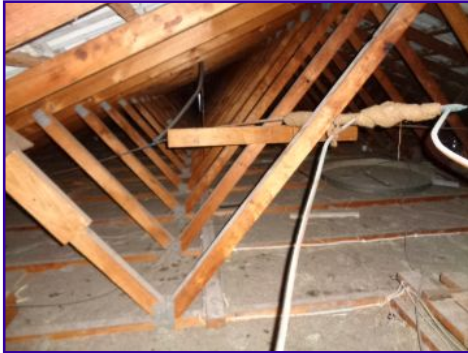
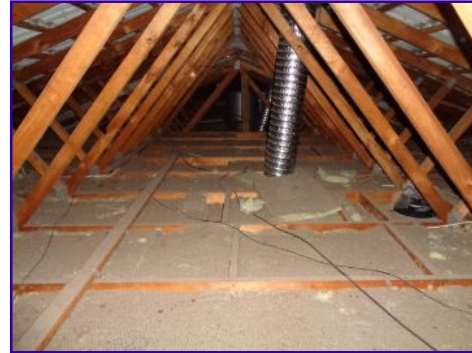
this is down the back end of the home, the home is fully insulated and the framing of the home is visually in good condition

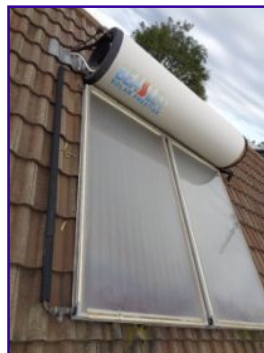
15.1. This unit was in working condition at the time of the inspection. All hot water services need to be inspected and reported on by a plumber and/or electrician It's recommended that a licensed plumber and/or electrician be consulted for further advice.
 15.2. Solar panels on roof with water storage unit.

it appears the house has the hot water supplied by a solar hot water system, i recommend this be assessed by a licensed plumber as i am not qualified to comment on such equipment.

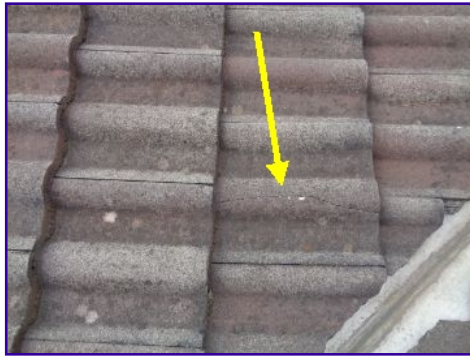
2.1. Tiles cracked in areas require repair or replacing to prevent water entry to roof cavity/attic which can cause long term framing and other structural issues.

there are a few broken tiles like this on the roof, this can allow water to enter the roof void, tiled roof must be well maintained and any broken tiles replaced.

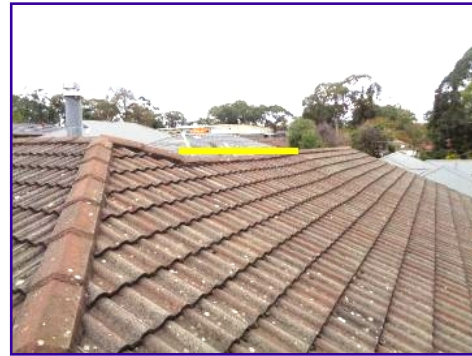
roof has slightly sagged at this point this is due to moisture build up in the ceiling and the timber has possible warped a bit, the roof will not fall down it has just basically become slightly miss shaped, to improve the ventillation in the roof void a roof vent should be installed.

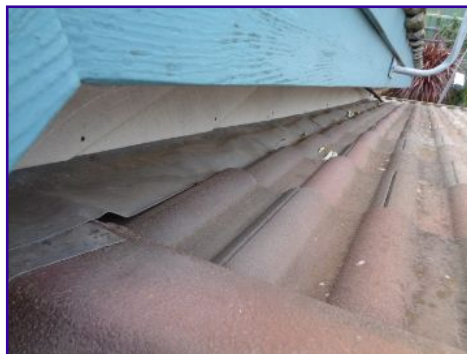
all visible flashings were inspected and were in good condition at the time of inspection, and also were installed in all areas requiring flashing.

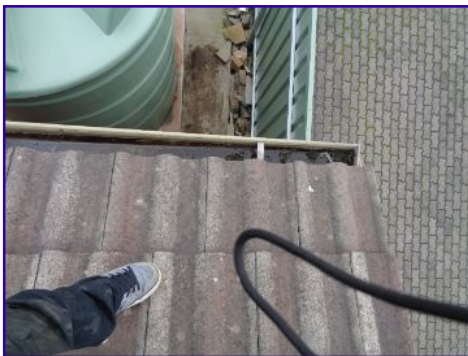
water pools in gutter in corner above rainwater tank, suggest a licensed roofing contractor assess.

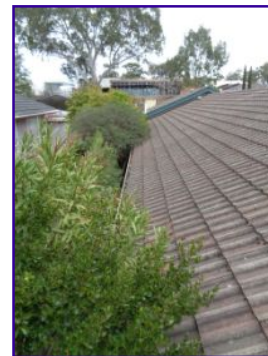
i suggest these trees be trimmed back to prevent the gutters blocking up from falling leaves, this will also help prevent pests such as possums having easy access to your roof void.
