PROPERTY & TIMBER PEST REPORT

Property Address **123 Example Boulevard Greater Brisbane Area
QLD 4000**

Report Number: **I026150**

Inspection Date & Time: **Tuesday 01 January 2013 08:00 AM**

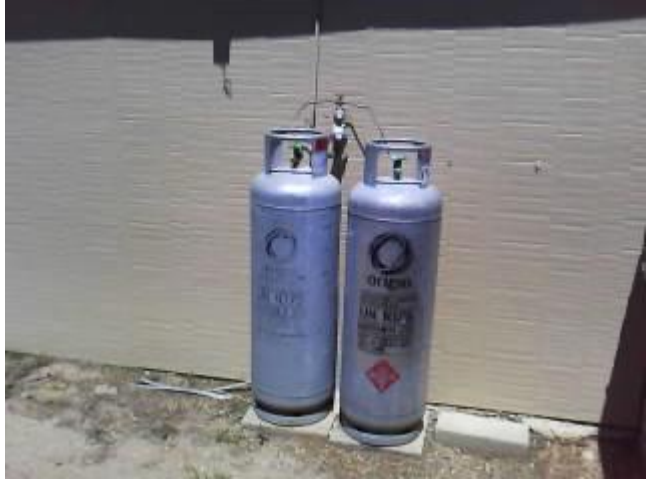
Description	LPG gas cylinders have not be adequately restrained in accordance with AS5601.1. If cylinders are knocked or blown over gas line may rupture releasing gas..

Location	The grounds at the rear of the building	
Recommendation	<p>This condition is considered dangerous. A further investigation by a licensed gasfitter is strongly recommended to determine the extent of remedial work required. The above recommendation should be implemented without delay</p> <p>Immediate action must be taken to ensure that anyone entering the area is warned of this hazard.</p>

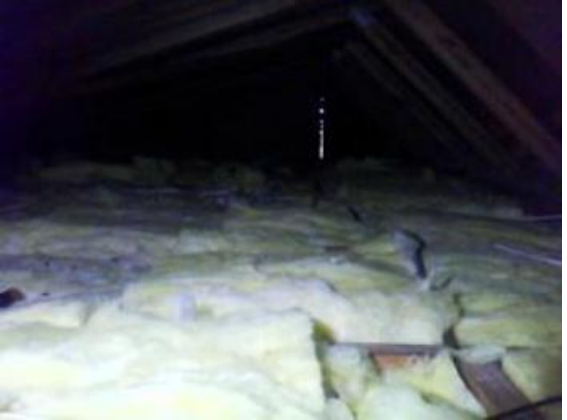
Description	A fall risk exists in the roof void as insulation wholly or partially covers ceiling joists and other framing members. In this situation it is not possible to ensure that the weight of a person can be supported. .

Location	The roof space in general	
Recommendation	This condition is considered dangerous. A further investigation by a competent person is strongly recommended to determine the extent of remedial work required. The above recommendation should be implemented as a matter of urgency.

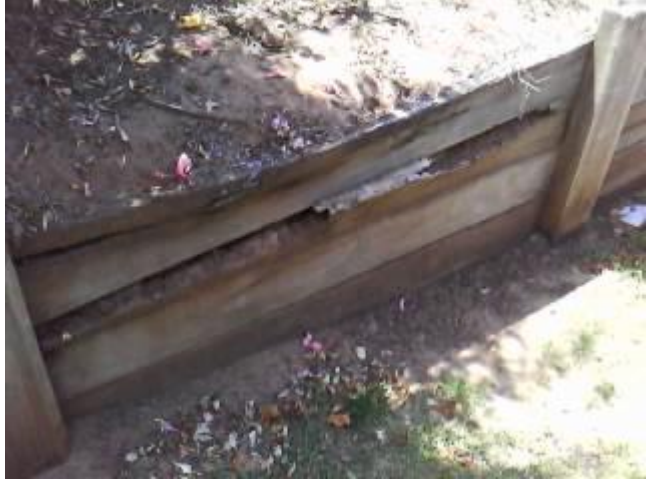
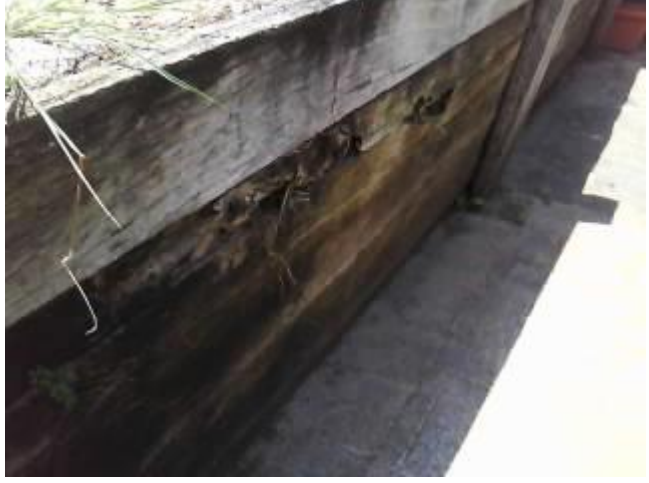
Structure	Retaining wall

Location	Eastern Side Of The Property	
Element	<u>Railway Sleepers</u>

Defect/Observation	<p><u>Fungal Decay</u> Damage <u>Sign of Fungal Decay</u> Collapse of structural timbers <u>Damage Status</u> Decayed wood</p> <p>Note. Decayed wood is reduced both in moisture content and size as indicated by cracking either along or across the grain or fibres coming apart in a stringy manner. Decayed wood will have undergone considerable strength reduction. It is important to correct any condition conducive to activity prior to replacing decayed wood.</p>	
Extent	Widespread	
Recommendation	<p>This defect falls within the category of “Timber Pest Activity and/or Damage”. It is strongly recommended that action be taken to manage timber pests and repair any damage. A further investigation by a Landscaper is also recommended to determine the extent of work required and associated costs. The above recommendation should be implemented without delay</p>

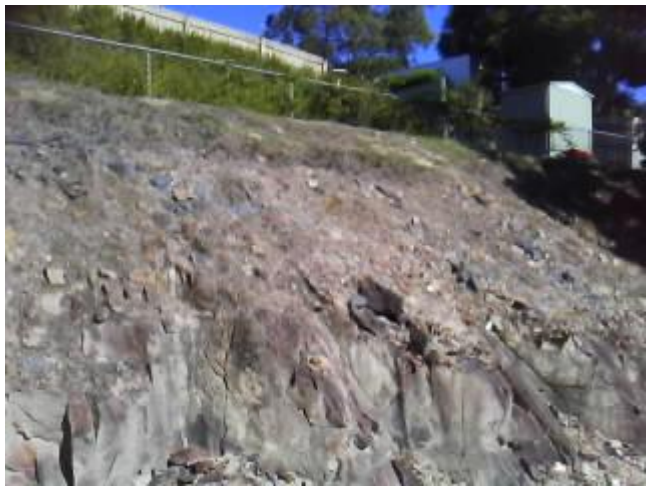
Area	Yard

Location	North-western side of the property	
Element	Unfinished Ground	
Defect/Observation	Eroded	
Extent	Widespread	
Recommendation	The consultant recommends that the client undertakes regular maintenance and continues to monitor the defect. Repairs may be necessary in the event the defect becomes more significant.

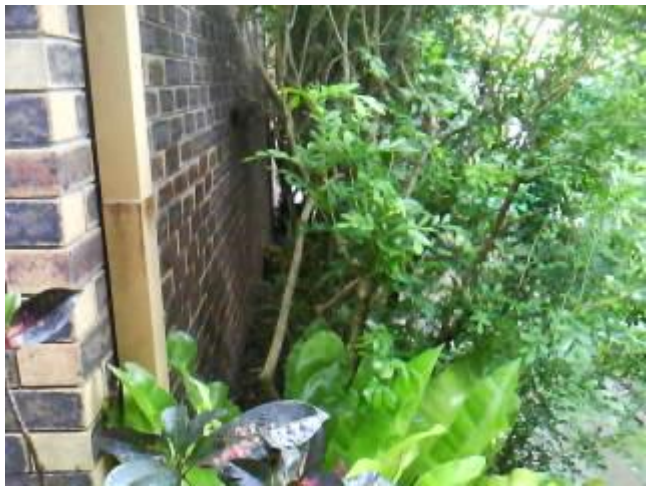
Area	Yard

Location	In general	
Element	Garden	
Defect/Observation	Too close to the building	
Extent	Widespread	
Recommendation	<p>This defect falls within the category of Conditions Conducive to Structural Damage & Timber Pest Activity. It is strongly recommended that this condition be removed. A further investigation by a Licensed Pest Controller (Timber Pest Specialist) and a Landscaper is also recommended to determine the extent of work required and associated costs. The above recommendation should be implemented promptly.</p>

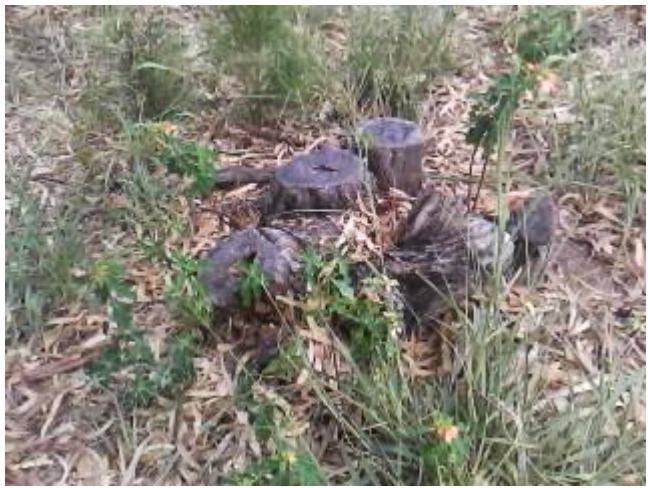
Area	Yard

Location	Western side of the property	
Element	Tree Stump	
Defect/Observation	<p><u>Termite Activity</u> <u>Sign of Activity</u></p> <p>Subterranean termite workings including mudding, shelter tubes and damage to timber not in service.</p> <p>Note: Where evidence of termite activity is located within a building or within 50 m of any building (but no live termites were found), it is possible that termites are still active in the concealed or inaccessible areas of the building and they may continue to cause further damage. A further more invasive inspection is strongly recommended. For further advice contact a licensed pest controller.</p>	
Extent	Localised	
Recommendation	<p>This defect falls within the category of "Timber Pest Activity and/or Damage". It is strongly recommended that action be taken to manage timber pests and repair any damage. The above recommendation should be implemented as soon as possible</p>

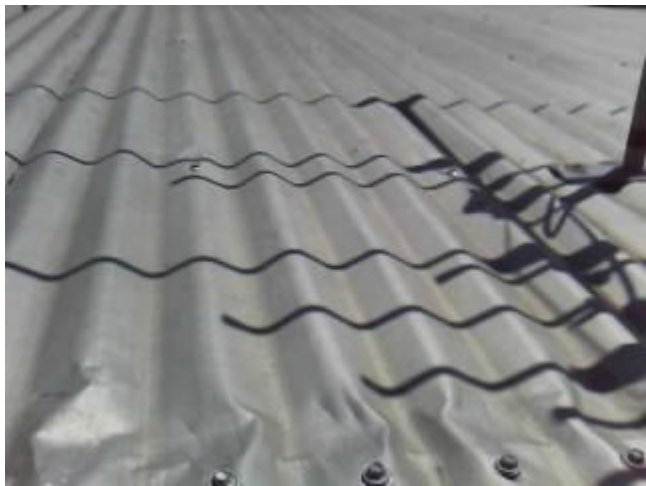
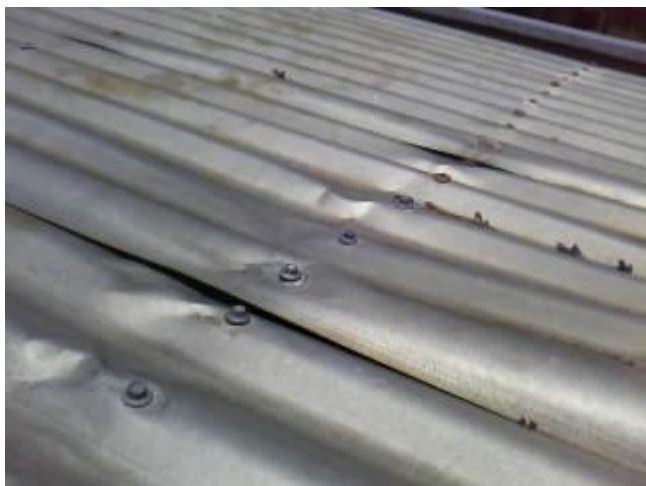
Structure	The roof to the main building.

Area Affected	On the eastern side of the building	
Element	Roof sheeting	
Defect/Observation	Dented, damaged	
Extent	Undetermined	
Recommendation	This defect should be addressed by a Licensed Roof Plumber as soon as possible.

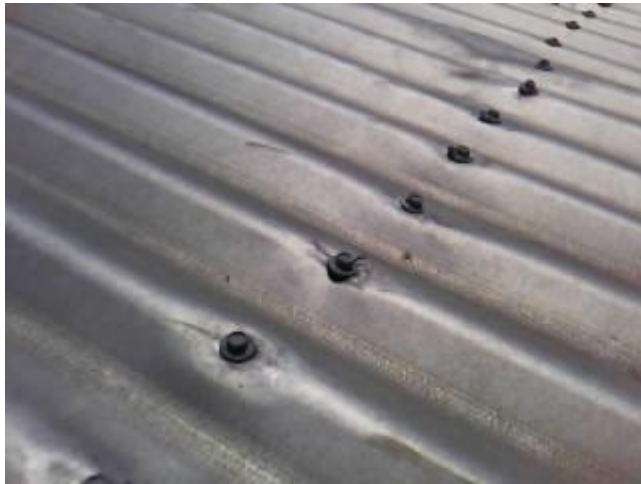
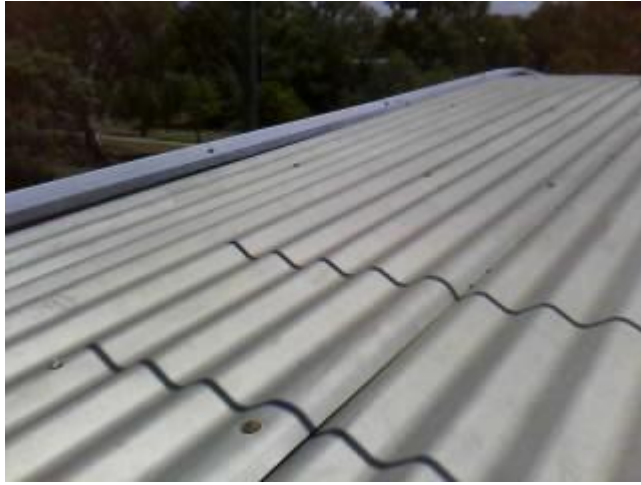
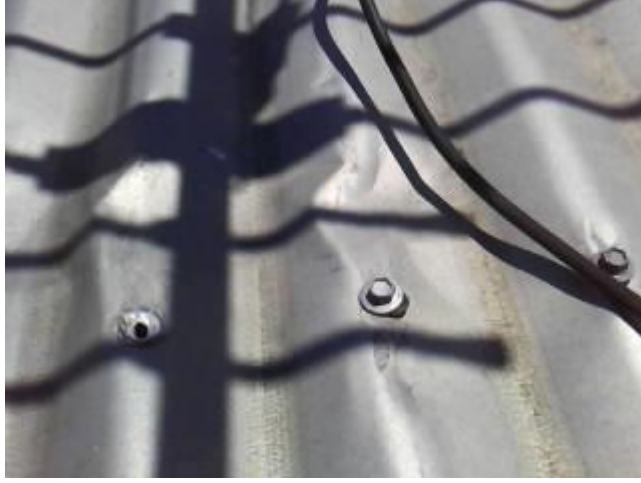
Structure	The roof to the main building.
Area Affected	In general
Element	Fastenings
Defect/Observation	Defective
Extent	Undetermined

This defect should be addressed by a Licensed Roof Plumber as soon as possible.

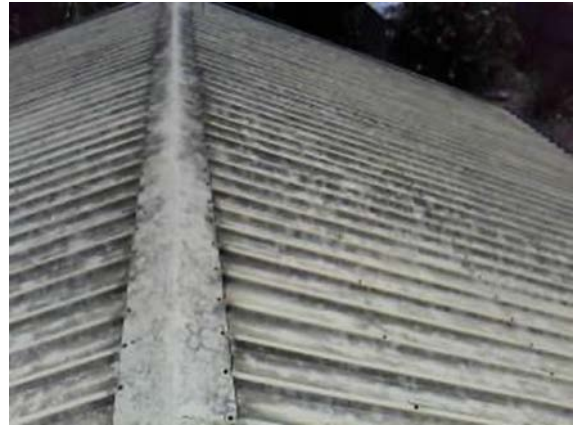
Structure	The roof to the main building.
Area Affected	In general
Element	Fastenings
Defect/Observation	Corroding
Extent	Widespread
Recommendation	This defect requires repair or replacement as soon as possible.

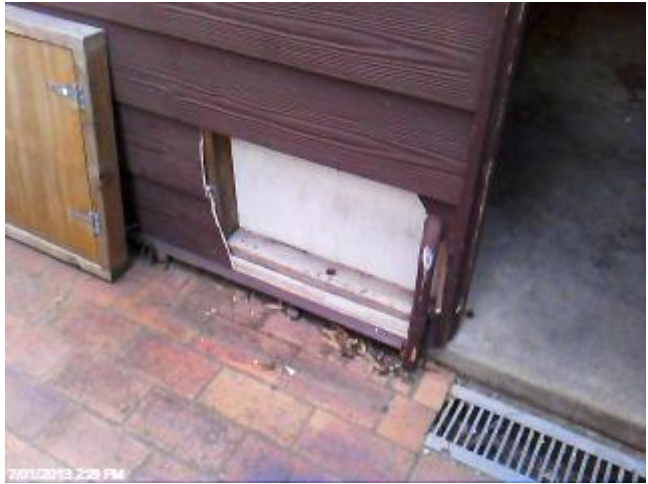
External Wall	External wall to the garage

Location	North-eastern side of the building	
Element	Cladding	
Element Type	Non-loadbearing	
Defect/Observation	Broken	
Extent	Localised	
Recommendation	Repairs and/or adjustments by a suitably qualified tradesperson are required to correct this defect.

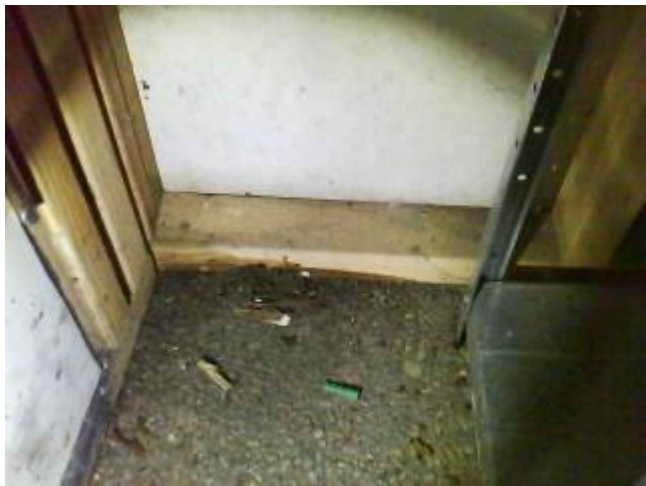
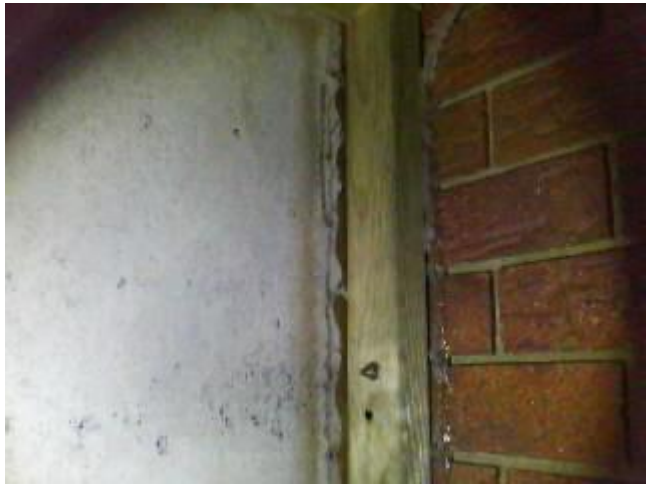
External Wall	External wall

Location	Carport Storeroom, South-western side of the building	
Element	Wall bottom plate

Element Type	Non-loadbearing	
Defect/Observation	<p><u>Termite Damage</u> <u>Sign of Damage</u> Visible damage to timber</p> <p>Note: Where evidence of termite damage is located within the building, it is possible that termites are still active in the concealed or inaccessible areas of the building and they may continue to cause further damage. A further more invasive inspection is recommended. For further advice consult a licensed pest controller.</p>	
Extent	Undetermined	
Recommendation	<p>This defect falls within the category of "Timber Pest Activity and/or Damage". It is strongly recommended that action be taken to manage timber pests and repair any damage. A further investigation by a Licensed Pest Controller (Timber Pest Specialist) and a Licensed Builder is also recommended to determine the extent of work required and associated costs. The above recommendation should be implemented without delay</p>

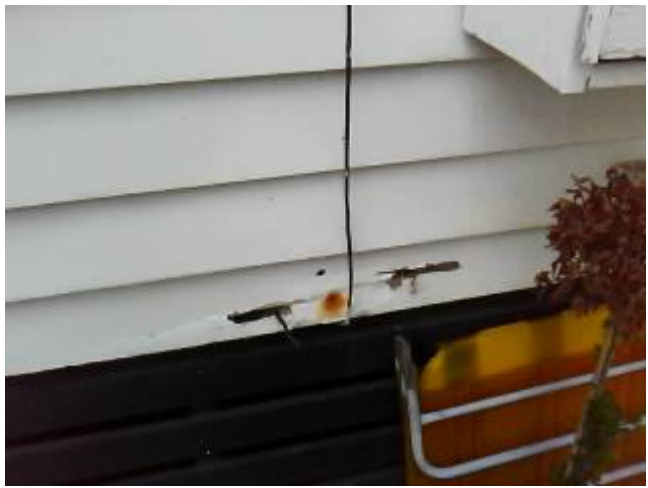
External Wall	External wall to the main building

Location	Western side of the building	
Element	Weather-boarding	
Element Type	Non-loadbearing	
Defect/Observation	<p>Fungal Decay Damage</p> <p><u>Sign of Fungal Decay</u></p> <p>Visible damage to timber</p> <p><u>Damage Status</u></p> <p>Undetermined</p> <p>Note. Where the overall condition of the timber is undetermined, further inspections are strongly recommended. This may require monitoring of the timber over a period of time and include the assessment of conditions conducive to activity (e.g. in different weather conditions).</p>	
Extent	Localised	
Recommendation	<p>This defect falls within the category of "Timber Pest Activity and/or Damage". It is strongly recommended that action be taken to manage timber pests and repair any damage. A further investigation by a Licensed Builder is also recommended to determine the extent of work required and associated costs. The above recommendation should be implemented as soon as possible</p>

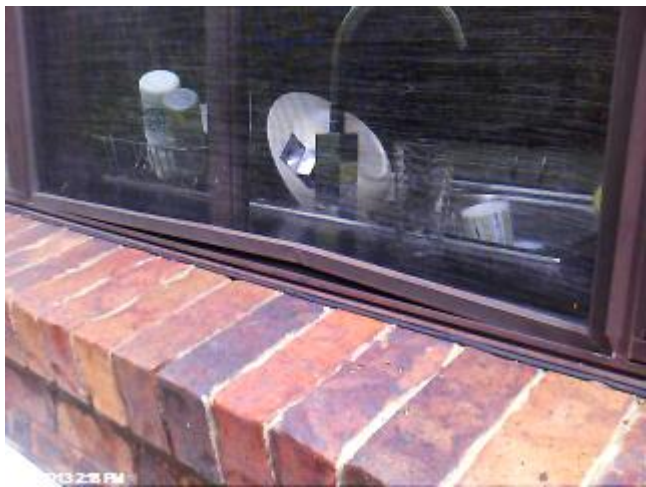
Location	Windows In general

Element	Fly screen frames	
Defect/Observation	Damaged	
Extent	Localised	
Recommendation	Repairs and/or adjustments by a suitably qualified tradesperson are required to correct this defect.

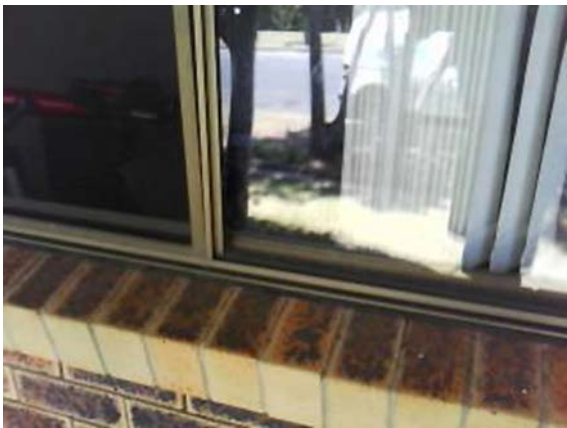
Location	Bedroom window Entry level Western side of the building

Element	Glass	
Defect/Observation	<u>Cracked</u>	
Extent	Localised	
Recommendation	This defect requires replacement as soon as possible.

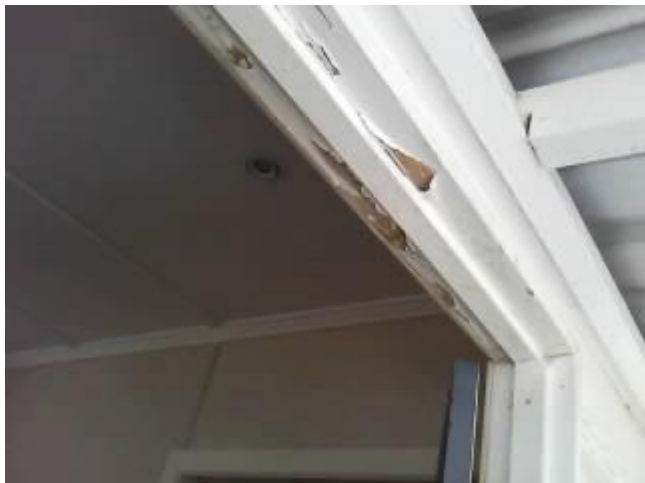
Doors	Front door

Location	Eastern side of the building	
Element	Head	
Defect/Observation	<p>Termite Damage</p> <p><u>Sign of Damage</u></p> <p>Visible damage to timber</p> <p>Note: Where evidence of termite damage is located within the building, it is possible that termites are still active in the concealed or inaccessible areas of the building and they may continue to cause further damage. A further more invasive inspection is recommended. For further advice consult a licensed pest controller.</p>	
Extent	Widespread	
Recommendation	<p>This defect falls within the category of “Timber Pest Activity and/or Damage”. It is strongly recommended that action be taken to manage timber pests and repair any damage. A further investigation by a Licensed Pest Controller (Timber Pest Specialist) and a Licensed Builder is also recommended to determine the extent of work required and associated costs. The above recommendation should be implemented without delay</p>

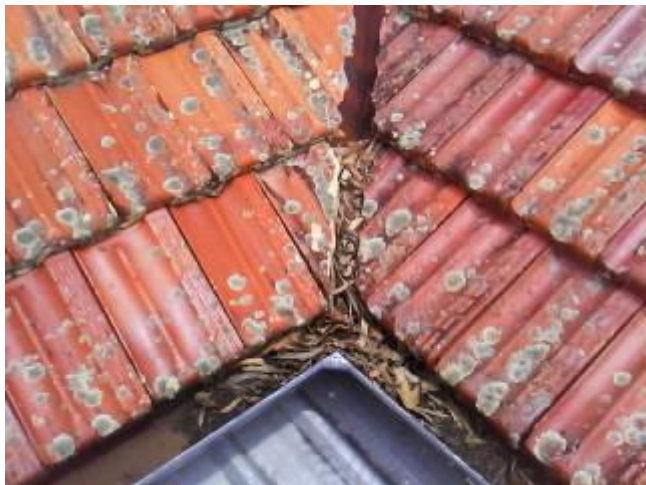
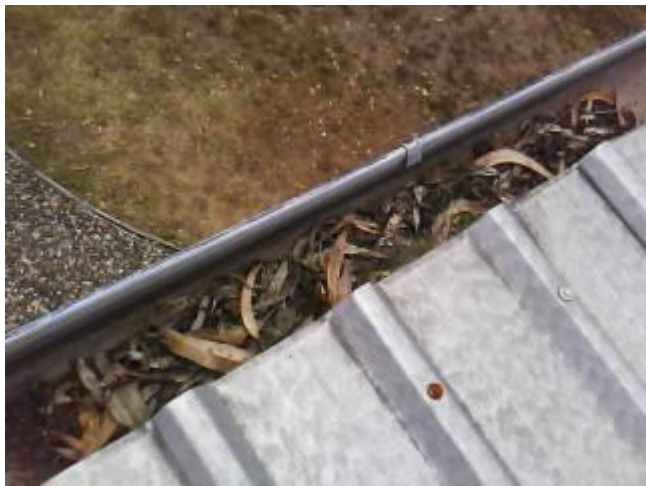
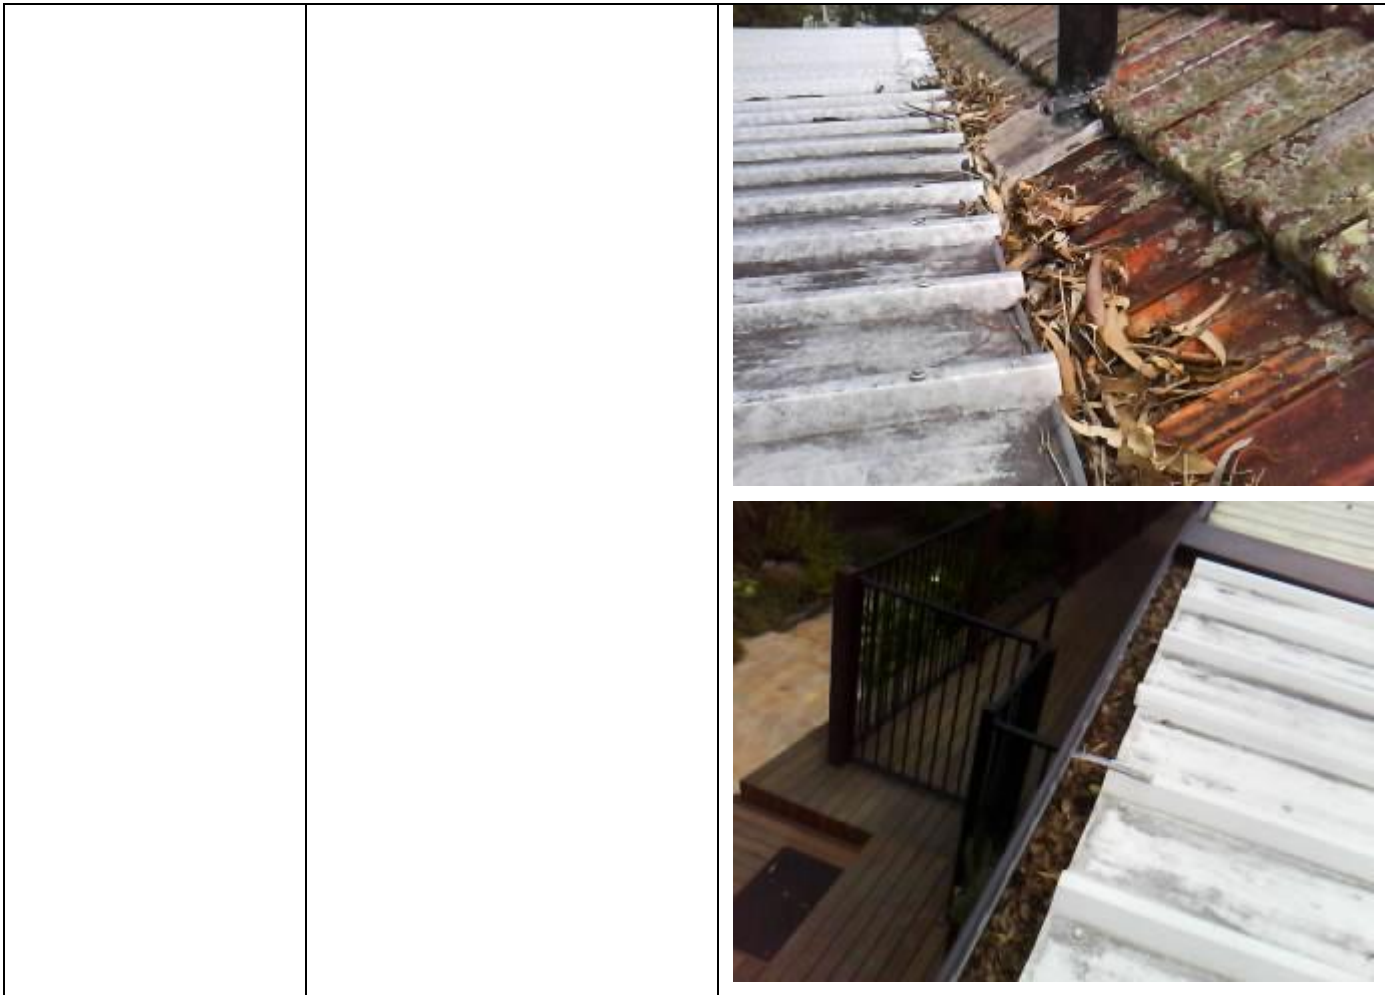
Location	Main building and additions In general
Element	Valley Gutter Eaves Gutters
Defect/Observation	Blocked with debris
Extent	Widespread
Recommendation	This defect falls within the category of Conditions Conducive to Structural Damage & Timber Pest Activity. It is strongly recommended that this condition be removed. The above recommendation should be implemented promptly.

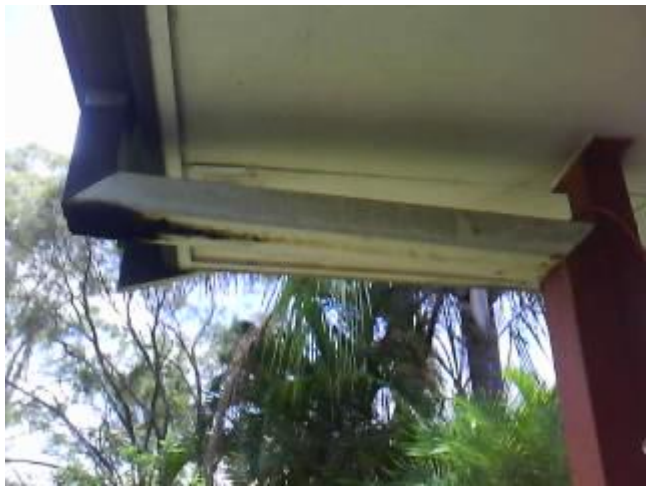
Location	Main building In general

Element	Metal Downpipes	
Defect/Observation	Corrosion Note: If the conditions that are have allowed the corrosion to take place are not removed and or the affected metal is not protected from further corrosion the corrosion is likely to continue. Where corrosion is significant replacement is usually more cost effective than repair.	
Extent	Localised	
Recommendation	This defect falls within the category of Conditions Conducive to Structural Damage & Timber Pest Activity. It is strongly recommended that this condition be removed. A further investigation by a Licensed Roof Plumber is also recommended to determine the extent of work required and associated costs. The above recommendation should be implemented promptly.

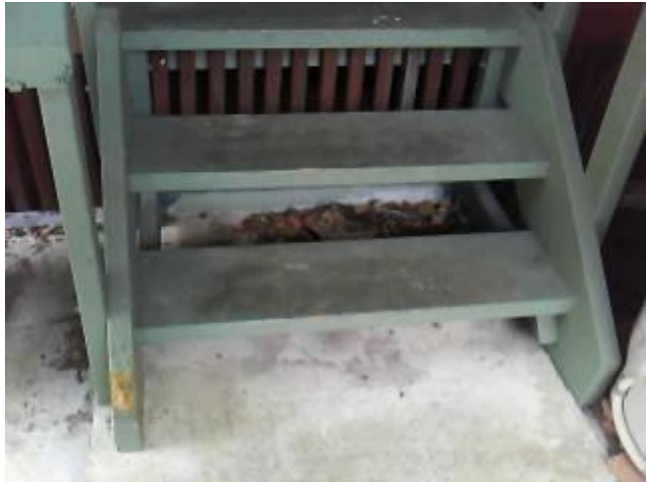
Location	Steps North-eastern side of the building

Element	Stringer	
Defect/Observation	Damaged	
Extent	Localised	
Recommendation	This defect requires repair or replacement as soon as possible.

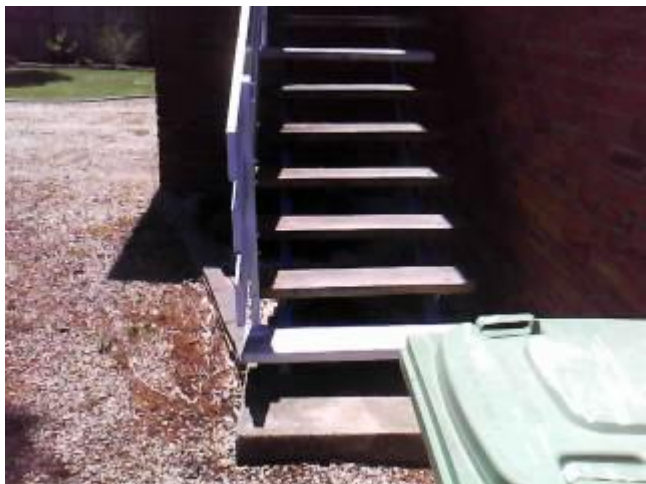
Location	Front stairs Northern side of the building

Element	Stairs	
Defect/Observation	Not level	
Extent	Localised	
Recommendation	This defect should be addressed by a Licensed Tradesperson as soon as possible.

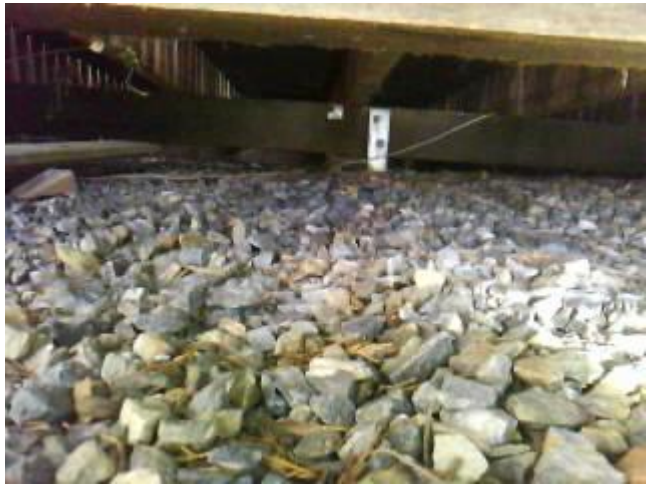
Location	Deck South-eastern side of the building

Element	Bearers	
Defect/Observation	Insufficient clearance from ground	
Extent	Widespread	
Recommendation	This defect falls within the category of Conditions Conducive to Structural Damage & Timber Pest Activity. It is strongly recommended that this condition be removed. A further investigation by a Licensed Pest Controller (Timber Pest Specialist) and a Licensed Builder is also recommended to determine the extent of work required and associated costs. The above recommendation should be implemented as soon as possible.

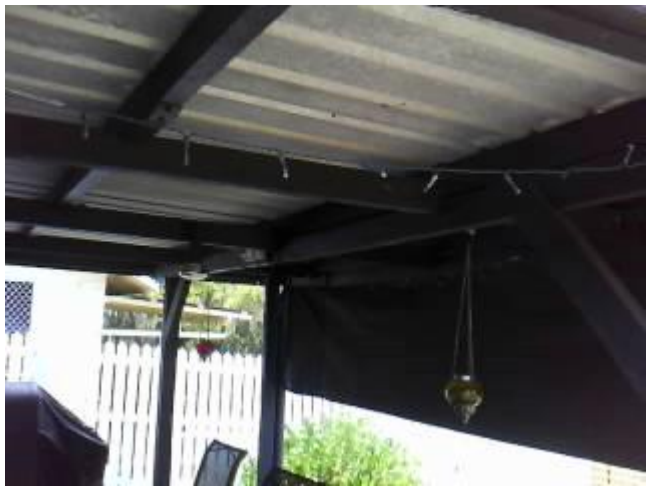
Location	South-western side of the building

Element	Pergola roof frame	
Defect/Observation	<u>Poor workmanship</u> , not compliant with standard building regulations.	
Extent	Localised	
Recommendation	This defect should be addressed by a Licensed Builder as soon as possible.

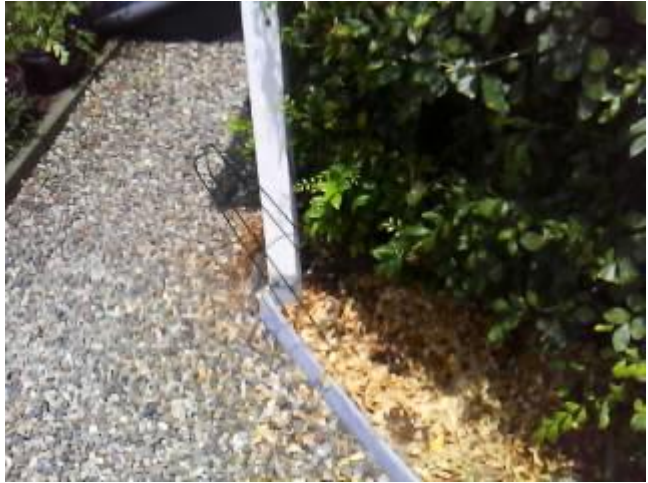
Element	Patio roof posts	
Defect/Observation	Earth-wood contact Note: Timbers in direct contact with the ground/soil produce a ready food source for termites. Also, susceptible timbers used in a hazardous environment are prone to fungal decay.	
Extent	Localised	
Recommendation	This defect falls within the category of Conditions Conducive to Structural Damage & Timber Pest Activity. It is strongly recommended that this condition be removed. The above recommendation should be implemented as soon as possible.

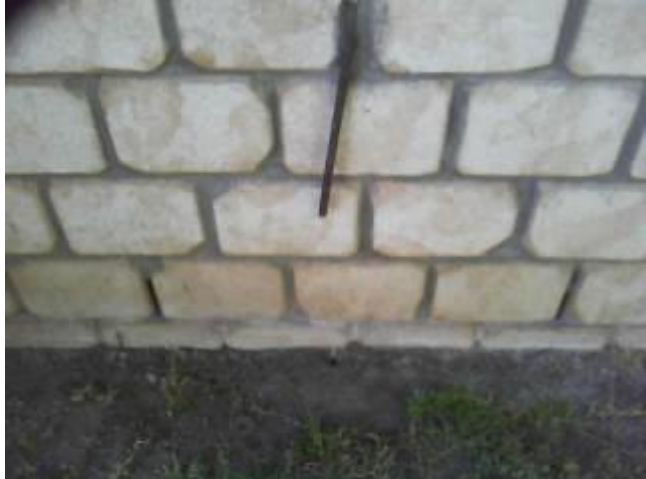
Location	In general

Element	Water heater	
Defect/Observation	Discharging near footings. All AC or Water Heater drainage should be connected to a storm water drain, down pipe or directed well away from footings.	
Extent	Localised	
Recommendation	This defect falls within the category of Conditions Conducive to Structural Damage & Timber Pest Activity. It is strongly recommended that this condition be removed. The above recommendation should be implemented promptly.

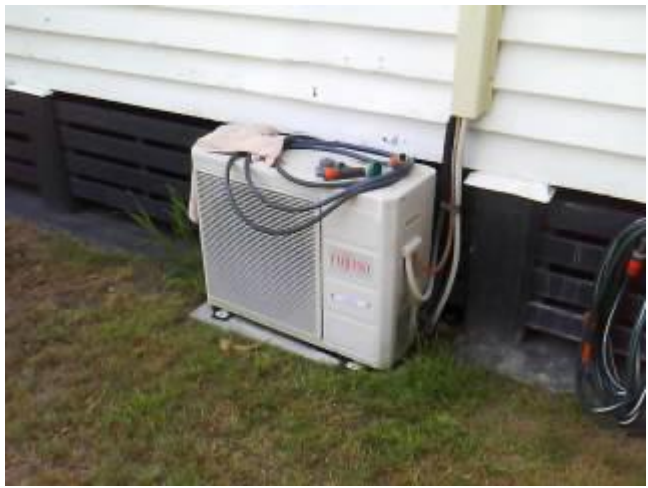
Location	Western side of the building

Element	Air-conditioning unit	
Defect/Observation	Discharging near footings. All AC or Water Heater drainage should be connected to a storm water drain, down pipe or directed well away from footings.	
Extent	Localised	
Recommendation	This defect falls within the category of Conditions Conducive to Structural Damage & Timber Pest Activity. It is strongly recommended that this condition be removed. A further investigation by a Licensed Installer is also recommended to determine the extent of work required and associated costs. The above recommendation should be implemented without delay.

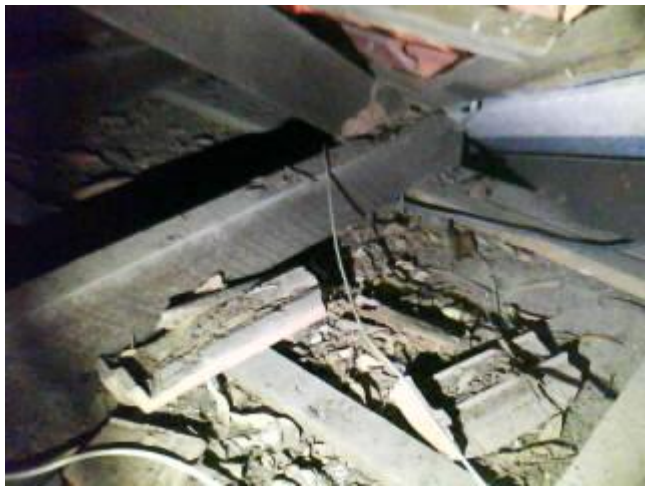
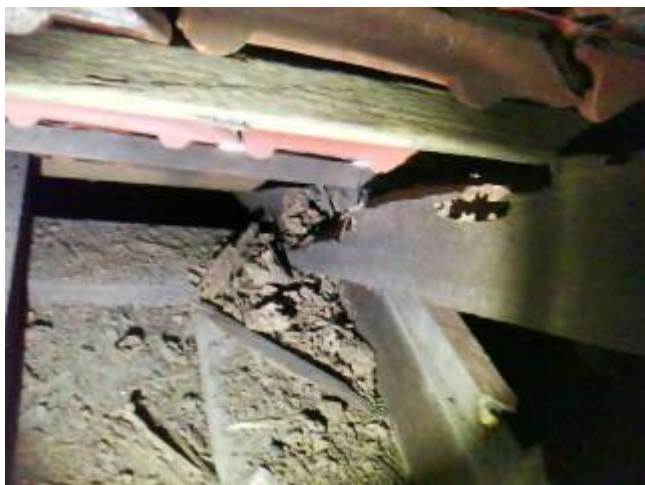
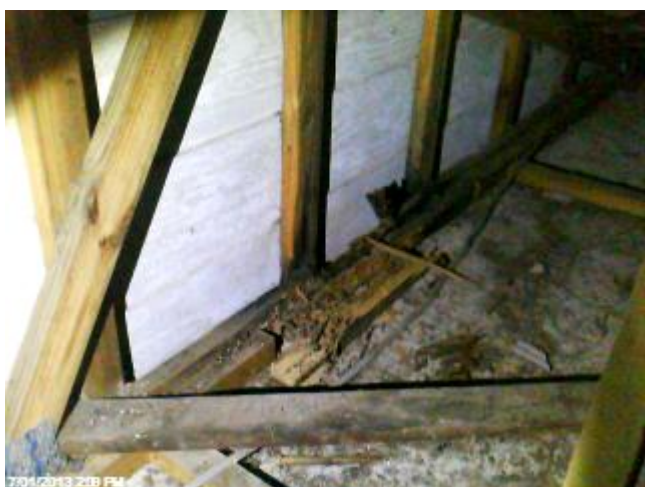
Structure	The roof to the main building

Area Affected	The areas on the eastern sides	
Element	Rafters Ceiling Joists	
Defect/Observation	<p><u>Termite Damage</u></p> <p><u>Sign of Damage</u></p> <p>Visible damage to timber</p> <p>Note: Where evidence of termite damage is located within the building, it is possible that termites are still active in the concealed or inaccessible areas of the building and they may continue to cause further damage. A further more invasive inspection is recommended. For further advice consult a licensed pest controller.</p>

Extent	Undetermined

Recommendation	<p>This defect falls within the category of "Timber Pest Activity and/or Damage". It is strongly recommended that action be taken to manage timber pests and repair any damage. A further investigation by a Licensed Pest Controller (Timber Pest Specialist) and a Licensed Builder is also recommended to determine the extent of work required and associated costs. The above recommendation should be implemented without delay</p>

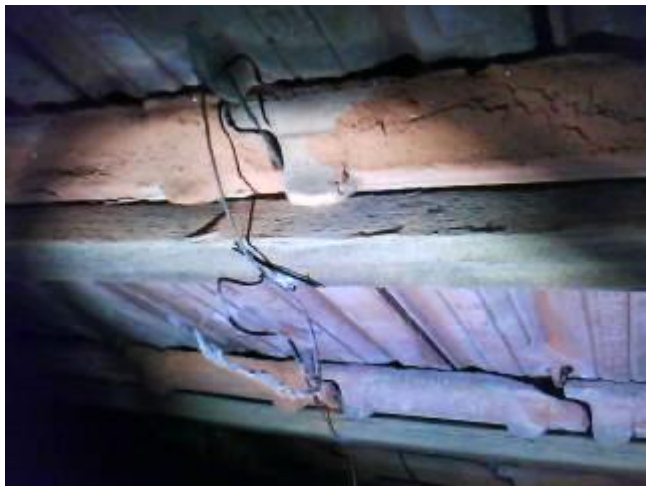
Structure	The roof to the main building

Area Affected	In general	
Element	Roof tiles	
Defect/Observation	Fretting	
Extent	Undetermined	
Recommendation	This defect should be addressed by a Licensed Roof Tiler without delay.

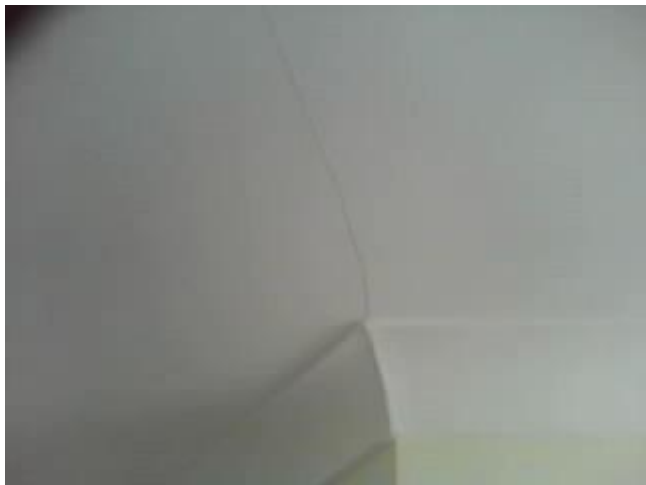
Element	Ceiling

Location	Hallway, Ground floor North-western side of the building	
Defect/Observation	Cracked	
Extent	Localised	
Recommendation	Repairs and/or adjustments by a suitably qualified tradesperson are required to correct this defect.

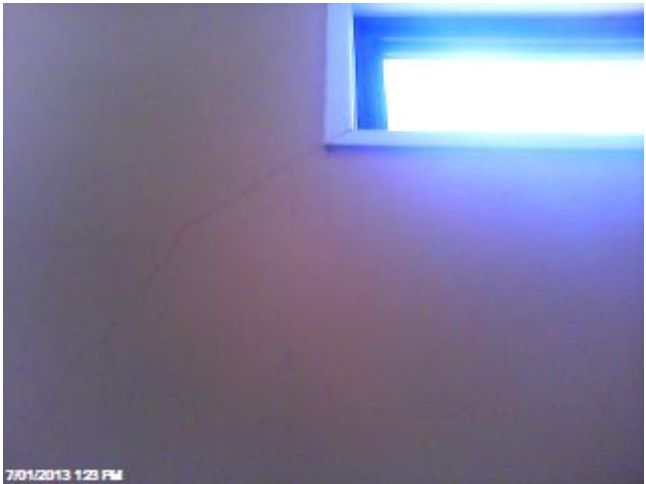
Location	Hallway, landing Upper level Below the window outside the left side bedroom

Element	Wall lining	
Defect/Observation	Cracked	
Extent	Localised	
Recommendation	Repairs and/or adjustments by a suitably qualified tradesperson are required to correct this defect.

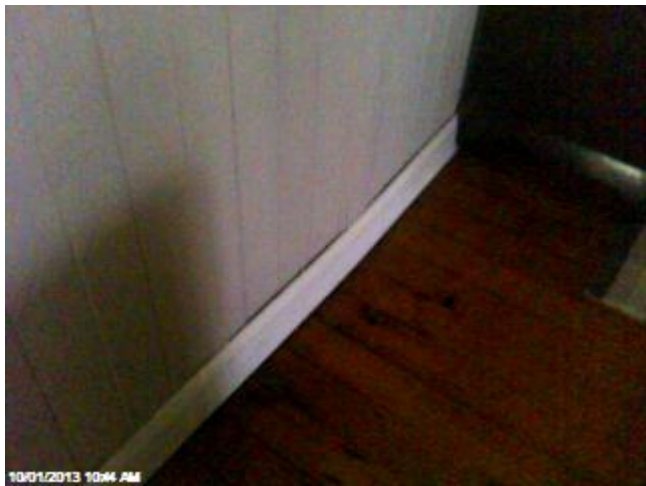
Location	Lounge Room Entry level Backing onto the shower

Element	Wall lining	
Defect/Observation	Moisture damage from possible leaking shower	
Extent	Localised	
Recommendation	This defect falls within the category of Conditions Conducive to Structural Damage & Timber Pest Activity. It is strongly recommended that this condition be removed. A further investigation by a Licensed Plumber is also recommended to determine the extent of work required and associated costs. The above recommendation should be implemented as soon as possible.

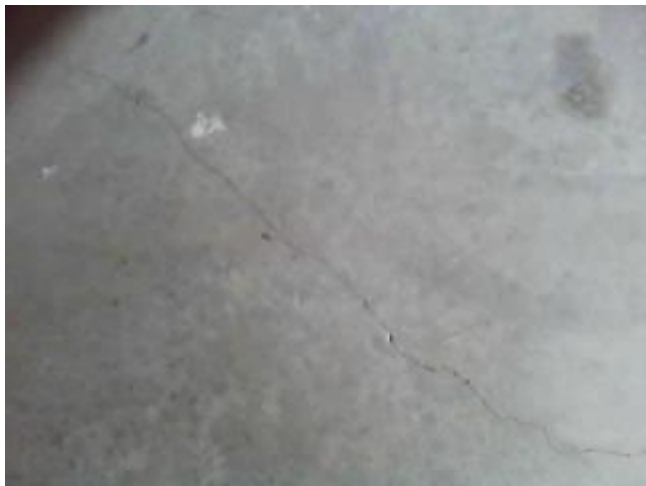
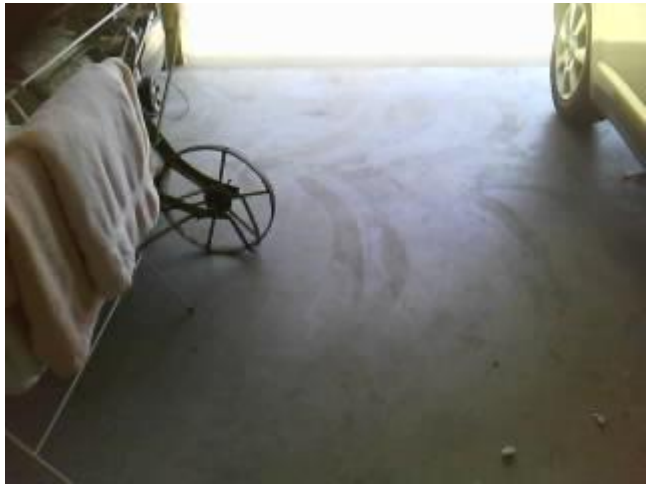
Element	Floor slab

Location	Garage, Ground floor North-western side of the building	
Defect/Observation	<u>Cracked</u> The consultant is of the opinion that the cracking is consistent with shrinkage during the drying process and/or minor settlement.

Extent	Localised	
Recommendation	The consultant recommends that the client undertakes regular maintenance (applying sealant to keep moisture from entering the crack and corroding the reinforcing steel) and continues to monitor the defect. Repairs may be necessary in the event the defect becomes more significant.

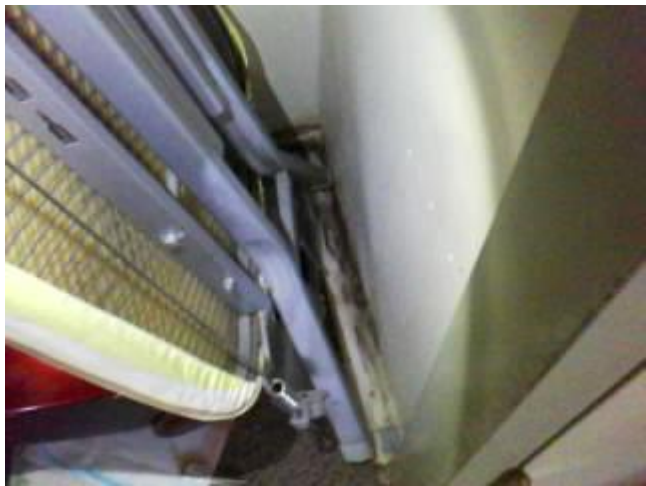
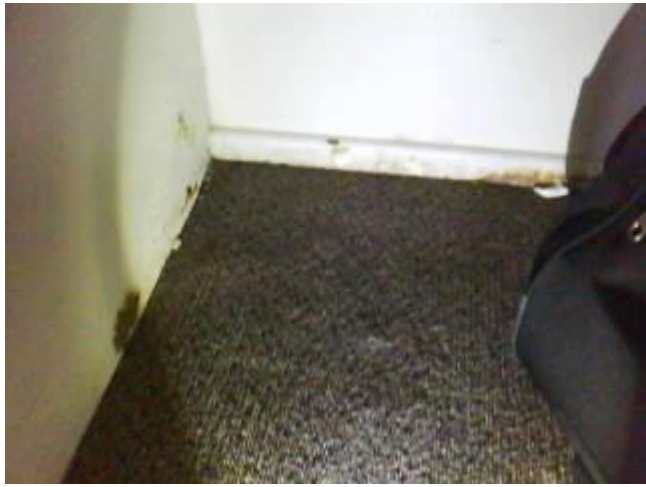
Element	Skirtings

Location	Broom cupboard Entry level Eastern side of the building	
Defect/Observation	Damp damage	
Extent	Widespread	
Recommendation	This defect falls within the category of Conditions Conducive to Structural Damage & Timber Pest Activity. It is strongly recommended that this condition be removed. A further investigation by a Licensed Builder is also recommended to determine the extent of work required and associated costs. The above recommendation should be implemented as soon as possible.

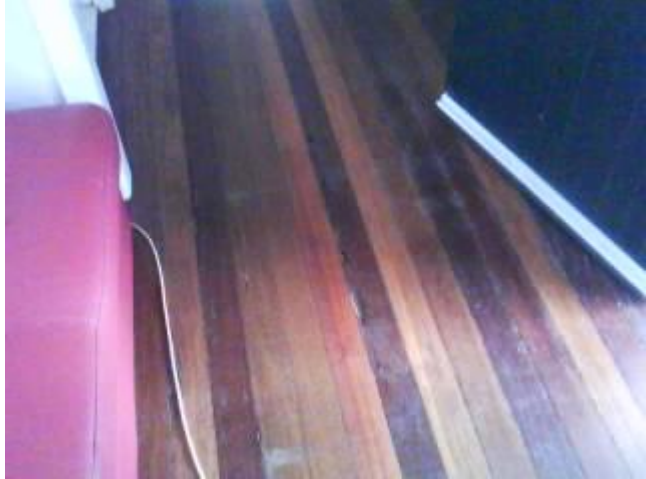
Element	Floorboards

Location	Living Room/front entry	
Defect/Observation	<p><u>Termite Damage</u> <u>Sign of Damage</u> Visible damage to timber</p> <p>Note: Where evidence of termite damage is located within the building, it is possible that termites are still active in the concealed or inaccessible areas of the building and they may continue to cause further damage. A further more invasive inspection is recommended. For further advice consult a licensed pest controller.</p>	
Extent	Localised	
Recommendation	<p>This defect falls within the category of "Timber Pest Activity and/or Damage". It is strongly recommended that action be taken to manage timber pests and repair any damage. A further investigation by a Licensed Pest Controller (Timber Pest Specialist) and a Licensed Builder is also recommended to determine the extent of work required and associated costs. The above recommendation should be implemented without delay</p>

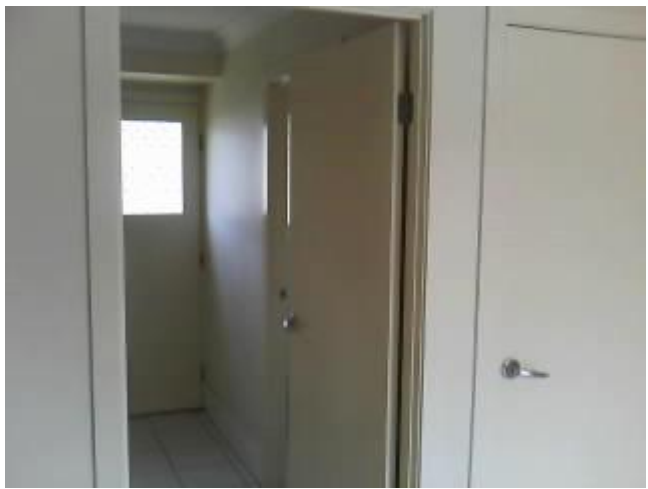
Door	Door

Location	Laundry, Entry level Western side of the building	
Element	Hinges	
Defect/Observation	Loose	
Extent	Localised	
Recommendation	Repairs and/or adjustments by a suitably qualified tradesperson are required to correct this defect.

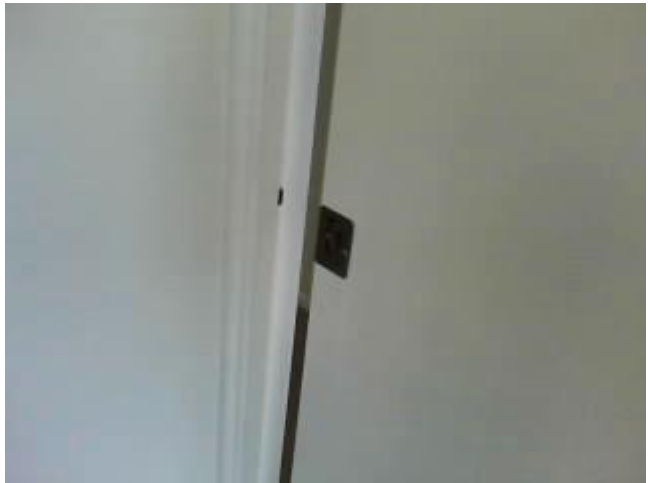
Door	Sliding door (in cavity)

Location	Bathroom First floor Eastern side of the building	
Element	Lock	
Defect/Observation	Defective	
Extent	Localised	
Recommendation	This defect should be addressed by a Licensed Tradesperson as soon as possible.

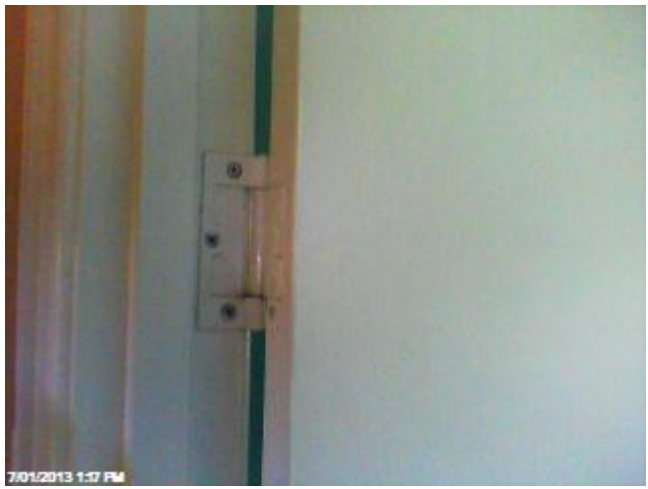
Door	Door

Location	WC	
Element	Hinges	
Defect/Observation	Do not lift off. Note: Toilet doors should be fitted with lift off hinges and adequate head clearance to allow the door to be removed.	
Extent	Localised	
Recommendation	Replace with lift off hinges as a matter of urgency.

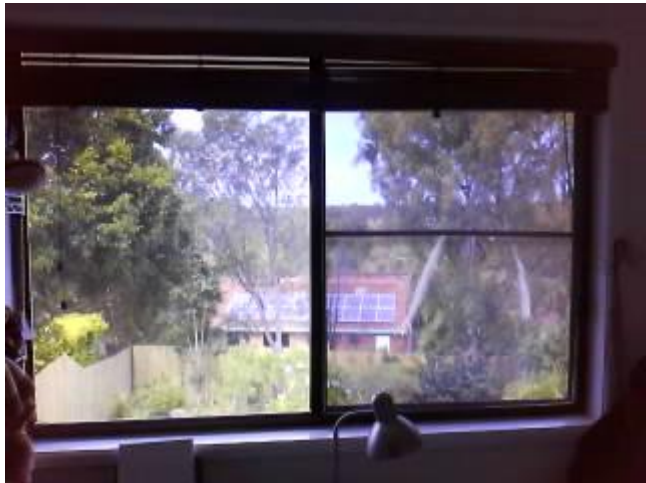
Window	Sliding Windows

Location	In general	
Element	Rollers or guides	
Defect/Observation	Worn	
Extent	Localised	
Recommendation	This defect should be addressed by a Licensed Tradesperson as soon as possible.

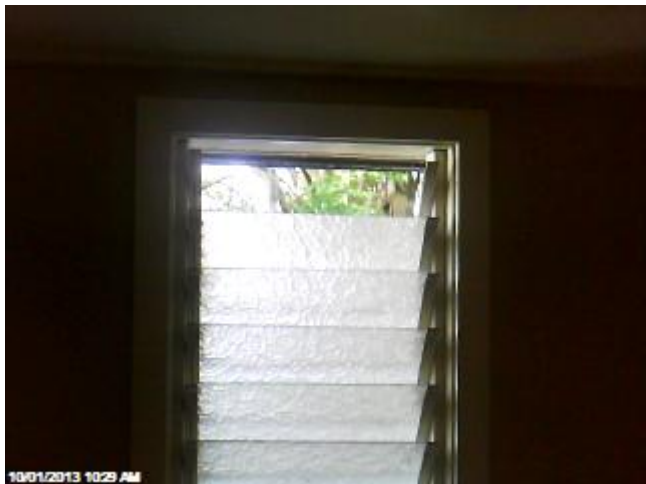
Window	Louver window

Location	Ensuite Entry level	
Element	Glass	
Defect/Observation	Missing	
Extent	Localised	
Recommendation	Replace the missing element as soon as possible.

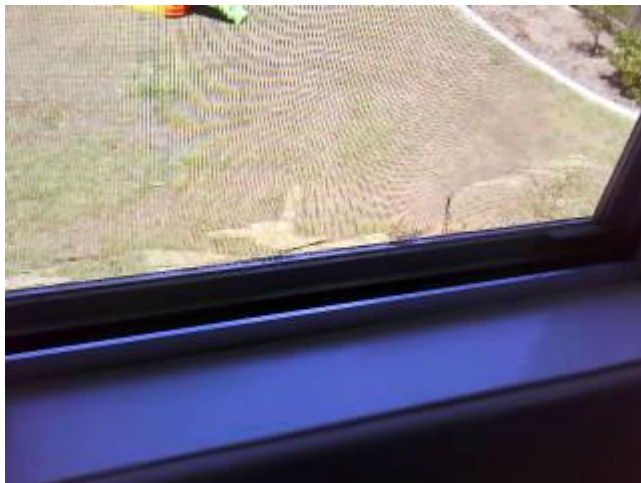
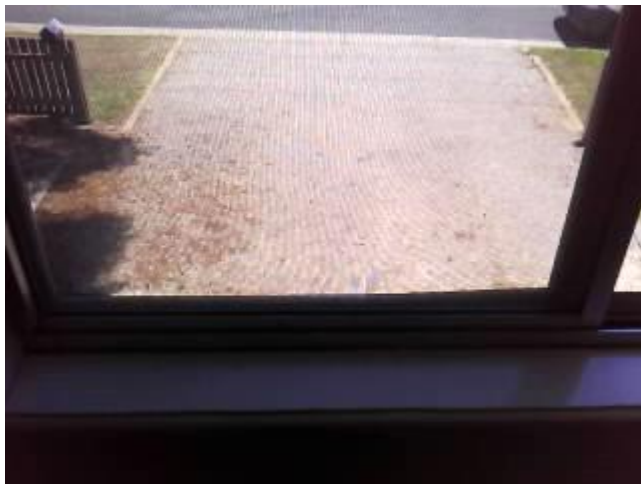
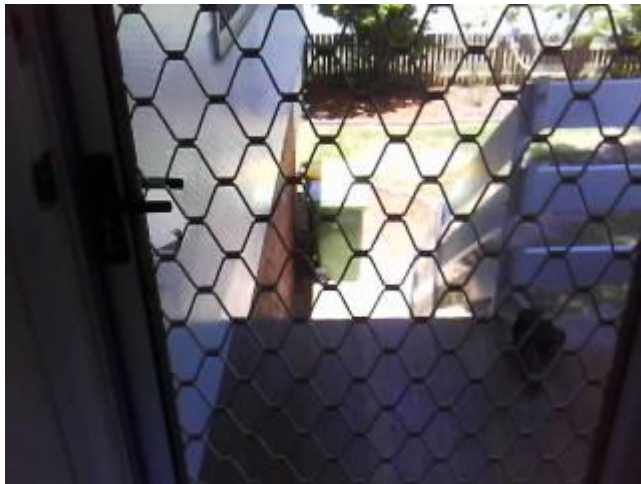
Window	Windows
Location	In general
Element	Flyscreens
Defect/Observation	Damaged
Extent	Localised

This defect should be addressed by a Licensed Tradesperson as soon as possible.

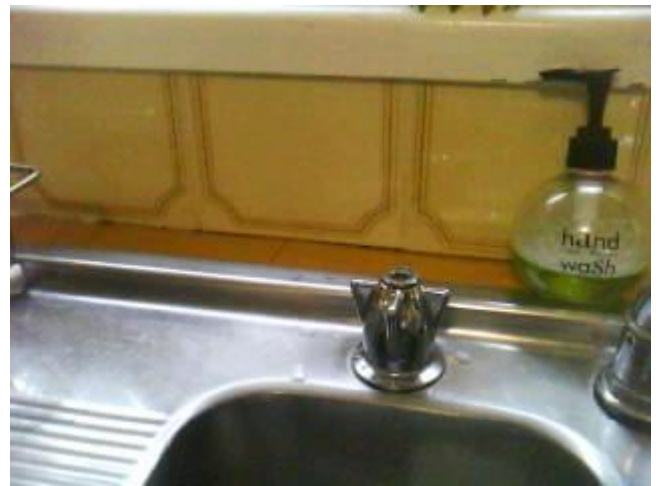
Built-In-Fittings	Built-in-fittings
Location	Kitchen, Ground floor Eastern side of the building
Element	Splashback
Defect/Observation	Poorly sealed
Extent	Localised
Recommendation	This defect falls within the category of Conditions Conducive to Structural Damage & Timber Pest Activity. It is strongly recommended that this condition be removed by resealing. The above recommendation should be implemented promptly.

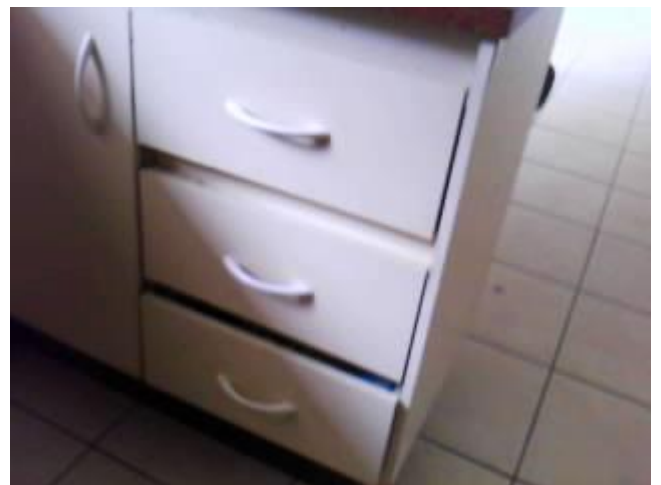
Built-In-Fittings	Built-in-fittings
Location	Kitchen, Entry level Eastern side of the building
Element	Drawers
Defect/Observation	Poor workmanship
Extent	Localised
Recommendation	This defect requires replacement as soon as possible.
