PROPERTY & TIMBER PEST REPORT

Property Address **123 Example Boulevard Greater Brisbane Area
QLD 4000**

Report Number: **I026150**

Inspection Date & Time: **Tuesday 01 January 2013 08:00 AM**

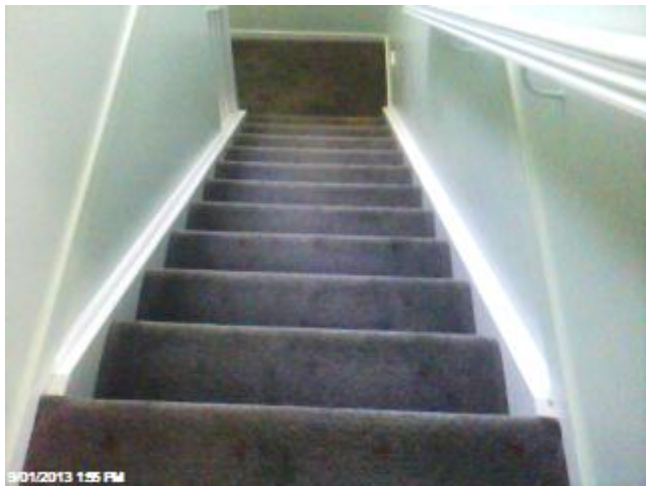
Woodwork	Staircase

Location	In general	
Element	Treads	
Defect/Observation	Creaky	
Extent	Localised	
Recommendation	Repairs and/or adjustments by a suitably qualified tradesperson are required to correct this defect.

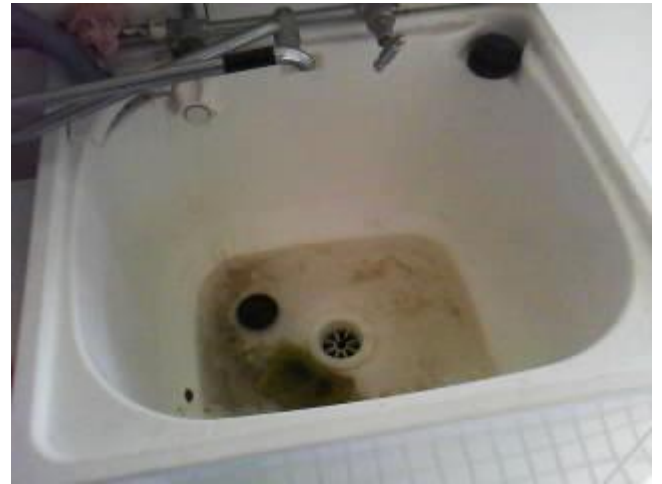
Fixture	Tub
Location	Laundry
Element	Tub
Defect/Observation	Defective, not draining
Extent	Localised
Recommendation	This defect should be addressed by a Licensed Plumber without delay.

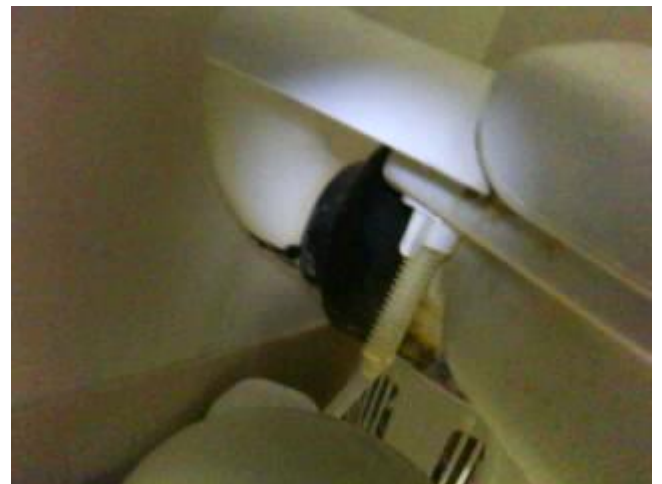
Fixture	Toilet
Location	WC Entry level Eastern side of the building
Element	Toilet flange gasket
Defect/Observation	Leaking
Extent	Localised
Recommendation	This defect falls within the category of Conditions Conducive to Structural Damage & Timber Pest Activity. It is strongly recommended that this condition be removed. A further investigation by a Licensed Plumber is also recommended to determine the extent of work required and associated costs. The above recommendation should be implemented as soon as possible.

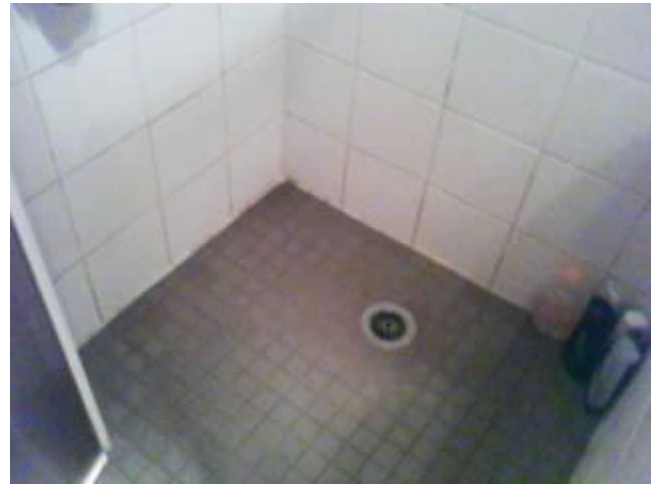
Fixture	Shower
Location	Bathroom Entry level Eastern side of the building
Element	Shower base
Defect/Observation	Poorly sealed
Extent	Localised
Recommendation	This defect falls within the category of Conditions Conducive to Structural Damage & Timber Pest Activity. It is strongly recommended that this condition be removed by resealing. The above recommendation should be implemented promptly.

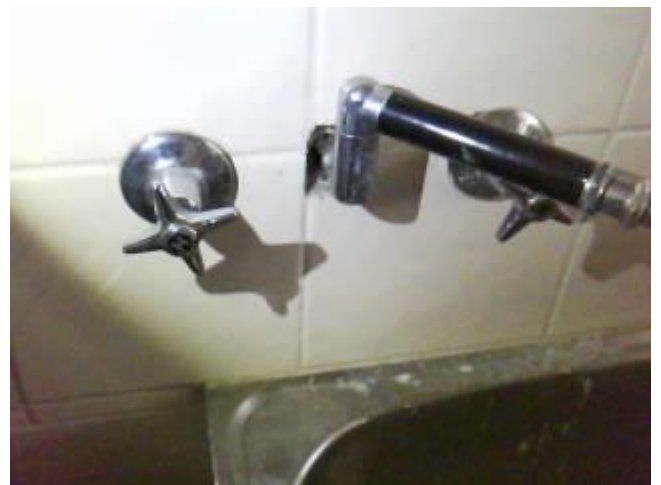
Fixture	Shower
Location	Laundry Entry level Eastern side of the building
Element	Tap flange
Defect/Observation	Poorly sealed
Extent	Localised
Recommendation	This defect falls within the category of Conditions Conducive to Structural Damage & Timber Pest Activity. It is strongly recommended that this condition be removed. The above recommendation should be implemented promptly.

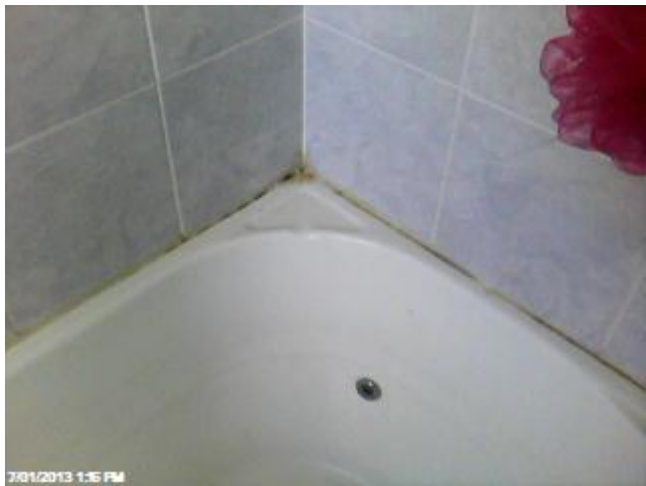
Fixture	Bath

Location	Bathroom Upper level	
Element	Sealant	
Defect/Observation	Poorly sealed aged and stained	
Extent	Localised	
Recommendation	This defect falls within the category of Conditions Conducive to Structural Damage & Timber Pest Activity. It is strongly recommended that this condition be removed by resealing. The above recommendation should be implemented promptly.

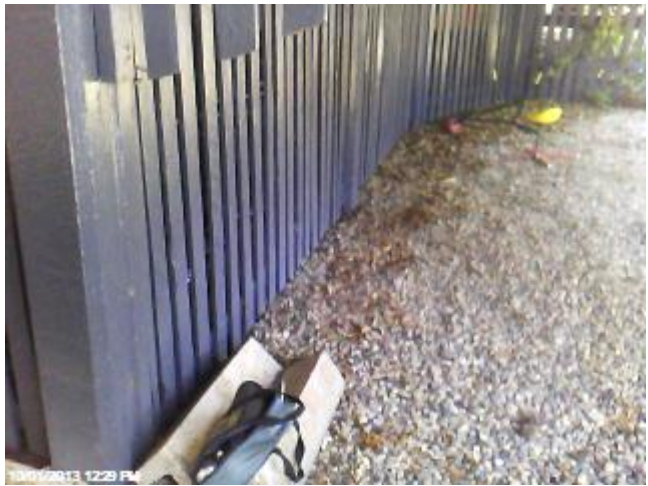
Subfloor Space Defect/Observation

Area	Subfloor space to the main building
Location	In general
Element	Subfloor timber slats
Defect/Observation	<p>Earth-wood contact</p> <p>Note: Untreated or non-durable timbers in direct contact with the ground/soil produce a ready food source for termites. Also, susceptible timbers used in a hazardous environment are prone to fungal decay.</p>
Extent	Widespread
Recommendation	<p>This defect falls within the category of Conditions Conducive to Timber Pest Activity. It is strongly recommended that this condition be removed. The above recommendation should be implemented promptly.</p>

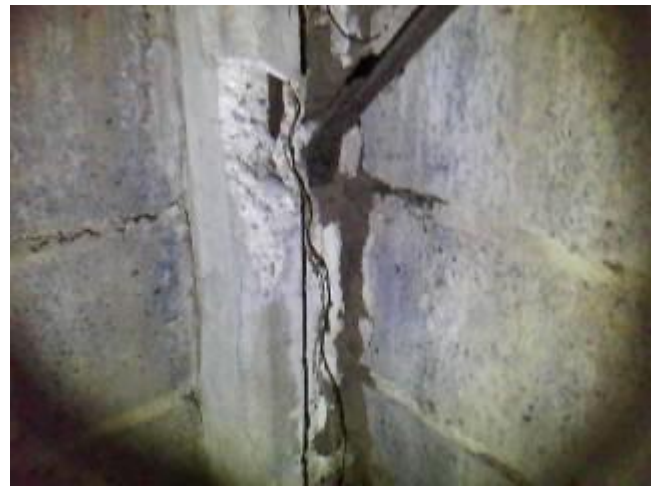
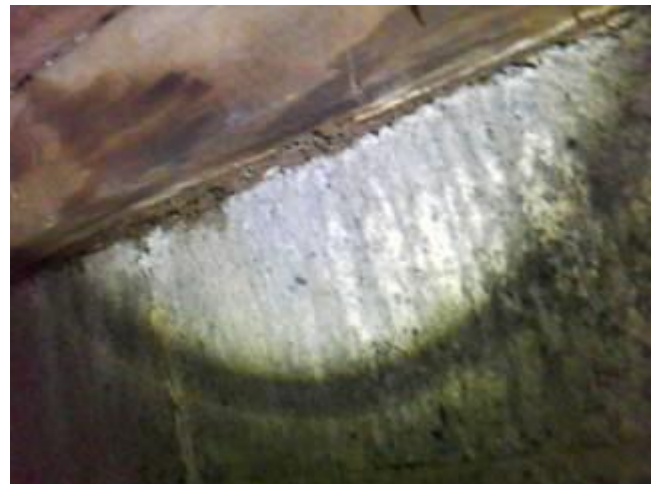
Subfloor Space Defect/Observation

Area	Subfloor space to the main building
Location	Eastern sides of the building
Element	Stumps/sub walls and Floor framing
Defect/Observation	<p><u>Termite Activity</u> <u>Sign of Activity</u></p> <p>Subterranean termite workings including mudding, shelter tubes and damage to timber not in service.</p> <p>Note: Where evidence of termite activity is located within a building or within 50 m of any building (but no live termites were found), it is possible that termites are still active in the concealed or inaccessible areas of the building and they may continue to cause further damage. A further more invasive inspection is strongly recommended. For further advice contact a licensed pest controller.</p>
Extent	Widespread
Recommendation	<p>This defect falls within the category of “Timber Pest Activity and/or Damage”. It is strongly recommended that action be taken to manage timber pests and repair any damage. A further investigation by a Licensed Pest Controller (Timber Pest Specialist) and a Licensed Builder is also recommended to determine the extent of work required and associated costs. The above recommendation should be implemented without delay</p>

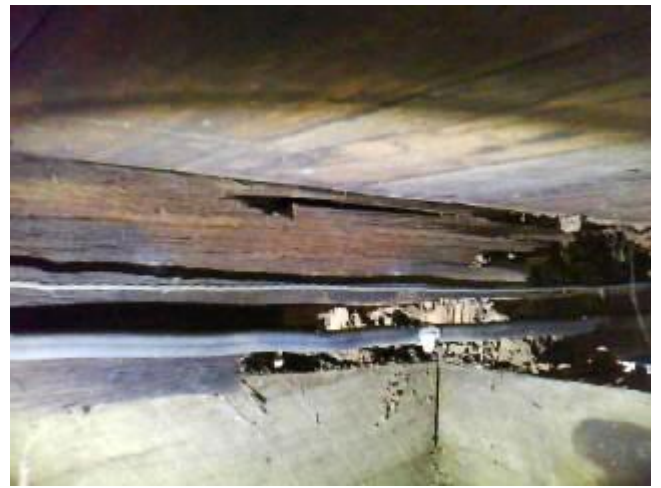
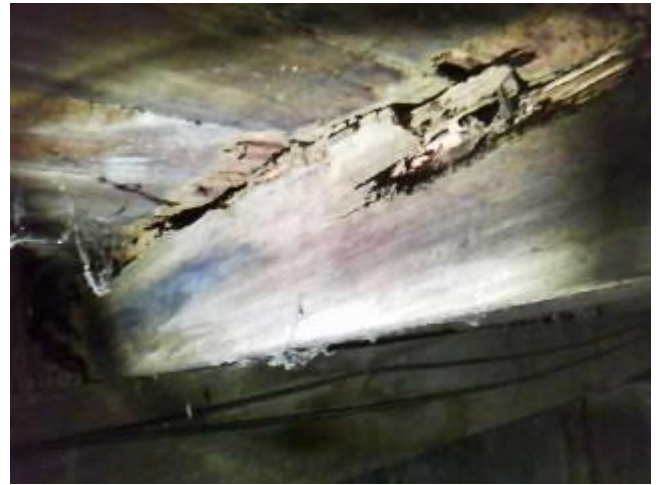
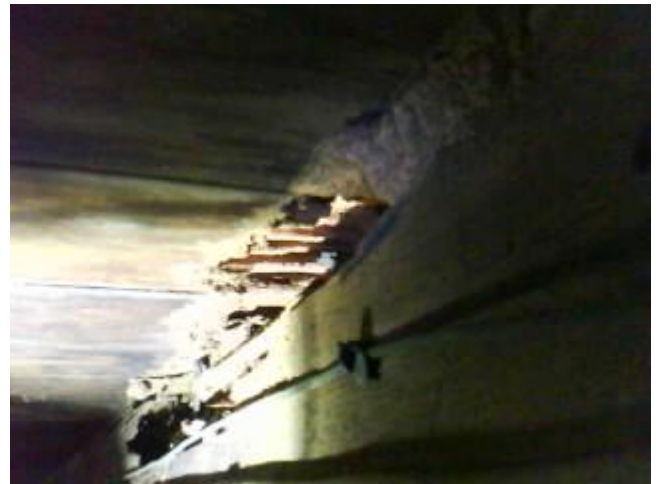
Subfloor Space Defect/Observation

Area	Subfloor space to the main building
Location	Eastern sides of the building
Element	<u>Joists</u> , Floorboards
Defect/Observation	<p><u>Termite Damage</u> <u>Sign of Damage</u> Visible damage to timber</p> <p>Note: Where evidence of termite damage is located within the building, it is possible that termites are still active in the concealed or inaccessible areas of the building and they may continue to cause further damage. A further more invasive inspection is recommended. For further advice consult a licensed pest controller.</p>
Extent	Undetermined
Recommendation	<p>This defect falls within the category of "Structural Damage". It is strongly recommended that this defect be corrected. A further investigation by a Licensed Pest Controller (Timber Pest Specialist) and a Licensed Builder is also recommended to determine the extent of work required and associated costs. The above recommendation should be implemented without delay.</p>

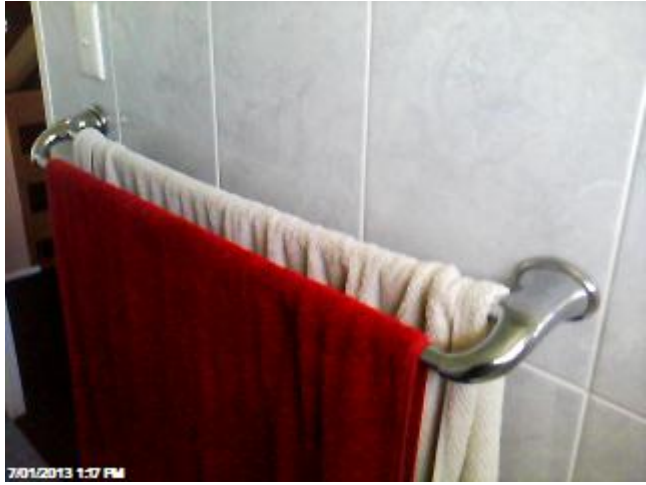
Element	Towel rail

Location	Bathroom Upper level	
Defect/Observation	Loose	
Extent	Localised	
Recommendation	Repairs and/or adjustments by a suitably qualified tradesperson are required to correct this defect.

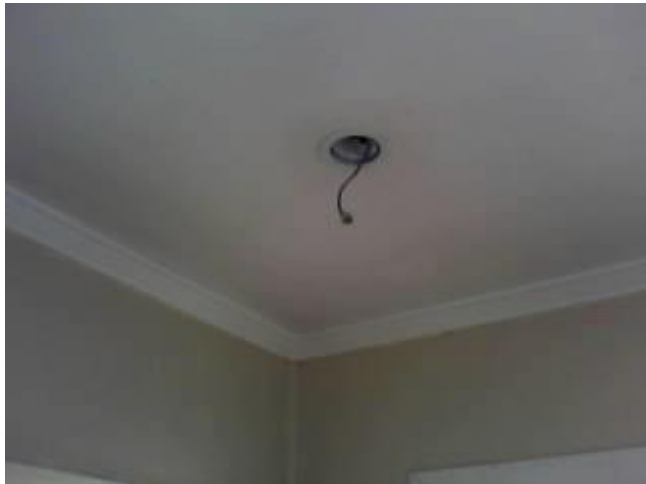
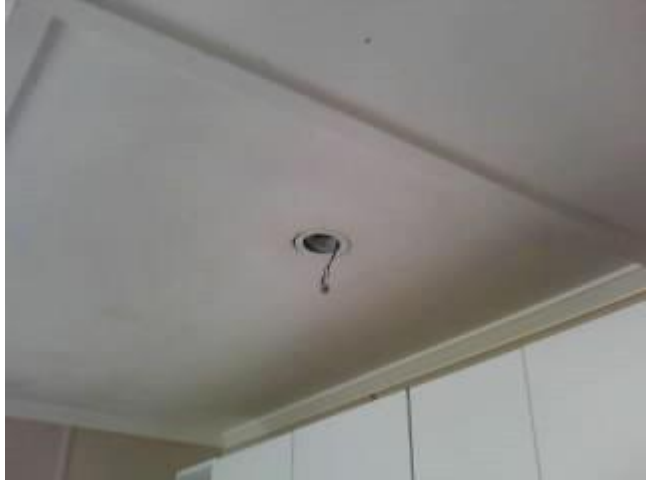
Element	Ceiling downlights

Location	Kitchen, Living Room	
Defect/Observation	2 Missing	
Extent	Localised	
Recommendation	This defect should be addressed by a Licensed Electrician as soon as possible.

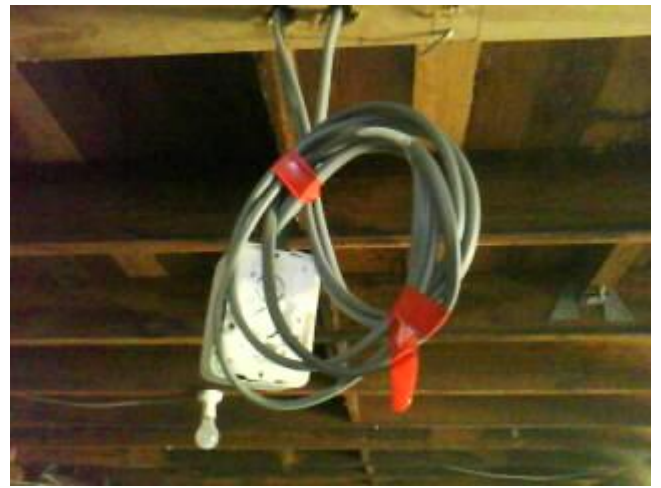
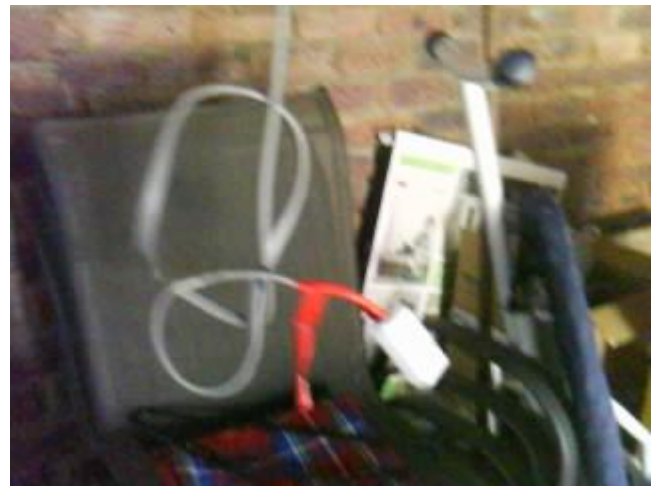
Element	Electrical cables
Location	Sub Floor Western side of the building
Defect/Observation	Incomplete
Extent	Localised
Recommendation	This defect should be addressed by a Licensed Electrician without delay.
