HANDOVER REPORT

Property Address **265 Example Lane, The Greater Brisbane Region
QLD 4000**

Report Number: **#####**

Inspection Date & Time: **Monday 01 January 2013 08:00 AM**

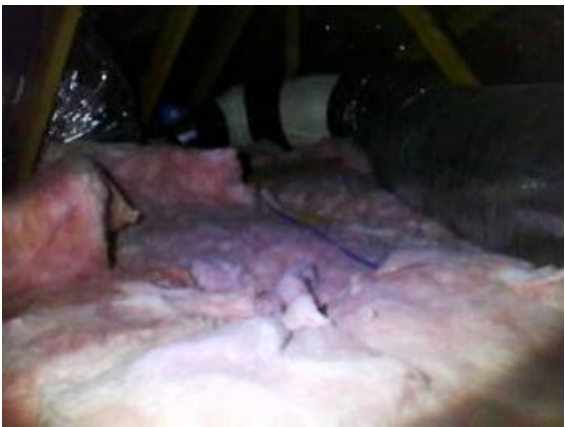
Description	A fall risk exists in the roof void as insulation wholly or partially covers ceiling joists and other framing members. In this situation it is not possible to ensure that the weight of a person can be supported. .

Location	The roof space in general	
Recommendation	This condition is considered dangerous. A further investigation by a competent person is strongly recommended to determine the extent of remedial work required. The above recommendation should be implemented as a matter of urgency.

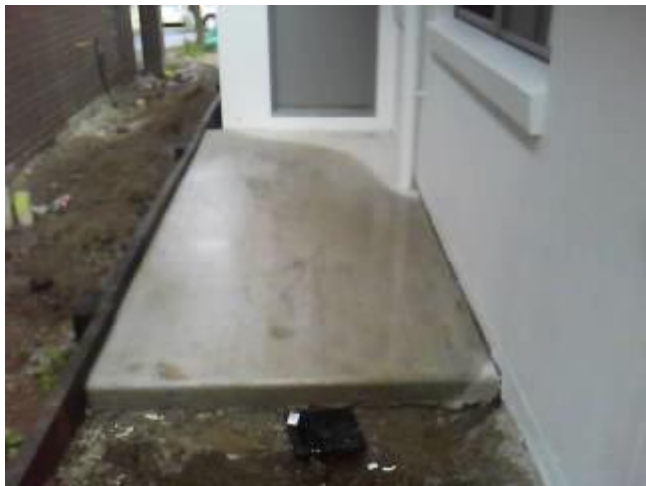
Area	Pathway

Location	Southern side of the property	
Element	Concrete	
Defect/Observation	Inadequate Slope away from building (water ponding next to building)	
Extent	Localised	
Recommendation	This defect falls within the category of Conditions Conducive to Structural Damage & Timber Pest Activity. It is strongly recommended that this condition be removed. A further investigation by a Licensed Pest Controller (Timber Pest Specialist) and a Licensed Tradesperson is also recommended to determine the extent of work required and associated costs. The above recommendation should be implemented as soon as possible.

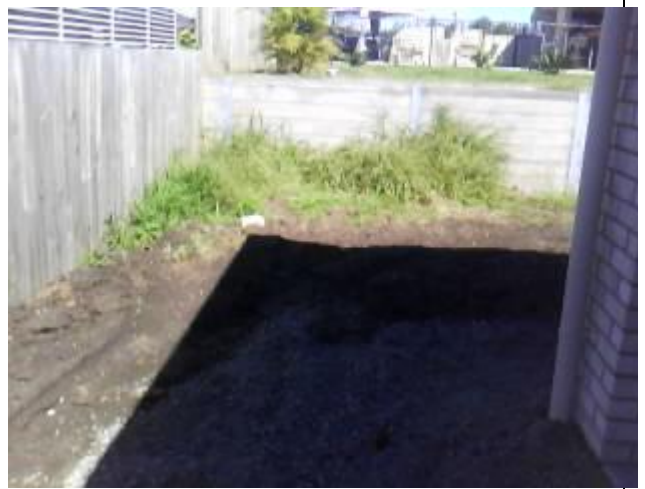
Area	Yard
Location	South-eastern side of the property
Element	Ground Around The Building
Defect/ Observation	<p>Poorly <u>Drained</u></p> <p>Poor drainage leads to excessive moisture being retained in the soil which over time can destabilise the foundations and promote timber pest activity such as fungal decay and termites.</p> <p>Drainage problems are often only discernible during wet periods.</p> <p>Note: The effect of poor drainage on foundations is often dependent on the soil type. Establishing soil type is beyond the scope of a standard pre-purchase inspection.</p> <p>Also, timbers pest activity including termites and fungal decay are commonly associated with poor drainage.</p> <p>Generally, to ensure that water drains away from the footings, the profile of the ground adjacent to the building should slope away from the base of the exterior walls and all stormwater drainage should be maintained in good condition and free from blockage.</p>

Extent	Widespread
Recommendation	<p>This defect falls within the category of Conditions Conducive to Structural Damage & Timber Pest Activity. It is strongly recommended that this condition be removed. A further investigation by a Licensed Pest Controller (Timber Pest Specialist) and a Licensed Plumber & Drainer is also recommended to determine the extent of work required and associated costs. The above recommendation should be implemented promptly.</p>

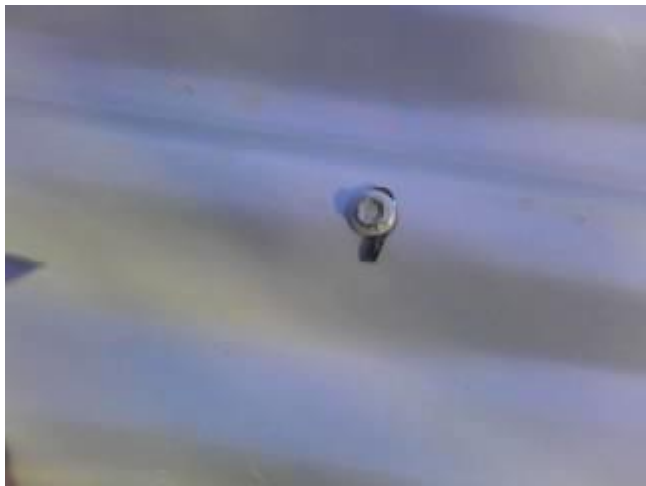
Structure	The roof to the main building.

Area Affected	In general	
Element	Fastenings	
Defect/Observation	The rubber seals to roofing screws are damaged.	
Extent	Localised	
Recommendation	This defect should be addressed by a Licensed Tradesperson as soon as possible.

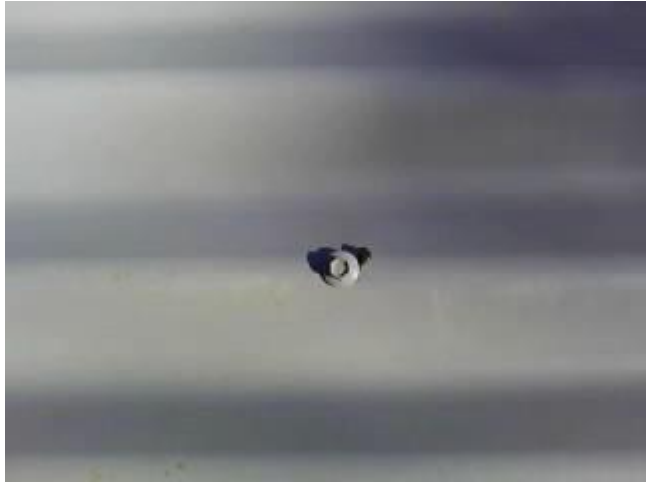
Structure	The lower roof to the main building.
Area Affected	On the north-eastern side of the patio
Element	Roof sheeting/ Fastening
Defect/Observation	Screw fixing through the bottom corrugation of the roof sheet.
Extent	Localised
Recommendation	The consultant recommends that the client undertakes regular maintenance and continues to monitor the defect. Repairs may be necessary in the event the defect becomes more significant.

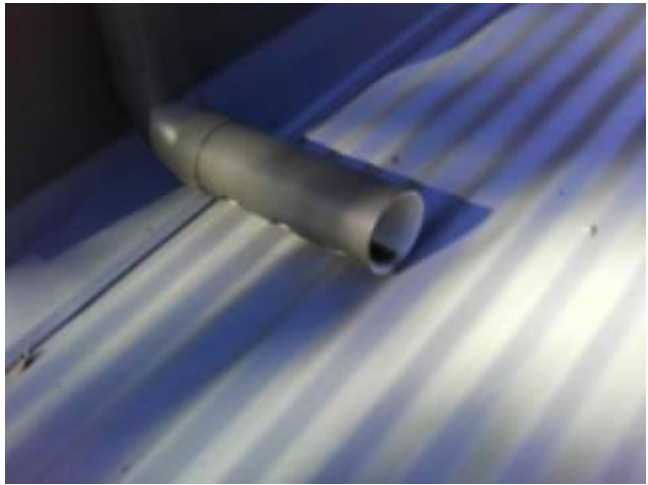
Area Affected	On the western side of the building	
Element	Downpipe spreaders	
Defect/Observation	Pipes not half capped on the ends to control flow. One not painted.	
Extent	Localised	
Recommendation	This defect should be addressed by a Licensed Tradesperson as soon as possible.

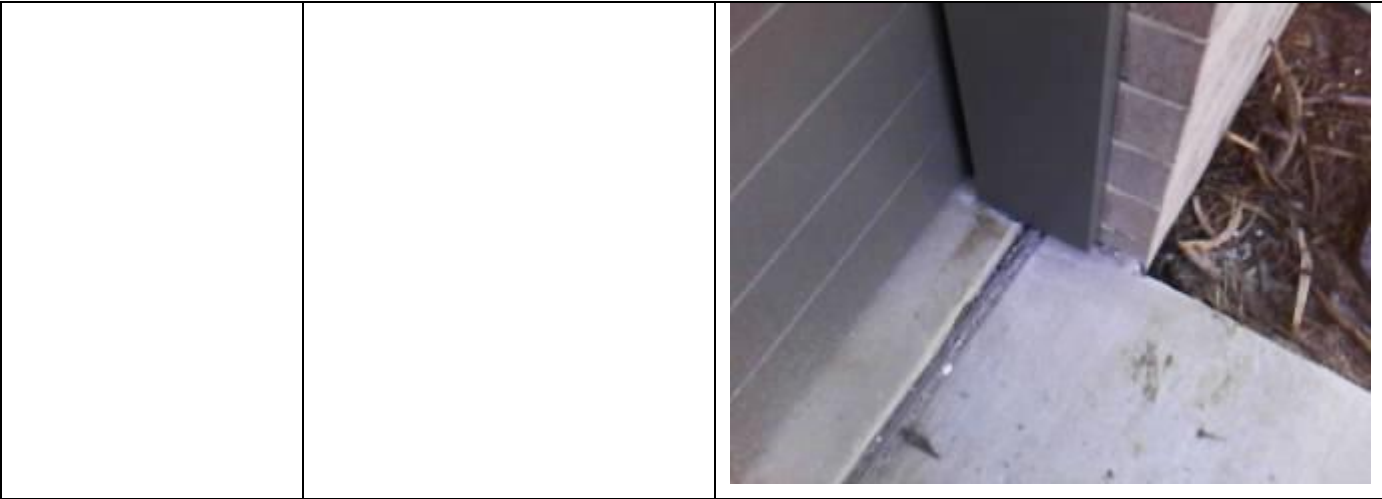
This defect falls within the category of Conditions Conducive to Timber Pest Activity. A further investigation by a Licensed Pest Controller (Timber Pest Specialist) is also recommended to determine the extent of work required and associated costs. The above recommendation should be implemented without delay.

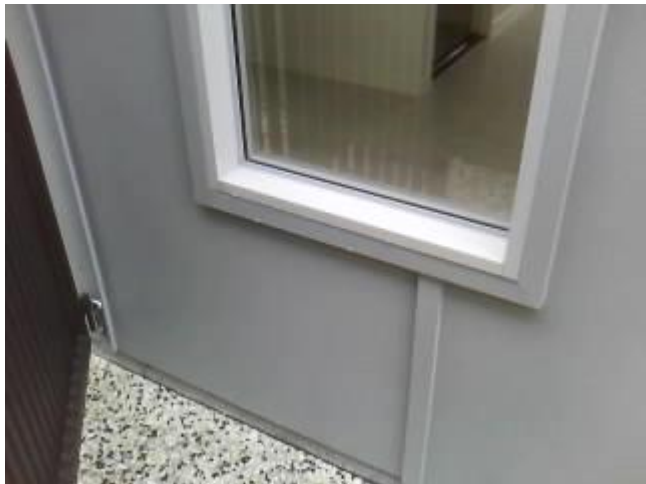
Location	Hallway window Ground floor Western side of the building

Element	<u>Sill</u>	
Defect/Observation	Flat sill, Holding water	
Extent	Localised	
Recommendation	The consultant recommends that the client undertakes regular maintenance and continues to monitor the defect. Repairs may be necessary in the event the defect becomes more significant.

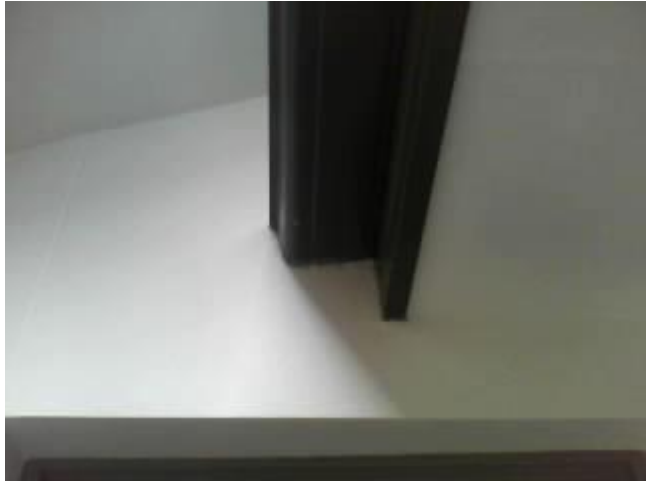
Location	Main building Southern side of the building Above rear garage door)

Element	Gutter	
Defect/Observation	Poor workmanship (gutter not sitting level)	
Extent	Localised	
Recommendation	This defect should be addressed by a Licensed Tradesperson as soon as possible.

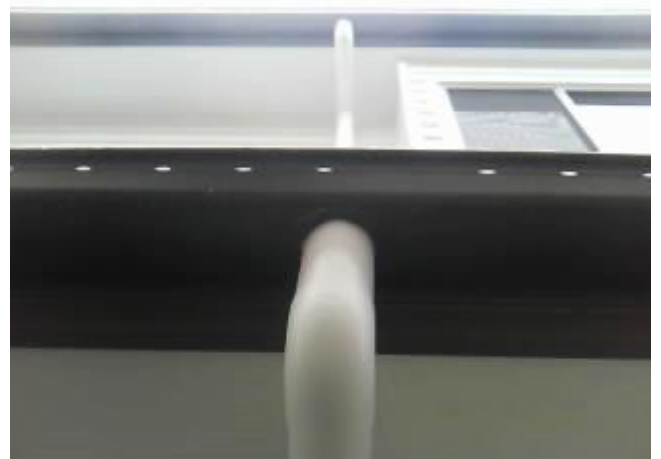
Location	Main building Northern side of the building
Element	Eaves Gutter (adjacent to centre downpipe)
Defect/Observation	Dented and/or deformation
Extent	Localised
Recommendation	This defect should be addressed by a Licensed Tradesperson as soon as possible.

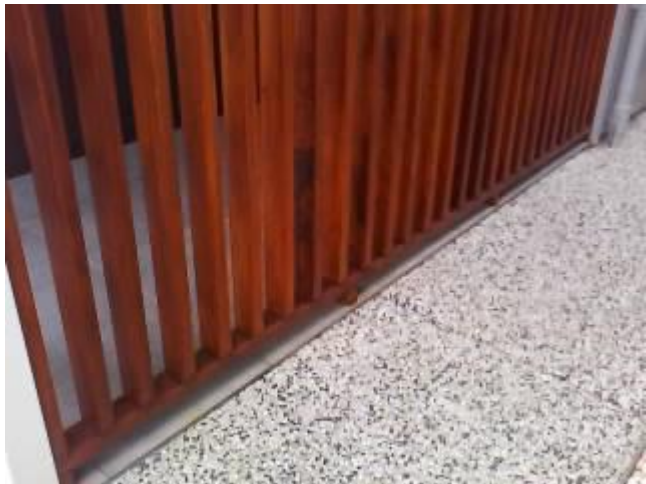
Location	Front entry North-western side of the building

Element	Floor tiles	
Defect/Observation	Timber stain	
Extent	Localised	
Recommendation	This defect should be addressed by a Licensed Tradesperson as soon as possible.

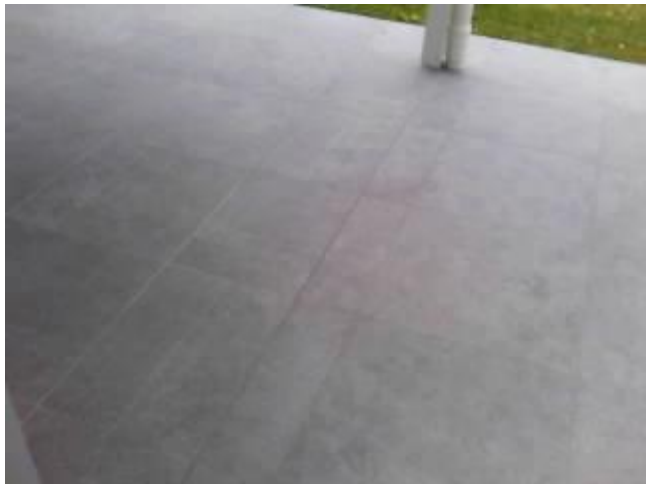
Location	Front entry and rear Patio
Element	Floor tiles/control joints
Defect/Observation	Not sealed
Extent	Localised

Recommendation	This defect should be addressed by a Licensed Tradesperson as soon as possible.
-----------------------	---

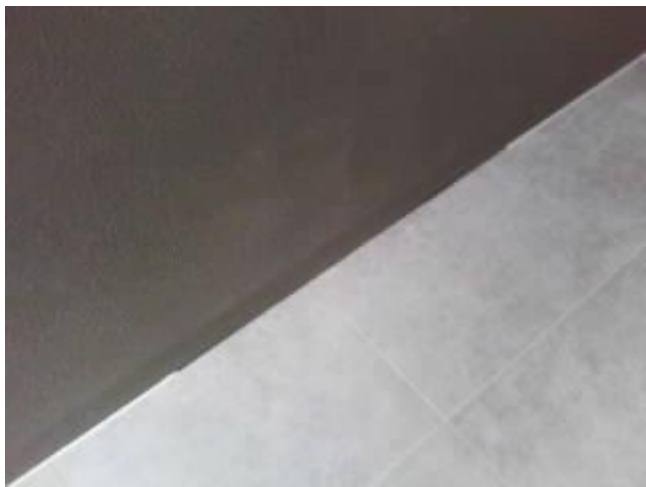
Location	Patio North-western side of the building
Element	Tiles
Defect/Observation	Cracked
Extent	Localised
Recommendation	This defect should be addressed by a Licensed Tradesperson as soon as possible.

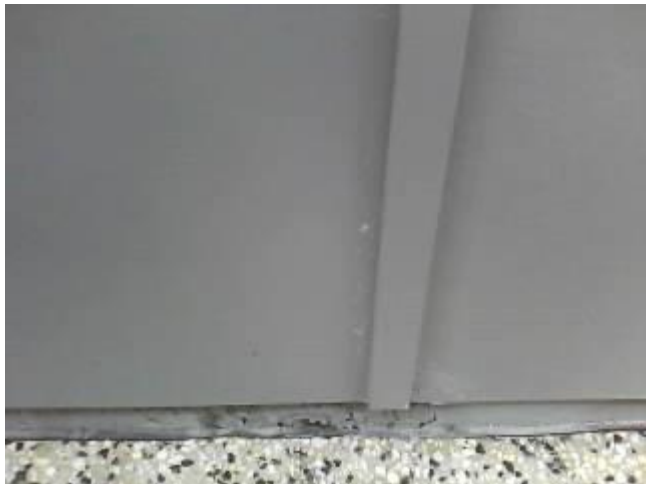
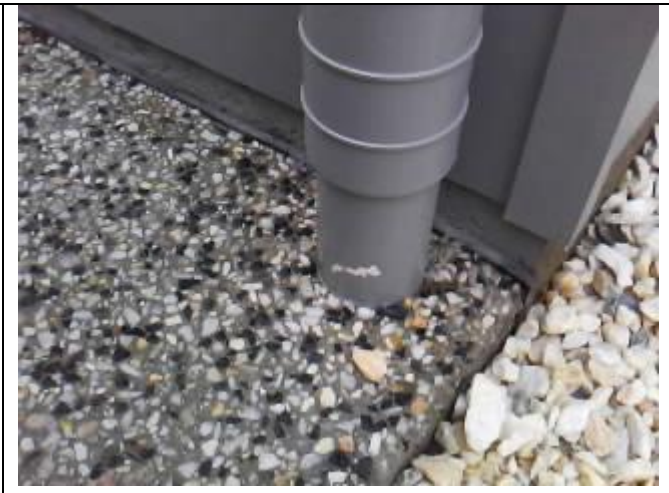
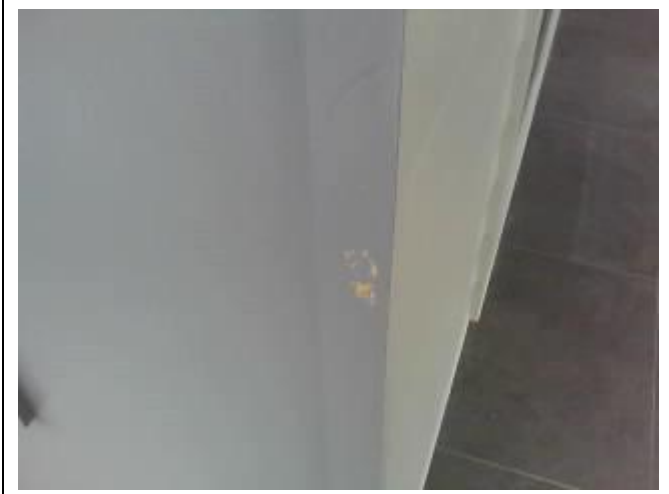
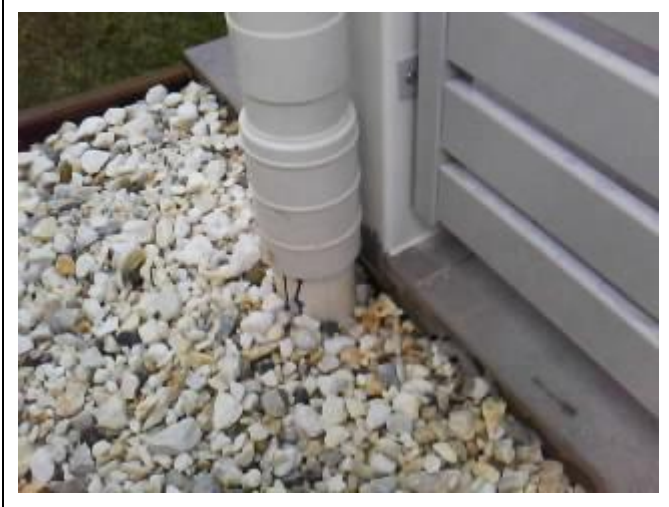
Location	Steel columns at front entry and rear patio, downpipes at rear patio and western side, external walls on the western side.	 
Element	Paintwork	
Defect/Observation	Scuffed, patchy, incomplete	
Extent	Localised	
Recommendation	This defect should be addressed by a Licensed Tradesperson as soon as possible.

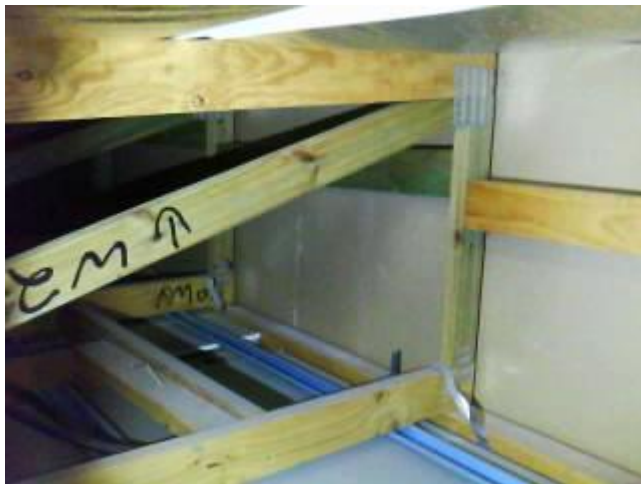
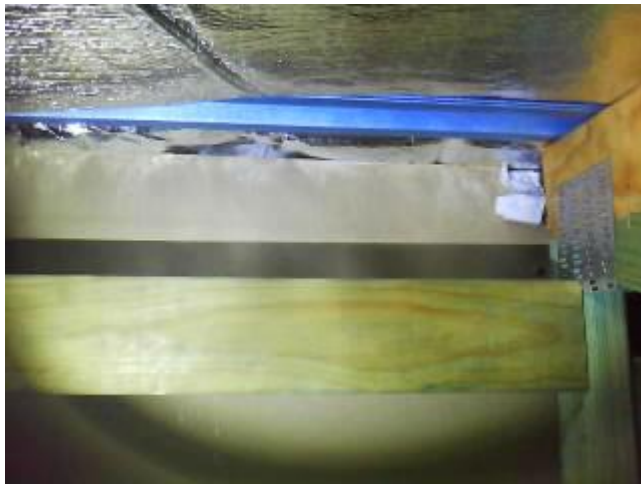
Structure	The roof to the main building
Area Affected	The area on the eastern side
Element	<u>Fire Separation Wall</u>
Observation	Plasterboard joints and screw heads not sealed. Space between top of wall and roof cover does not appear to be sealed/packed with an appropriate rockwool or mineral fibre wool.
Extent	Widespread
Recommendation	It should be confirmed with the builder or building certifier that the fire separation wall has been installed in accordance with the building codes requirements and the approved construction plans.

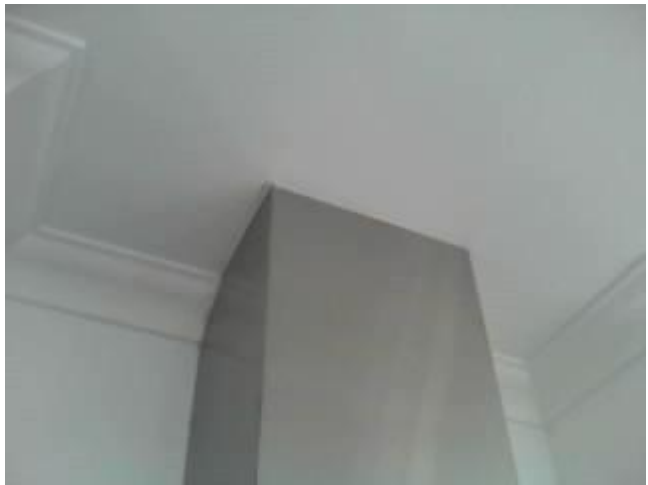
Element	Ceiling & Cornice

Location	Kitchen, First floor	
Defect/Observation	Poorly finished around exhaust vent	
Extent	Localised	
Recommendation	This defect should be addressed by a Licensed Tradesperson as soon as possible.

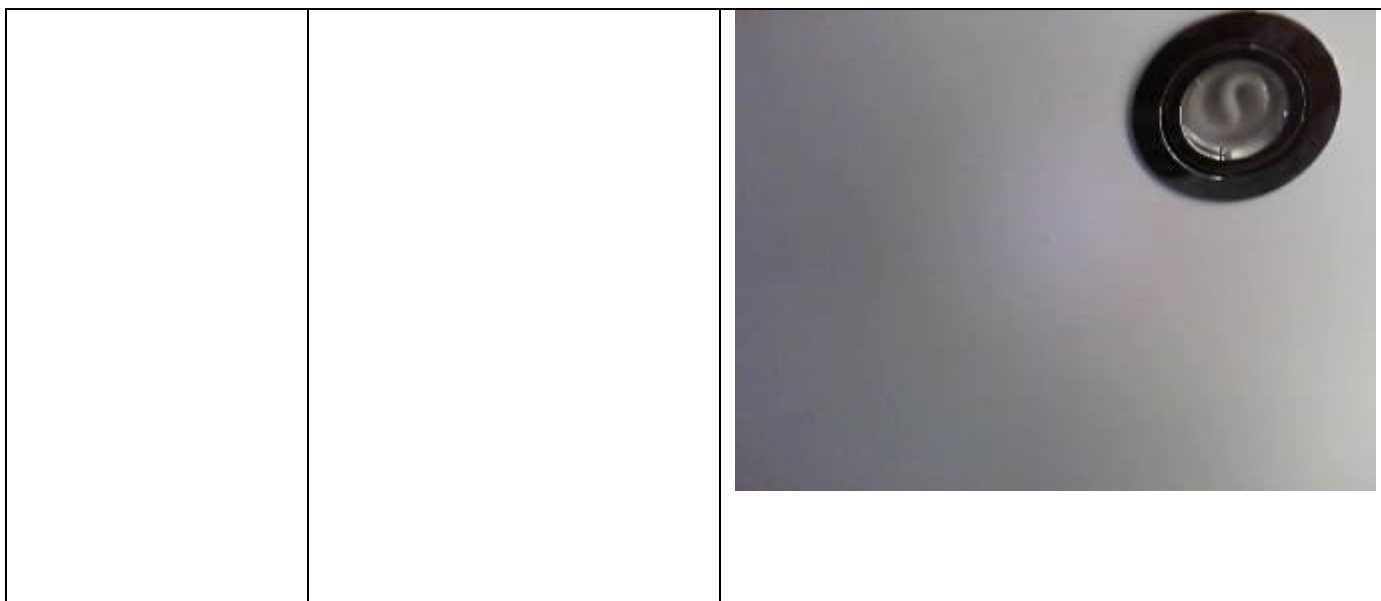
Location	In general throughout	
Defect/Observation	Impact/scratch marks around downlights	
Extent	Localised	
Recommendation	This defect should be addressed by a Licensed Tradesperson as soon as possible.

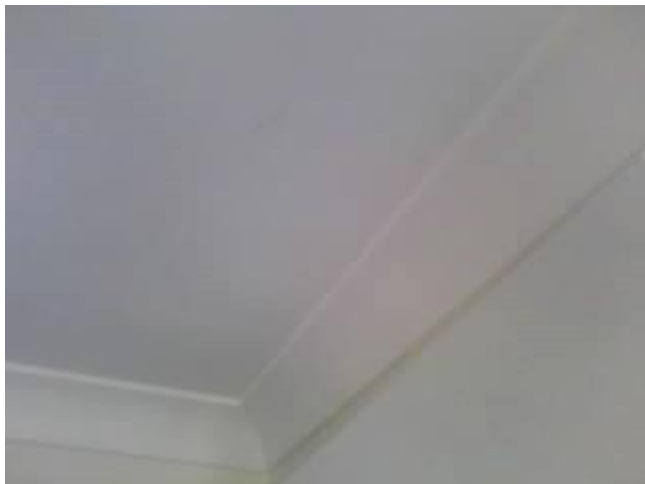
Element	Ceiling

Location	Front entry	
Defect/Observation	Scratch mark	
Extent	Localised	
Recommendation	<p>This defect should be addressed by a Licensed Tradesperson as soon as possible.</p>

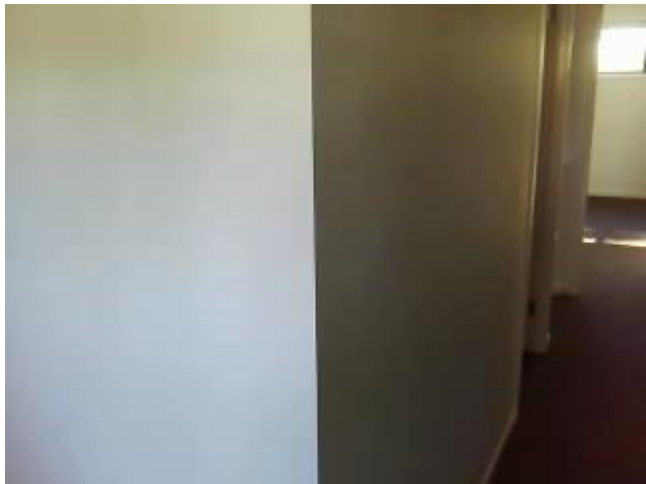
Location	Hallway First floor Southern side of the building

Element	External corner	
Defect/Observation	Scuff marks	
Extent	Localised	
Recommendation	This defect should be addressed by a Licensed Tradesperson as soon as possible.

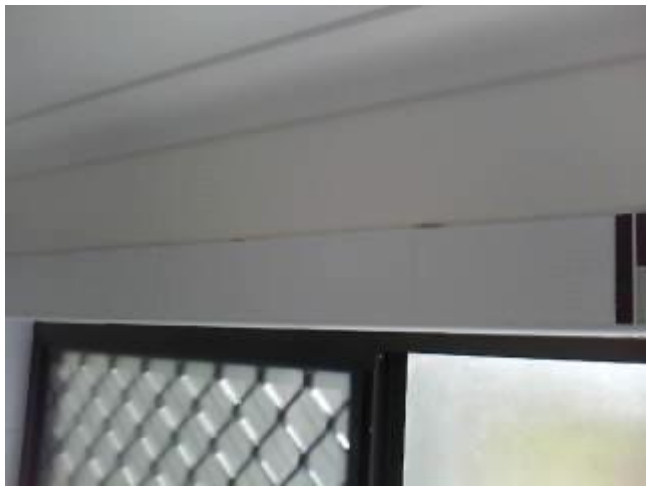
Location	Ensuite First floor North-eastern side of the building

Element	Wall lining	
Defect/Observation	Patchy marks in paintwork	
Extent	Localised	
Recommendation	This defect should be addressed by a Licensed Tradesperson as soon as possible.

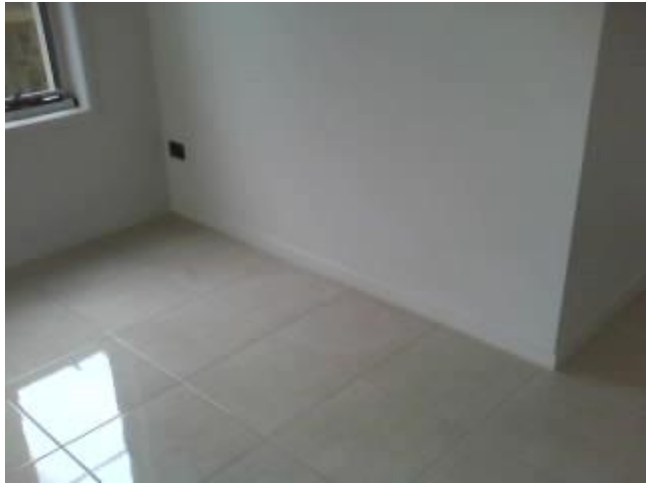
Location	Family Room (adjacent to toilet) Ground floor South-western side of the building

Element	Paintwork	
Defect/Observation	Discoloration	
Extent	Localised	
Recommendation	Repainting is required.

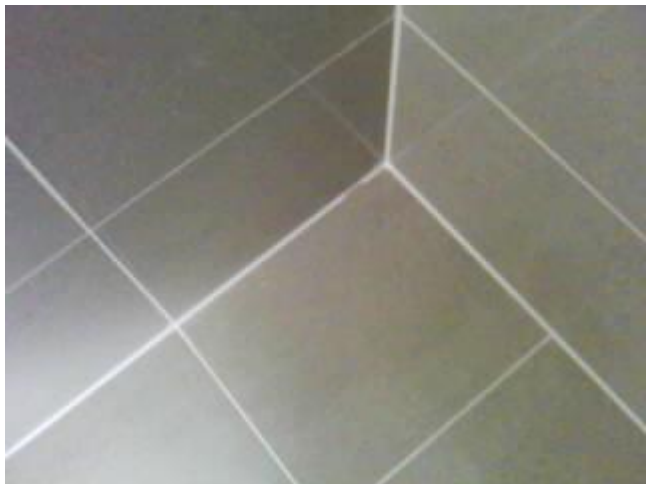
Element	Floor tiles

Location	Ensuite, adjacent toilet	
Defect/Observation	Gap in sealant	
Extent	Localised	
Recommendation	This defect should be addressed by a Licensed Tradesperson as soon as possible.

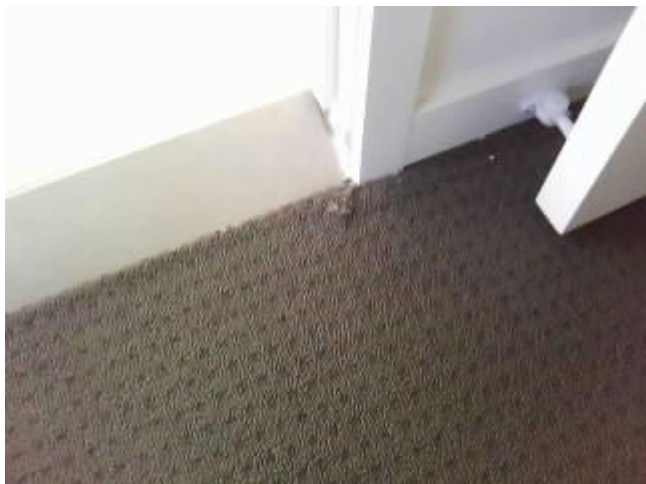
Element	Carpet

Location	Master Bedroom/ Ensuite First floor North-eastern side of the building	
Defect/Observation	Snag	
Extent	Localised	
Recommendation	This defect should be addressed by a Licensed Tradesperson as soon as possible.

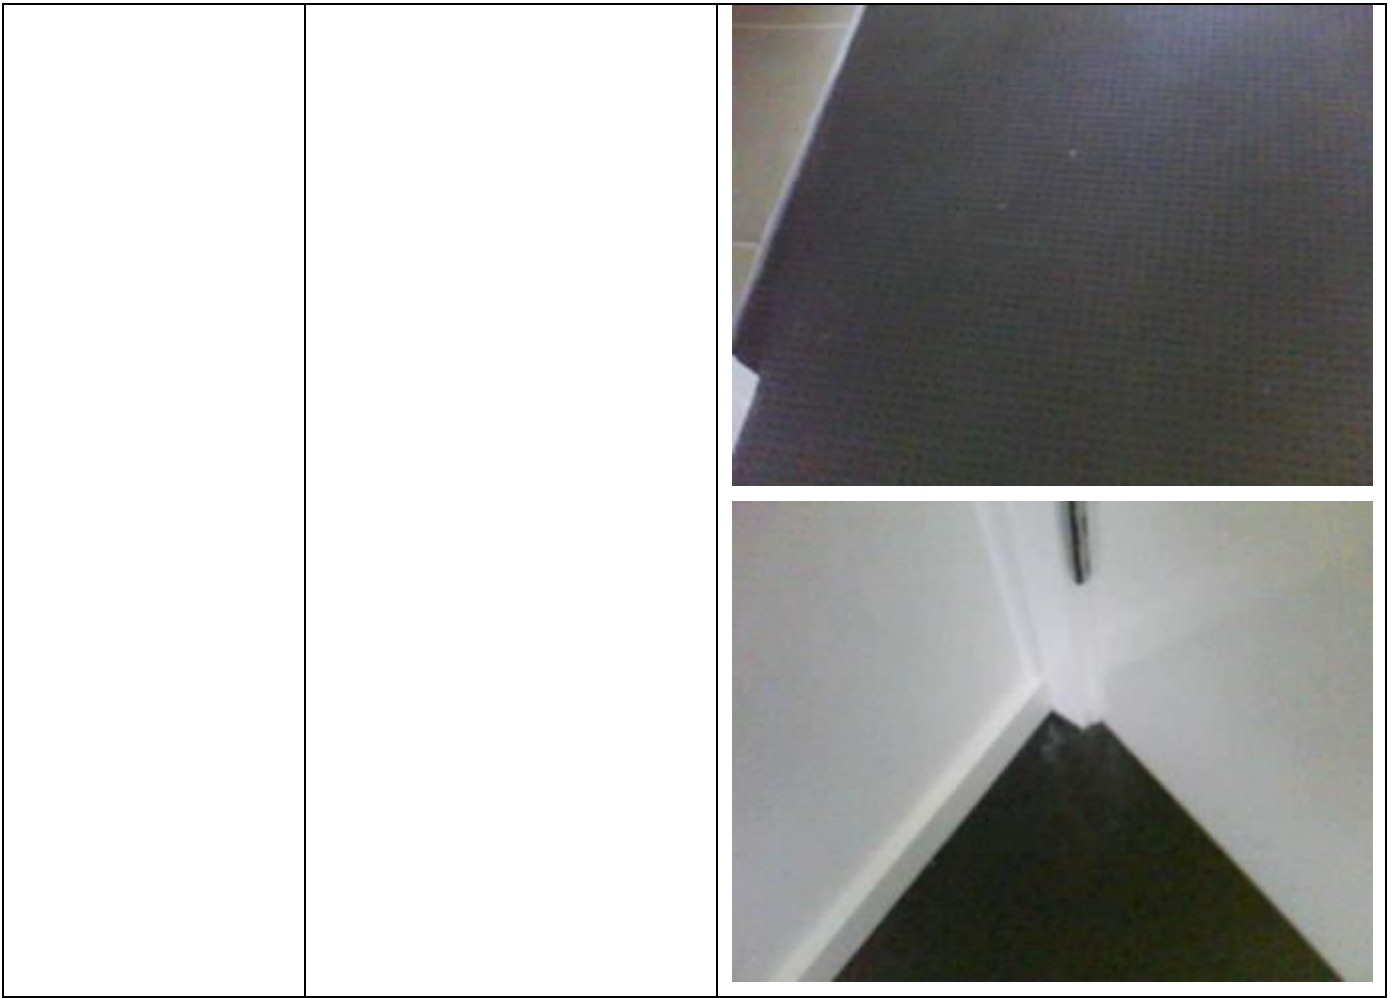
Element	Carpets	 
Location	Stairs, Bedrooms, Hallway First floor In general	
Defect/Observation	Paint/plaster stains on carpet	
Extent	Localised	
Recommendation	This defect should be addressed by a Licensed Tradesperson as soon as possible.

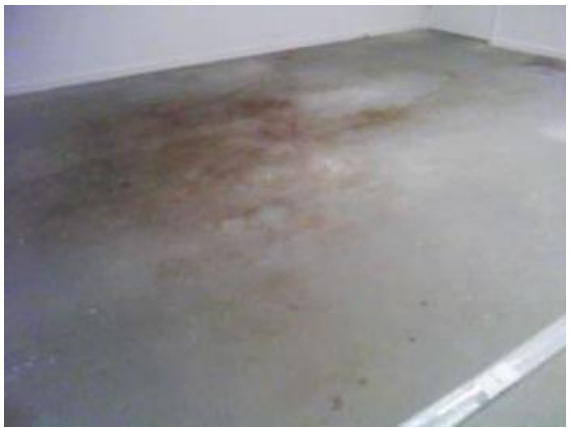
Element	Floor slab

Location	Garage, Ground floor North-eastern side of the building	
Defect/Observation	<u>Stained</u>	
Extent	Widespread	
Recommendation	This defect should be addressed by a Licensed Tradesperson as soon as possible.

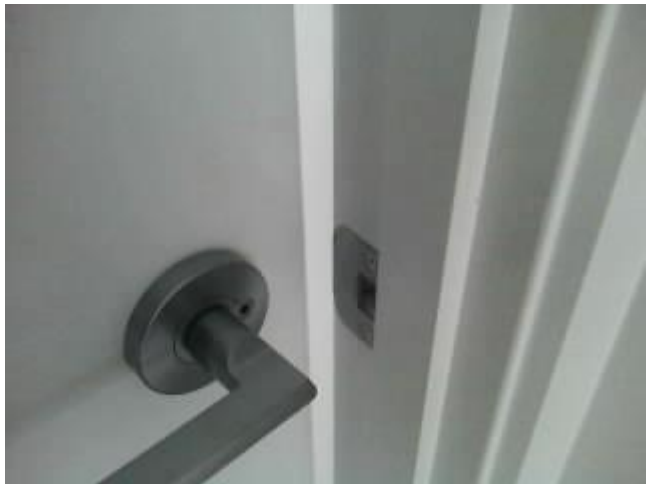
Door	Door

Location	WC, First floor South-eastern side of the building	
Element	Hardware	
Defect/Observation	Not latching	
Extent	Localised	
Recommendation	Repairs and/or adjustments by a suitably qualified tradesperson are required to correct this defect.

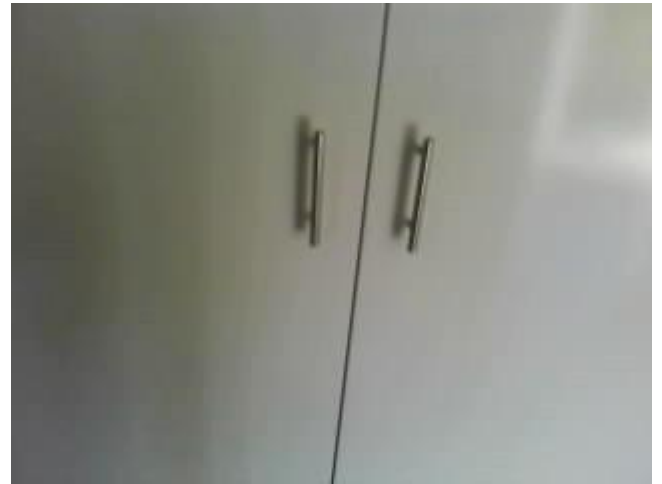
Door	Cupboard door
Location	Hallway, Entry level In general
Element	Handle
Defect/Observation	Out of plumb
Extent	Localised
Recommendation	Repairs and/or adjustments by a suitably qualified tradesperson are required to correct this defect.

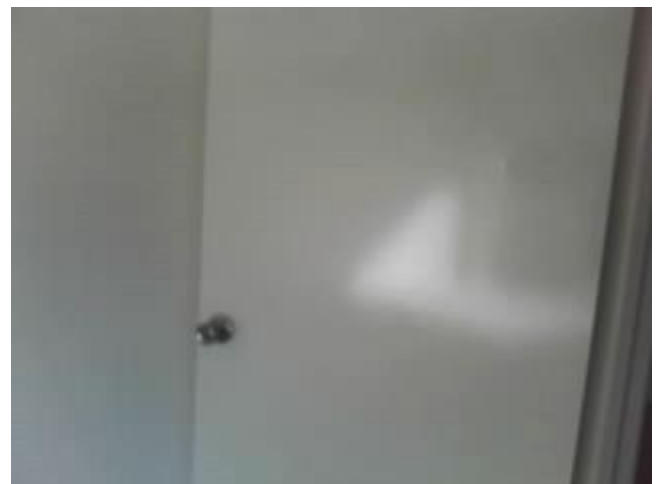
Door	Door
Location	Garage, Entry level North-eastern side of the building
Element	Finish
Defect/Observation	Poorly painted
Extent	Localised
Recommendation	Repainting is required.

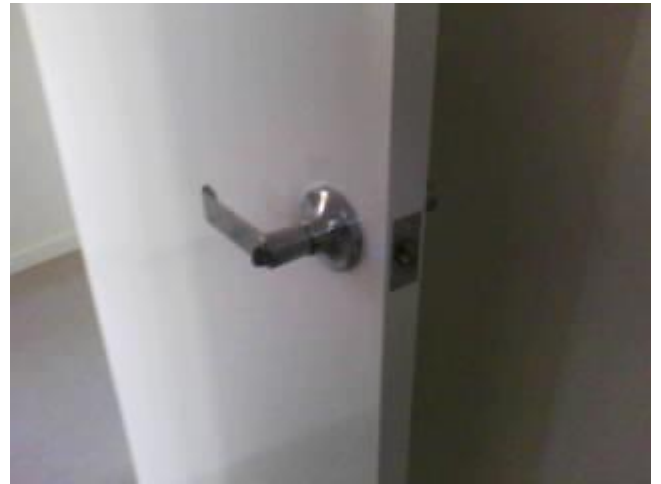
Door	Door
Location	Garage
Element	Latch
Defect/Observation	Back to front
Extent	Localised
Recommendation	This defect should be addressed by a Licensed Tradesperson as soon as possible.

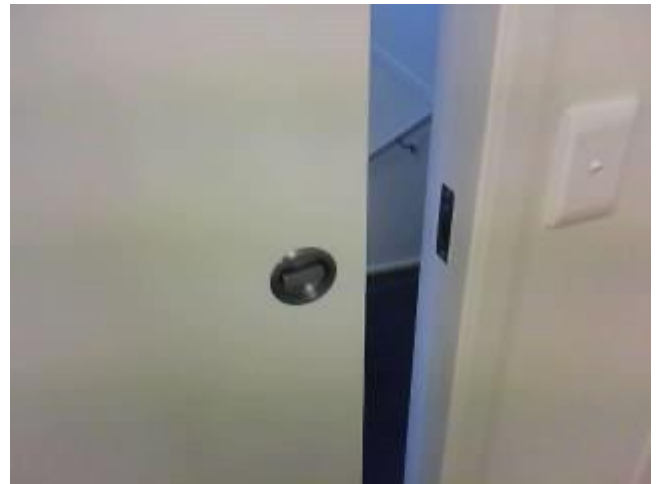
Internal Door Defect/Observation

Door	Sliding door (in cavity)
Location	Bathroom First floor Eastern side of the building
Element	Lock
Defect/Observation	Defective
Extent	Localised
Recommendation	This defect should be addressed by a Licensed Tradesperson as soon as possible.

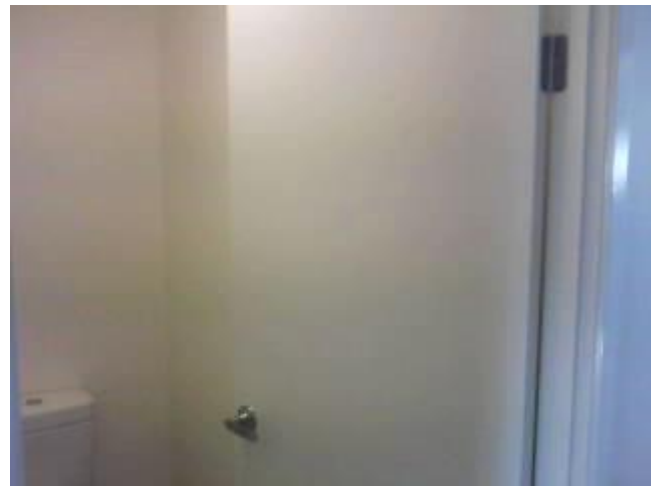
Internal Door Defect/Observation

Door	Door
Location	WC First floor
Element	Hinges Door
Defect/Observation	Do not lift off. Note: Toilet doors should be fitted with lift off hinges and adequate head clearance to allow the door to be removed. Door also binding
Extent	Localised
Recommendation	This defect should be addressed by a Licensed Tradesperson as soon as possible.

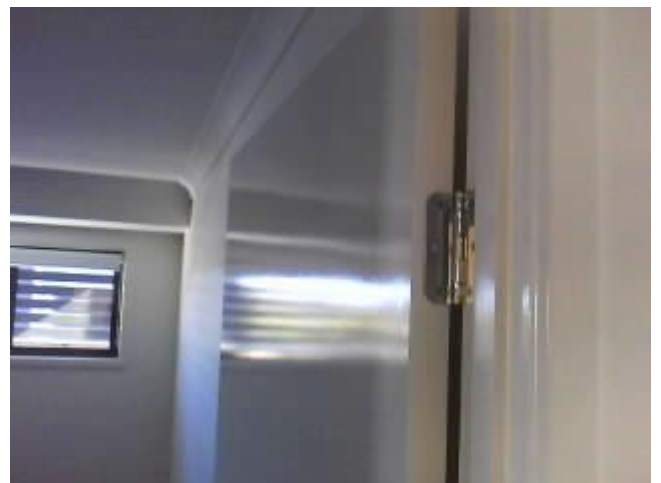
Internal Door Defect/Observation

Door	Door
Location	Middle Bedroom First floor Western side of the building
Element	Hinge
Defect/Observation	Missing screw
Extent	Localised
Recommendation	This defect should be addressed by a Licensed Tradesperson as soon as possible.

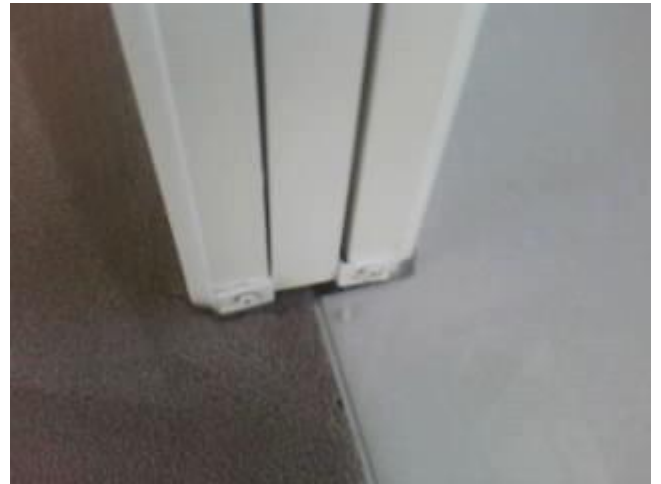
Internal Door Defect/Observation

Door	Sliding door (in cavity)
Location	Media Room, Entry level Northern side of the building
Element	Floor Guide
Defect/Observation	Loose
Extent	Localised
Recommendation	Repairs and/or adjustments by a suitably qualified tradesperson are required to correct this defect.

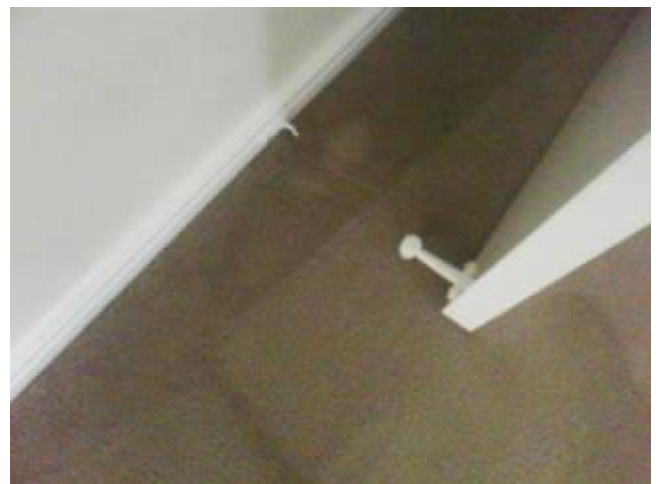
Internal Door Defect/Observation

Door	Door
Location	Bedroom, First floor North-western side of the building
Element	Door stop
Defect/Observation	Broken
Extent	Localised
Recommendation	This defect requires replacement as soon as possible.

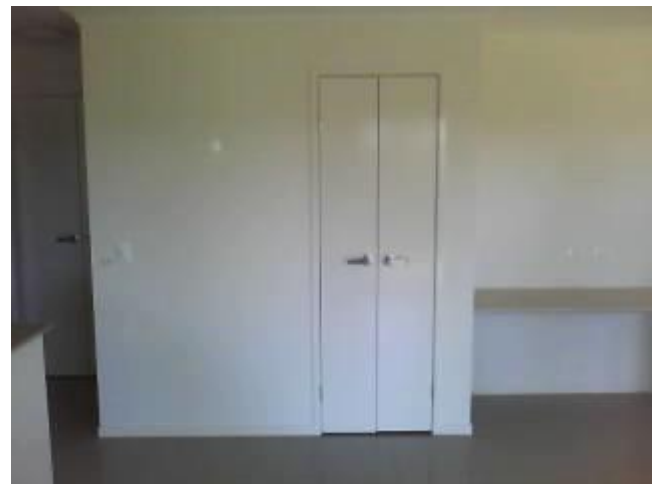
Built-in-Fittings Defect/Observation

Built-In-Fittings	Cupboard
Location	Living Room
Element	Doors
Defect/Observation	Bottom edges not even
Extent	Localised
Recommendation	This defect should be addressed by a Licensed Tradesperson as soon as possible.

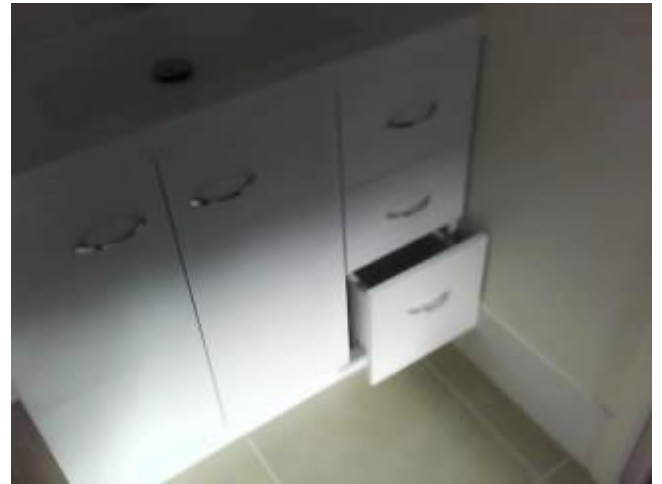
Built-in-Fittings Defect/Observation

Built-In-Fittings	Vanity unit
Location	Ensuite First floor North-eastern side of the building
Element	Bottom Drawer
Defect/Observation	Binding
Extent	Localised
Recommendation	This defect should be addressed by a Licensed Tradesperson as soon as possible.

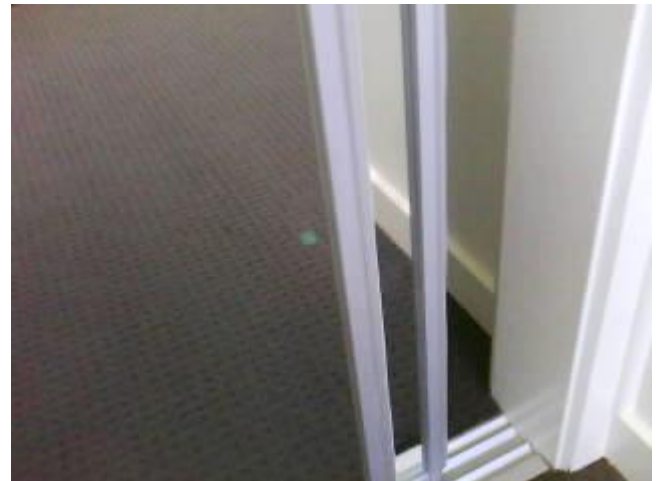
Built-in-Fittings Defect/Observation

Built-In-Fittings	Built-in-wardrobe
Location	Bedroom First floor South-western side of the building
Element	Mirror Door
Defect/Observation	Marked
Extent	Localised
Recommendation	This defect should be addressed by a Licensed Tradesperson as soon as possible.

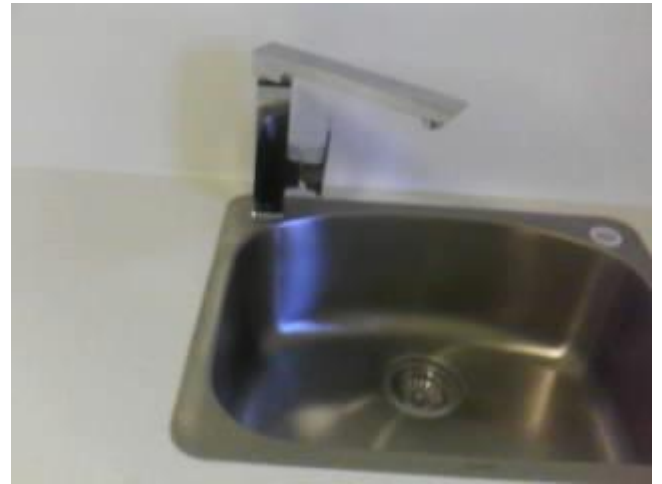
Sanitary Fixture Defect/Observation

Fixture	Basin
Location	Laundry Entry level Northern side of the building
Element	Mixer & sink
Defect/Observation	Loose
Extent	Localised
Recommendation	Repairs and/or adjustments by a suitably qualified tradesperson are required to correct this defect.

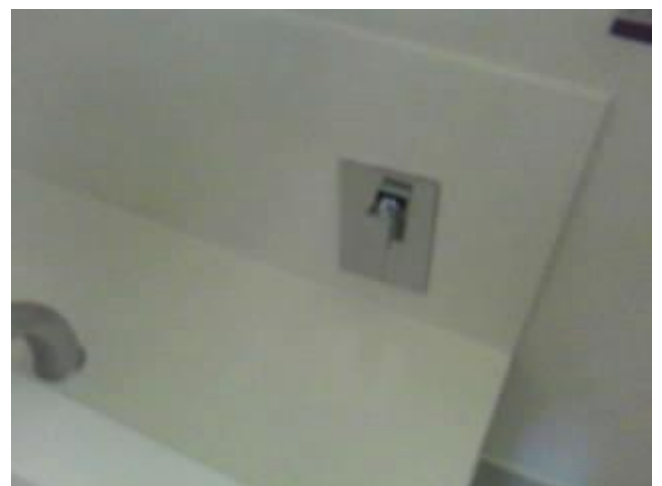
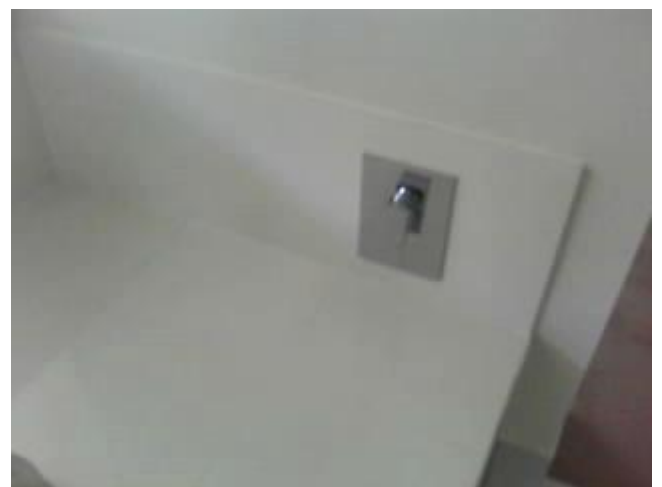
Sanitary Fixture Defect/Observation

Fixture	Bath
Location	Bathroom & ensuite First floor Southern side of the building
Element	Backing plate
Defect/Observation	Loose
Extent	Localised
Recommendation	Repairs and/or adjustments by a suitably qualified tradesperson are required to correct this defect.

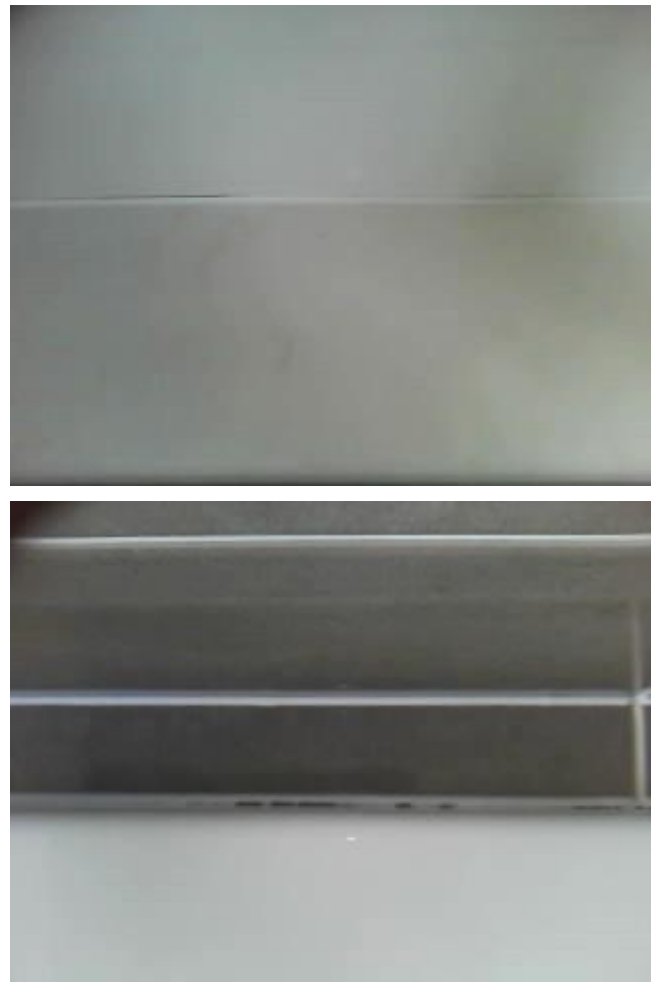
Built-in-Fittings Defect/Observation

Built-In-Fittings	Built-in-fittings
Location	Bathroom, Ensuite, First floor Throughout
Element	Sink Bath
Defect/Observation	Poorly sealed
Extent	Localised
Recommendation	This defect falls within the category of Conditions Conducive to Structural Damage & Timber Pest Activity. It is strongly recommended that this condition be removed by resealing. The above recommendation should be implemented promptly.

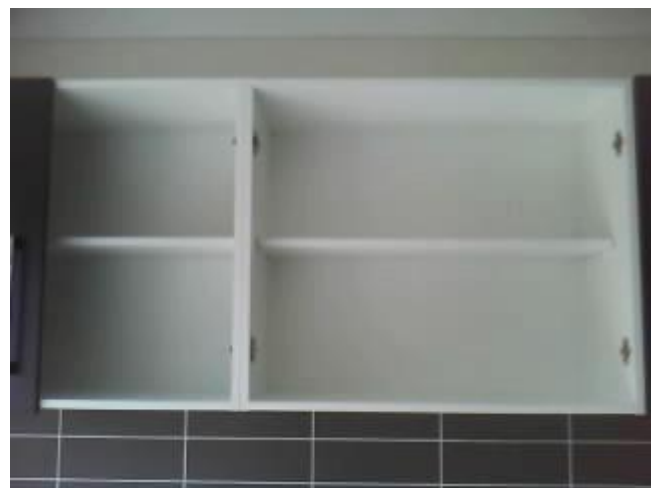
Built-in-Fittings Defect/Observation

Built-In-Fittings	Cupboards
Location	Laundry, Ground floor Western side of the building
Element	Doors
Defect/Observation	Missing
Extent	Localised
Recommendation	Replace the missing element as soon as possible.

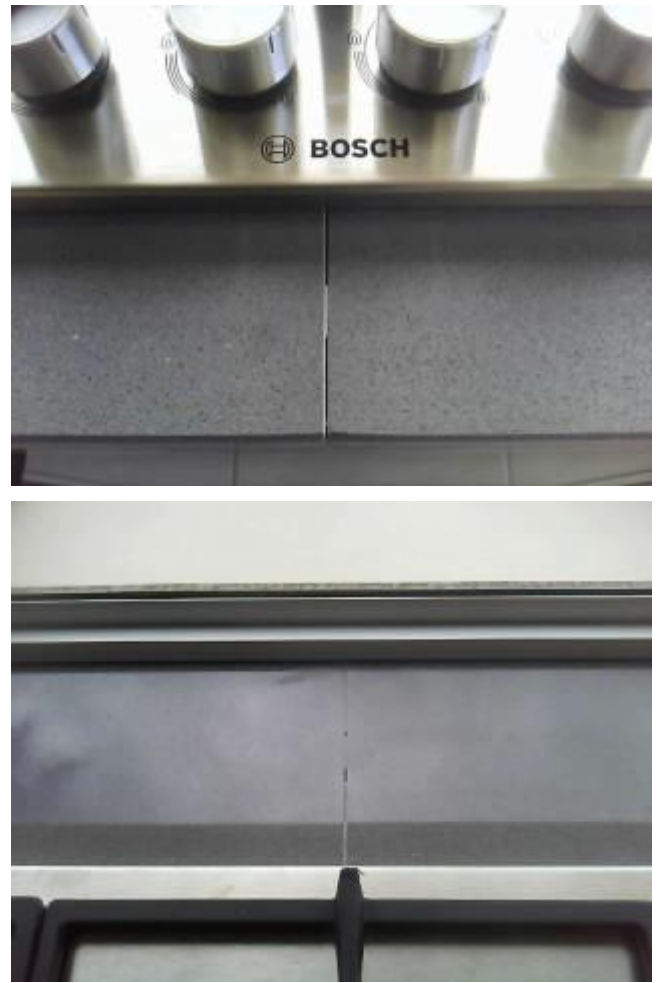
Built-in-Fittings Defect/Observation

Built-In-Fittings	Cupboards
Location	Kitchen, Ground floor South-eastern side of the building
Element	Join in Worktop
Defect/Observation	Poorly finished
Extent	Localised
Recommendation	This defect should be addressed by a Licensed Tradesperson as soon as possible.

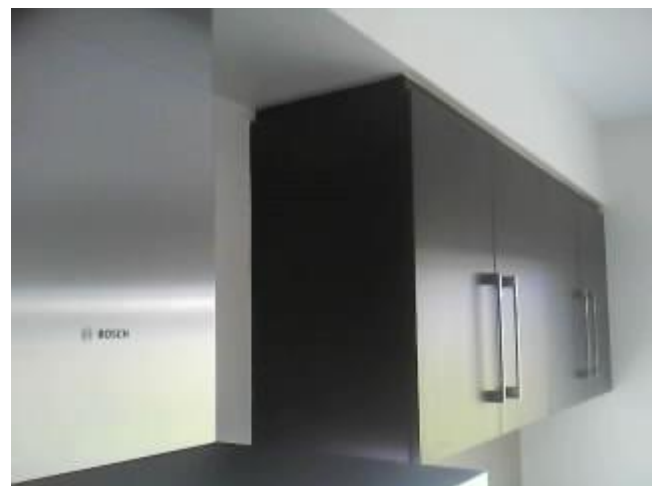
Built-in-Fittings Defect/Observation

Built-In-Fittings	Overhead Cupboards
Location	Kitchen, Ground floor South-eastern side of the building
Element	Door Hinges
Defect/Observation	Poorly adjusted (1 x door binding on hinge side edge strip of cupboard)
Extent	Localised
Recommendation	This defect should be addressed by a Licensed Tradesperson as soon as possible.

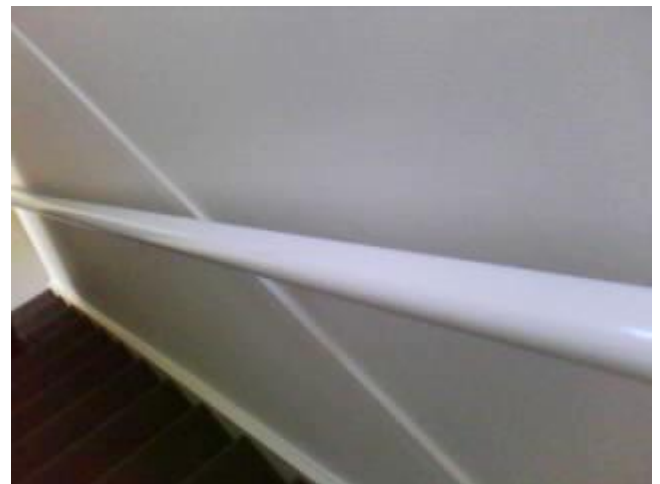
Woodwork Defect/Observation

Woodwork	Handrail
Location	Stairwell
Element	Paintwork
Defect/Observation	Scratch marks
Extent	Localised
Recommendation	This defect should be addressed by a Licensed Tradesperson as soon as possible.

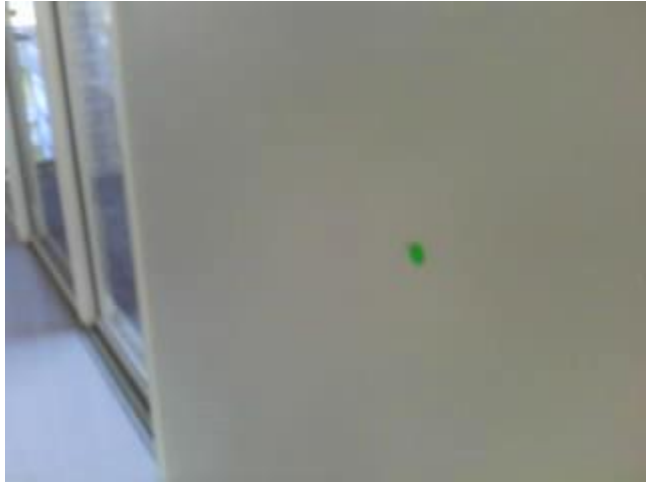
Other Internal Detail Defect/Observation

Element	Paintwork

Location	Hallway, Entry level In general	
Defect/Observation	Deterioration	
Extent	Localised	
Recommendation	Repainting is required.
