Pre-Purchase Building Inspection & Report - Residential Building

Visual Timber Pest Inspection & Report

SAMPLE ONLY

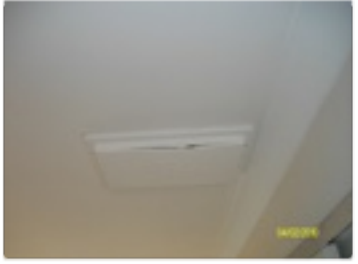
Description of Area	Type of Defect	Description & Significance of Defects Noted	Image
<p>Ceilings Plasterboard</p> <p>Note. Inspection hatch in laundry ceiling under Bathroom. (Screw fixed)</p>

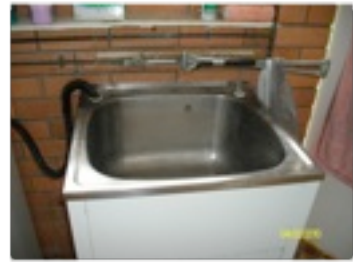
Description of Areas Inspected	Type of Defect	Description & Significance of Defects Noted	Image
<p>Stainless steel tub / Metal cabinet Surface mounted plumbing - Tapware turned on and visually checked for leaks No splashback tiles Natural ventilation - window Ceramic tiled floor</p>

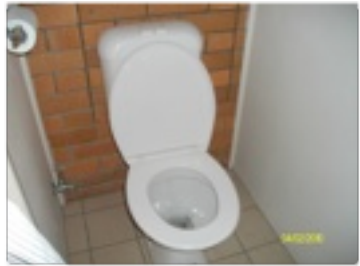
Description of Areas Inspected	Type of Defect	Description & Significance of Defects Noted	Image
<p>Floor Ceramic tiled floor / floor waste sighted</p> <p>Wall Tiles Skirting & splashback tiles</p>			
<p>Cistern and Pan Cistern flushed and visually checked for leaks</p>

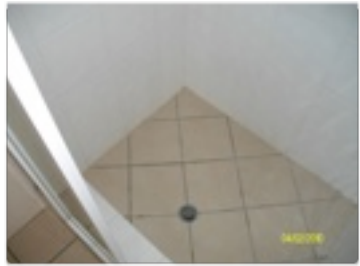
<p>Shower Tiled recess / Glass shower screen Tapware turned on & visually checked for leaks</p>

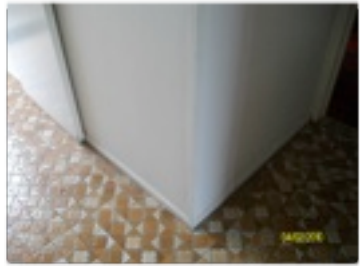
<p>Vanity Single hand basin / laminate vanity Tapware turned on & visually checked for leaks</p>			
<p>Moisture Testing Tested wall in Laundry backing on to shower recess - no excess moisture detected</p> <p>Ventilation Natural ventilation - window</p>

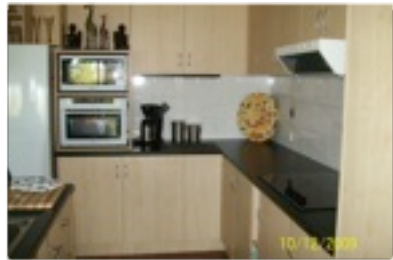
Description of Areas Inspected	Type of Defect	Description & Significance of Defects Noted	Image
<p>Renovated Laminate cupboards / benchtops Splashback tiles</p> <p>Appliances Installed Under bench oven, cooktop, rangehood - Operation of appliances not tested – not part of scope of inspection.</p>

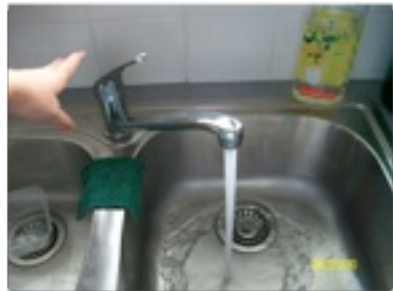
<p>Sinks /Taps 1.5 bowl stainless steel sink Tapware turned on</p>

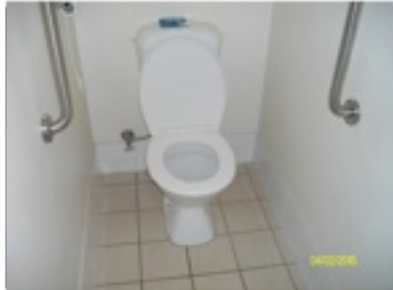
Description of Areas Inspected	Type of defect	Description & Significance of Defects Noted	Image
<p>Floor Ceramic tiled floor / No floor waste sighted</p> <p>Wall Tiles Skirting tiles</p>			
<p>Cistern and Pan Cistern flushed and visually checked for leaks</p> <p>Ventilation Natural ventilation - window</p>

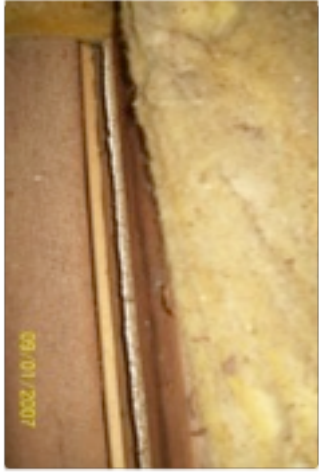
<p>Wall Frames Hardwood top plates sighted</p>
