Building Inspection Report

25 Intrepid Lane, The Placetobe, 7171

Inspection prepared for: Gary Brown Inspection Date: 1/6/2011 Time: 3.55pm Age: 2004

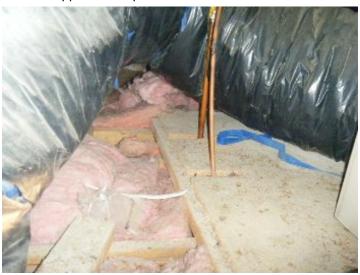
3. Insulation Condition

Insulation averages 125 to 150mm.
Observations:
Insulation appears adequate.

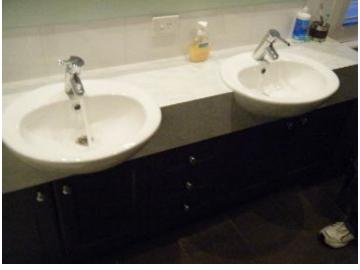
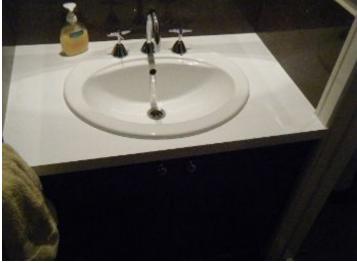
The sink and related components functioned normally when tested.

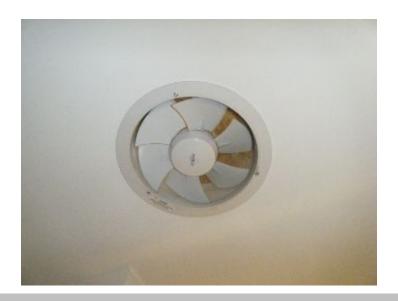
3. Exhaust Fan

- The bathroom exhaust fans responded to normal user controls.
- The toilet exhaust fans responded to normal user controls.

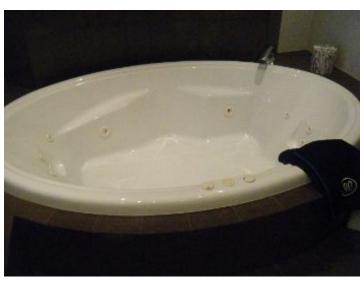
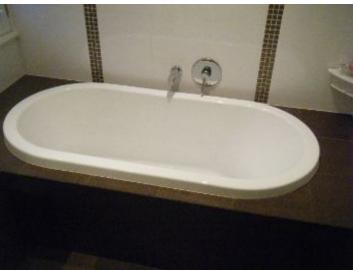
6. Bath Tubs

•	J. D	atti	1 455							
1	/AINT	PREV	MONIT	DEFR	DEFIC					
Г						Observations:				
				Х		The bath tub and related components operated normally when tested.				
L						• Spa bath upstairs was noted but it was not tested as this is not part of our inspection. This				
						should be filled to the minimum level and tested at the final inspection.

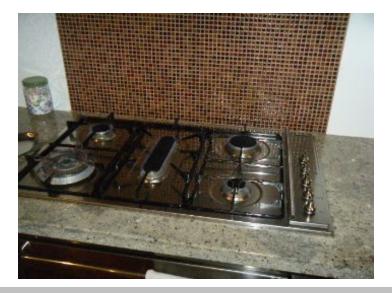
1. Cook top condition

• Gas cook top noted and operated normally when tested.

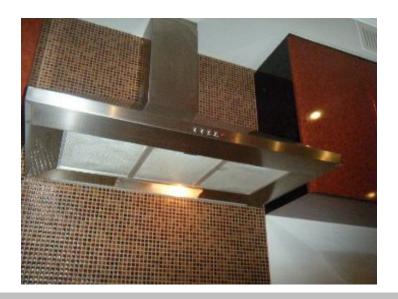
6. Vent Condition

MAINT	PREV	MONIT	DEFR	DEFIC	. Na Aprila 1 and
					Materials: The built in vent hood responded normally to user controls
					•
I	l	1	l	I

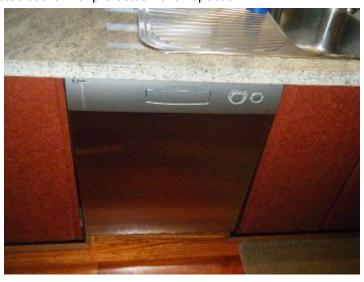
7. Dishwasher

• Dishwasher was not tested as this is not within the scope of our inspection. This should be tested at the final pre-settlement inspection.

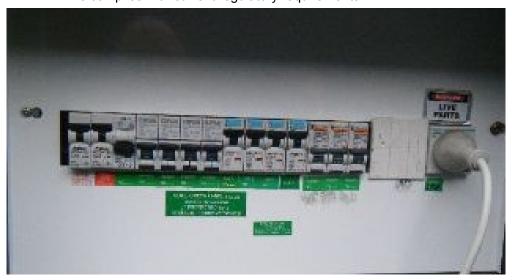
1. Electrical Panel

• There are at least 2 RCD's installed which protect both the powerpoint and light circuits. This complies with current regulatory requirements.

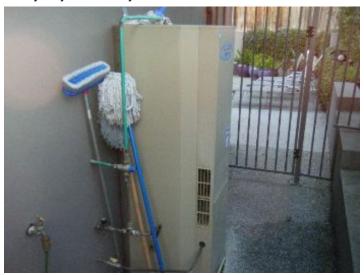
1. Water Heater Condition

• No major system safety or function concerns noted at time of inspection.

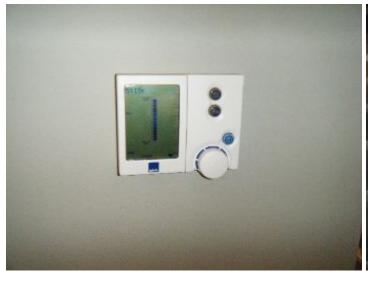
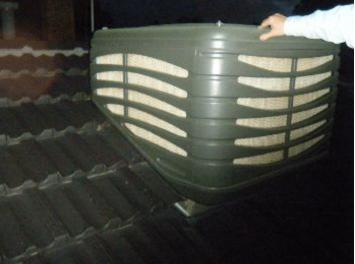
1. Evaporative Air Conditioner

Comment: The central evaporative air conditioner system was tested and responded to normal user controls.

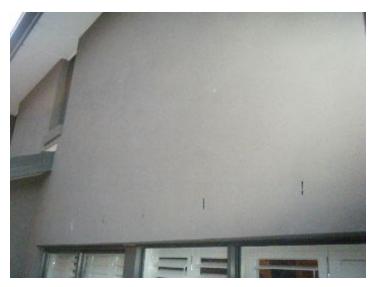
2. Render

MAINT	PREV	MONIT	DEFR	DEFIC	Observations
					Observations: • Appears satisfactory.
					rippodio odilolaciony.

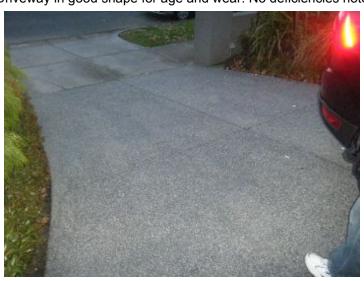
1. Driveway and Walkway Condition

MAINT	PREV	MONIT	DEFR	DEFIC	Matadala Anna da Maria
					Materials: Concrete driveway noted.
					Observations:
					Driveway in good shape for age and wear. No deficiencies noted

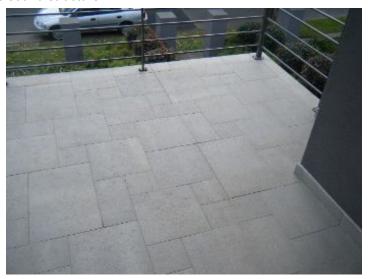
3. Balcony

• Appears in satisfactory and functional condition with normal wear for its age. Appears to be sound structure.

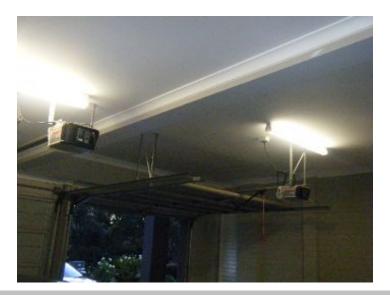
2. Garage Door Condition

MAINT	PREV	MONIT	DEFR	DEFIC	Matadala o u u u u
					Materials: Sectional door noted.
					Observations:
					• No deficiencies observed.

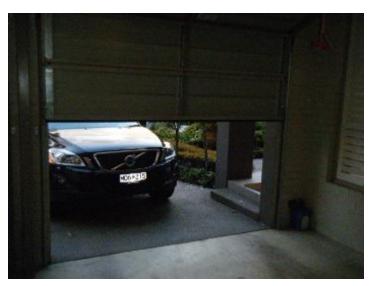
3. Garage Opener Status

• Appeared functional using normal controls, at time of inspection.

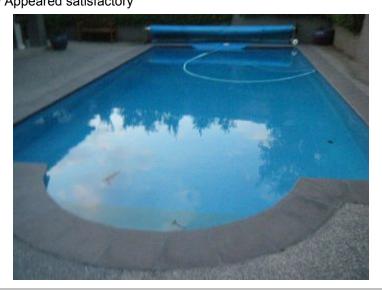
3. Structure Condition

Type: Below ground
Materials: Vinyl
Observations:
• Appeared satisfactory
