# **Building Inspection Report**

25 Intrepid Lane, The Placetobe, 7171

Inspection prepared for: Gary Brown Inspection Date: 1/6/2011 Time: 3.55pm Age: 2004

Weather: Overcast
\*\*\*\* Sample Inspection Report \*\*\*\*

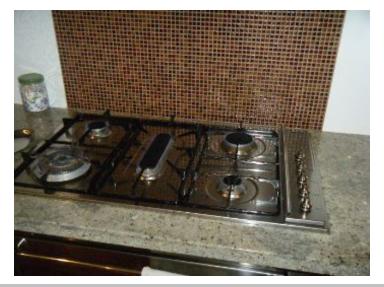
# 1. Cook top condition MAINT PREV MONIT DEFR DEFIC

• Gas cook top noted and operated normally when tested.

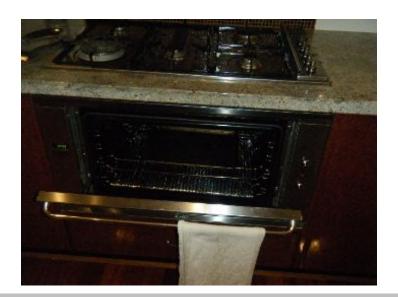
## 2. Oven & Range

IVIAINI	PREV	MONII	DEFR	DEFIC	Observations
						Observations:
						• The electric oven elements were tested at the time of inspection and appeared to function
Ų						properly.

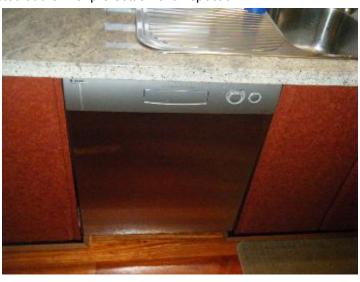
#### 7. Dishwasher

• Dishwasher was not tested as this is not within the scope of our inspection. This should be tested at the final pre-settlement inspection.

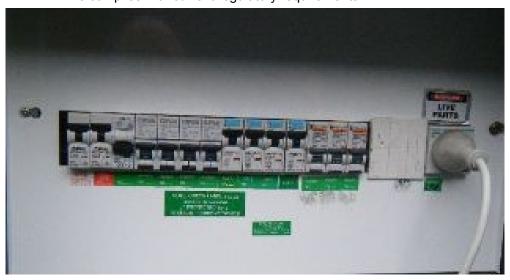
### 1. Electrical Panel

• There are at least 2 RCD's installed which protect both the powerpoint and light circuits. This complies with current regulatory requirements.

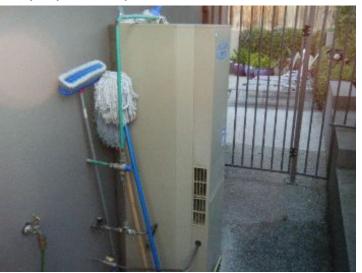
### 1. Water Heater Condition

• No major system safety or function concerns noted at time of inspection.

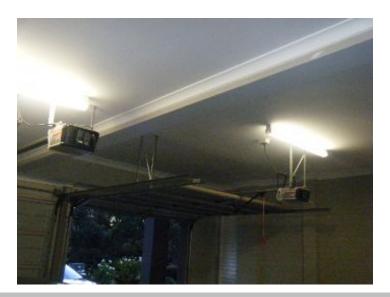
## 2. Garage Door Condition

MAINT	PREV	MONIT	DEFR	DEFIC	Material and the state of the s
					Materials: Sectional door noted. Observations:
					No deficiencies observed

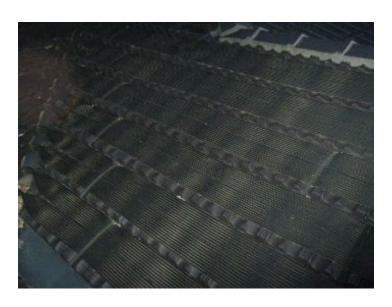
MAINT PREV MONIT DEFR DEFIC Materials: A solar pool water heating system was noted.

• The solar heating system was not tested as it is not within the scope of our inspection.
