Building Inspection Report

25 Intrepid Lane, Placetobe Lane, 7171

Inspection prepared for: Gary Brown Inspection Date: 1/6/2011 Time: 3.55pm

Resicert Structural Plus Inspection

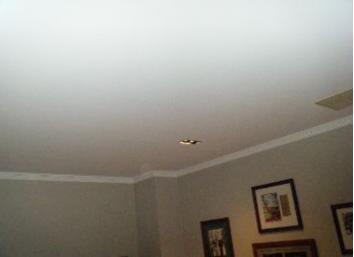
MAINT	PREV	MONIT	DEFR	DEFIC	Materials:
					Materials:
					 The ceilings are gyprock which appear to be functional.

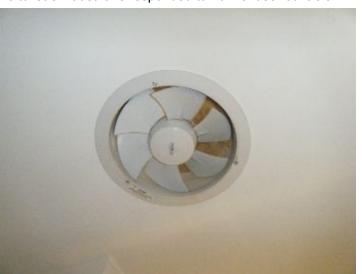
- Observations:
 The bathroom exhaust fans responded to normal user controls.
 The toilet exhaust fans responded to normal user controls.

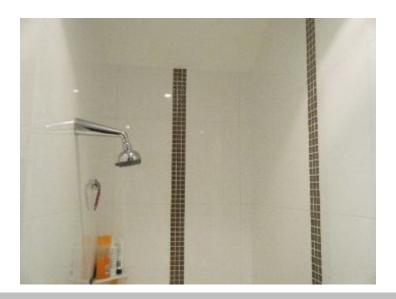
MAINT	PREV	MONIT	DEFR	DEFIC	
					Observations:
					• The shower(s) and related components operated normally when tested.

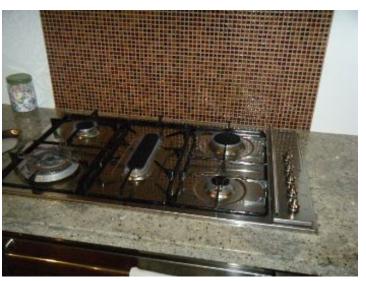
MAINT	PREV	MONIT	DEFR	DEFIC	Observations
					Observations:
					 Gas cook top noted and operated normally when tested.

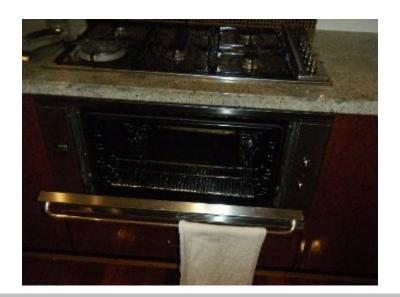
MAIN	T PREV	MONIT	DEFR	DEFIC	Observations
					Observations:
					• The electric oven elements were tested at the time of inspection and appeared to function
		-			properly.

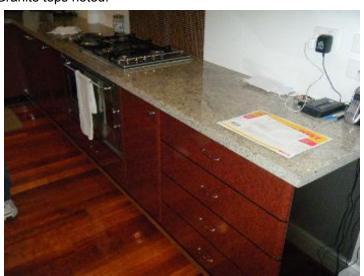
IVIZILIAI	1 1 LL V	IVICIALI	DLIII	DLITO	OL C
						Observations:
						 Appeared functional at time of inspection.
ı						Granite tops noted

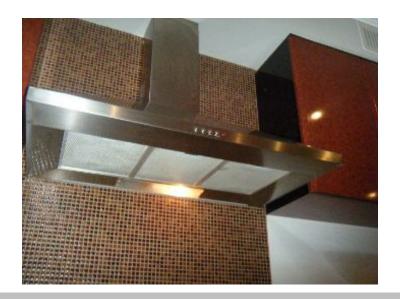
IVIAINI	PREV	MONT	DEFR	DEFIC	Matadala 1 1 11 11 11 11 11 11 11 11 11 11 1
					Materials: The built in vent hood responded normally to user control
i		I		l	,,,,
		I		l

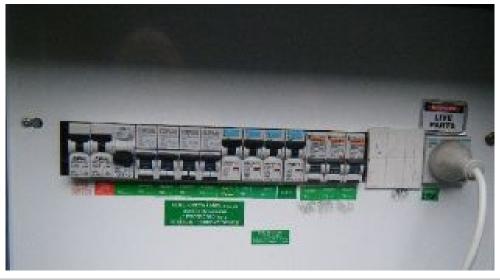
• There are at least 2 RCD's installed which protect both the powerpoint and light circuits. This complies with current regulatory requirements.

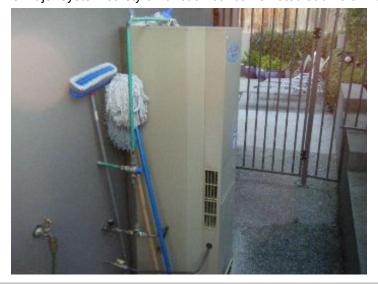
Observations:
• No major system safety or function concerns noted at time of inspection.

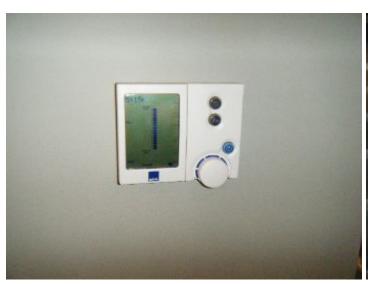
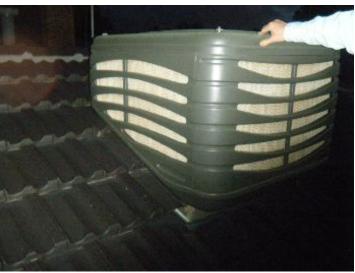
MAINT	PREV	MONIT	DEFR	DEFIC	0.0000000000000000000000000000000000000
					Comment: The central evaporative air conditioner system was tested and responded to
		1			normal user controls.

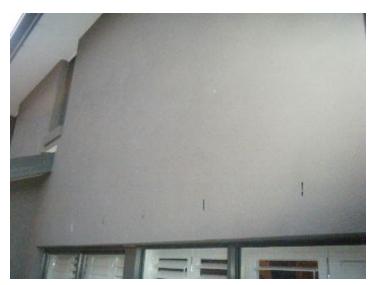
MAINI	PREV	MONII	DEFR	DEFIC	OL
					Observations:
					 Appears satisfactory.

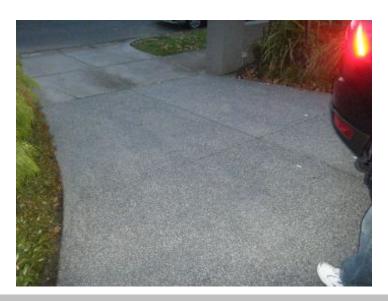
MAINT	PREV	MONIT	DEFR	DEFIC	- NA state data con the state of the state o
					Materials: Concrete driveway noted.
					Observations:
				•	 Driveway in good shape for age and wear. No deficiencies noted.

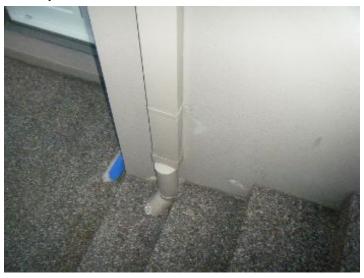
• Surface drainage conditions within 3 metres of the inspected structure(s) appeared satisfactory.

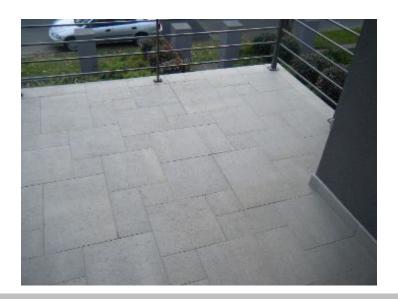
• Appears in satisfactory and functional condition with normal wear for its age. Appears to be sound structure.

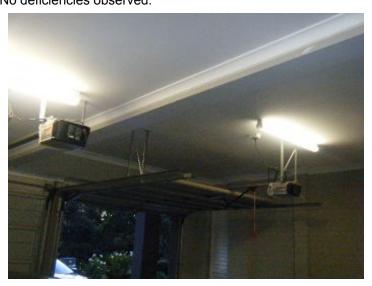
MAINI	PREV	MONII	DEFR	DEFIC	Matadala a di unioni di Matadala a di managara di Matadala di Matadala di Matadala di Matadala di Matadala di M
					Materials: Sectional door noted
					Observations:
					• No deficiencies observed

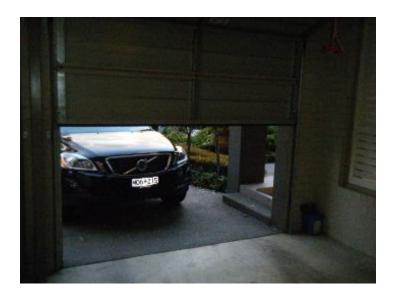
MAINT	PREV	MONIT	DEFR	DEFIC	Observations
					Observations:
					Observations: • Appeared functional using normal controls, at time of inspection.

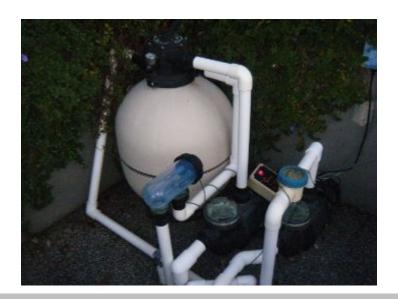
MAINT	PREV	MONIT	DEFR	DEFIC	01
					Observations: • Operated normally when tested.

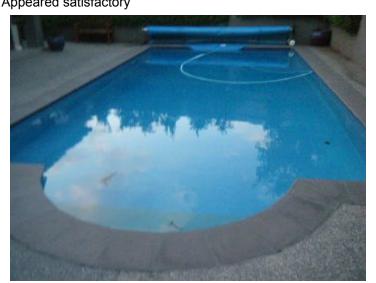
Type: Below ground
Materials: Vinyl
Observations:
• Appeared satisfactory

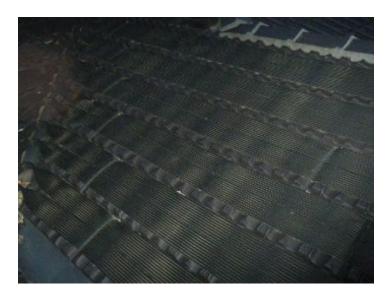
• The solar heating system was not tested as it is not within the scope of our inspection.
