REPORT

PROPERTY	
VENDORS AGENT	
BUILD DATE	c1960's FRONT ORIENT East
OWNER	N/A
DATE	16th Mar 14 NO. PAGES 3

Building Defect Report

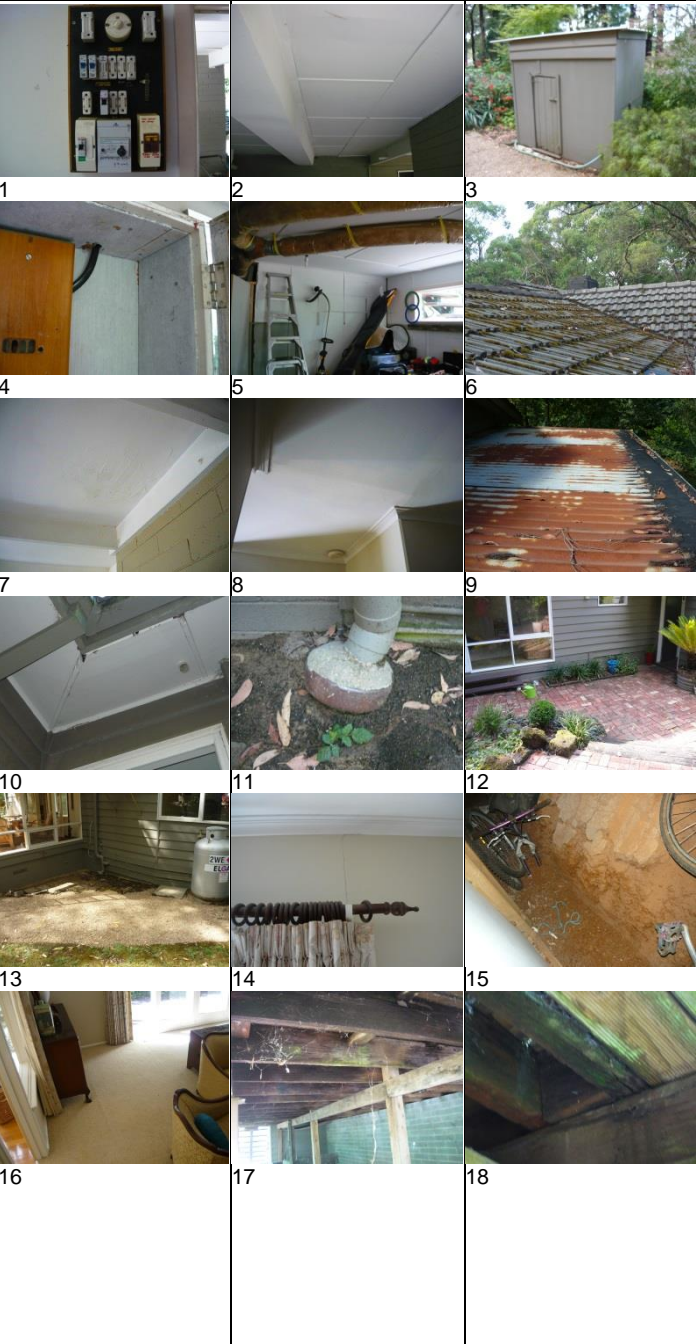
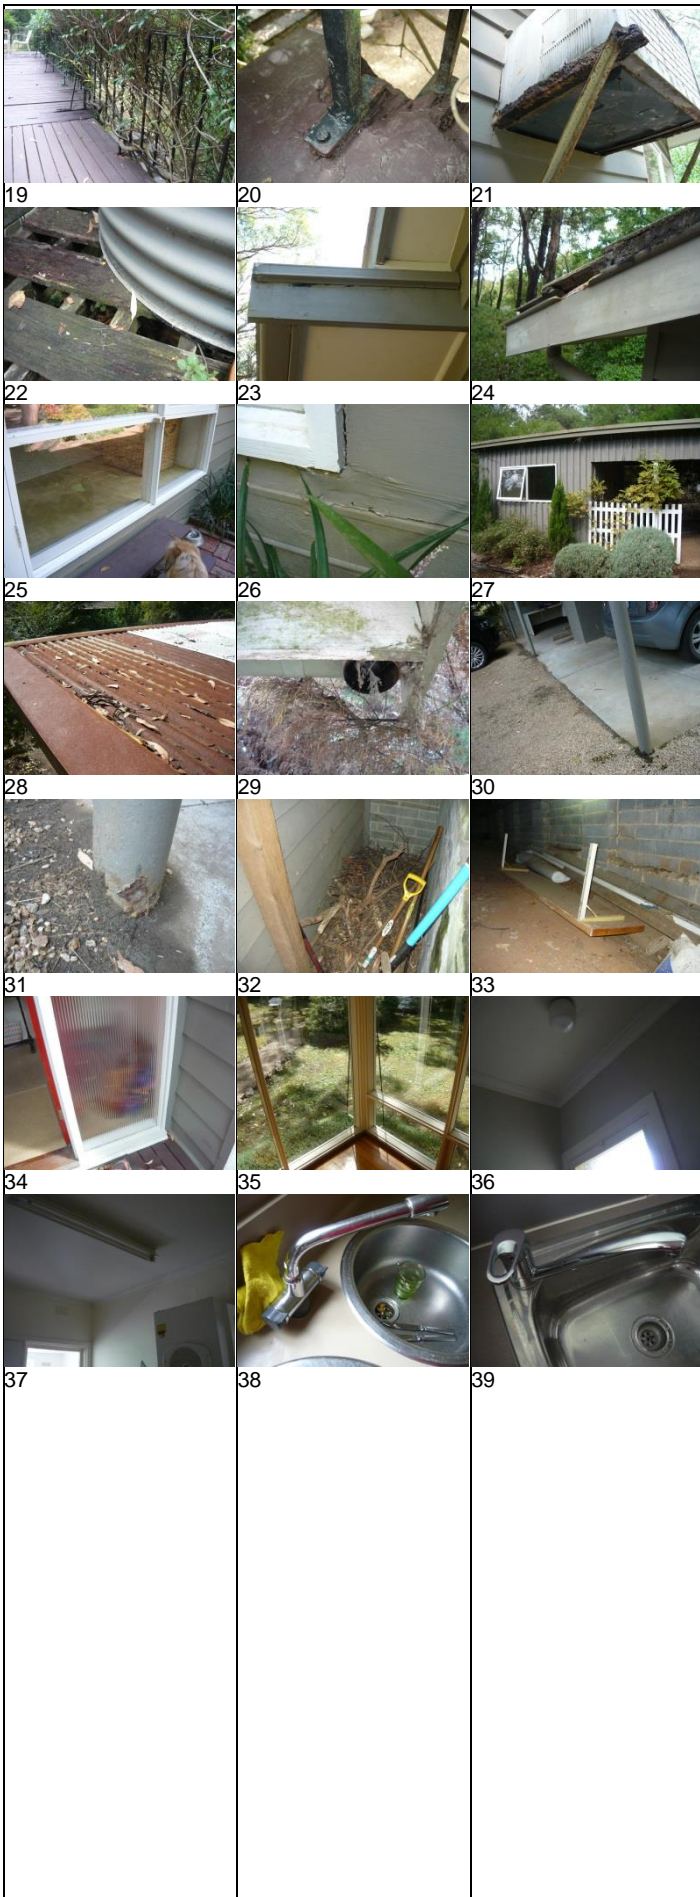
1. Power supply is protected by RCD safety switch on power circuits; light circuits appear to be unprotected; recommend safety testing and upgrading as possible by licensed electrician;

2. Carport ceiling sheet lining material is assumed to contain asbestos; sample lab testing is strongly recommended; asbestos is considered dangerous to occupants of house as exposed side of asbestos sheet in roof space is abraded by dust and breeze, resulting in airborne asbestos particles being capable of entering the house through down lights, exhaust fans, air vents, etc; it is strongly recommended that all asbestos products, materials and contaminated materials are removed from the premises and a vacuum clean-up of affected areas is undertaken by a licensed asbestos contractor prior to your occupation;

3. Garden shed exterior lining material is assumed to contain asbestos; act as for defect 2;
4. Electrical meter box interior lining material is assumed to contain asbestos; act as for defect 2;

5. Workshop wall and ceiling lining material is assumed to contain asbestos; act as for defect 2;
6. Roof tiles have developed fungus/moss growth; this is capable of causing roof leaks (see defects 7,8); surface cleaning is recommended;

7. Stained ceiling is evidence of past and/or present roof leak;
8. As for defect 7;
9. Skillion roof surface on house South is heavily rusted;
10. Eave sheet lining material is assumed to contain asbestos; act as for defect 2;

11. Original earthenware storm water pipe system appears to still be in use; these pipes are commonly collapsed and/or blocked; recommend installation of replacement PVC storm water pipes;

12. Area of paving on South side has no surface drainage; rain water run-off is entering the sub-floor space of the house; this defect has and/or will cause subsidence of the floor and wall footing in addition to creating a termite conducive environment; (see defects 14,15,16);

13. Un-drained paved area on South West side; see defect causes item 12;
14. Wall subsidence crack (see cause defects 11,12,13);
15. Evidence of entry of rain water surface run-off to house sub-floor area; (see defects 11,12,13,14);

16. Area of floor affected by stump subsidence (see defects 11,12,13,14,15);
17. North front deck structure is dilapidated; recommend replacement;
18. Evidence of timber rot in front deck; (see item 17);

19. Front deck metal balustrade is rusted, becoming disconnected from the deck structure and additionally is below BCA minimum required height;
20. Example of rusted and/or rotted deck balustrade mounting;

21. Air conditioner metal brackets are heavily rusted and capable of collapse;
22. Timber water tank mounting structure is heavily rotted;
23. Timber rot is present of fascia boards;

24. As for defect 23;
25. Joinery glazing in lower window panes is considered below BCA safety weight/type and may be dangerous to children; re-glazing in laminated glass or application of professionally installed self-adhesive safety film is recommended;

26. Example of timber rot in house weather boards;
27. Stable building;
28. Stable roof sheets are partially rusted;
29. Stable roof down pipe is missing;

30. Base of steel posts supporting East section of house are rusting;
31. Example of rusting base of steel support posts (see defect 30);
32. Collected timber stored adjacent to house wall is conducive to termite infestation;

33. Discarded timber in the house sub-floor area is conducive to termite infestation;
34. Joinery glazing in front door side light panes is considered below BCA safety weight/type and may be dangerous to children; re-glazing in laminated glass or application of professionally installed self-adhesive safety film is recommended;

35. As for defect 34;
36. Toilet has no form of forced air ventilation;
37. Laundry has no form of forced air ventilation;
38. Pipe hammer is present on hot supply mixer tap;

39. As for defect 38.
